FACILITY CONDITION ASSESSMENT

EDWARD KELLY PRESCHOOL
3340 Bradshaw Road
Sacramento, California 95827

June 9, 2020

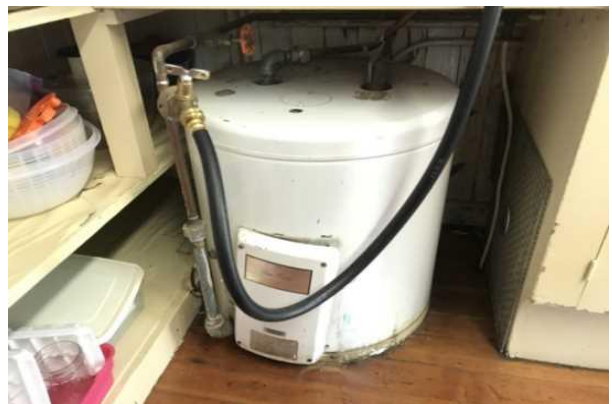
#12	WATER HEATER, ELECTRIC
-----	------------------------

Water Heater in Poor condition.

The unit is well past the manufactures expected useful life should be replaced with a more efficient unit. - AssetCALC ID: 1466021

Uniformat Code: D2023
Recommendation: **Replace in 2019**

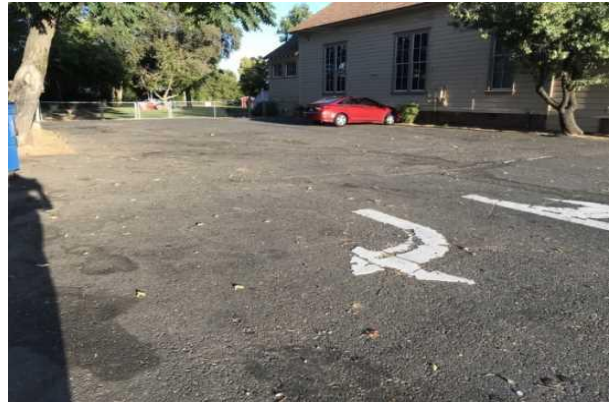
#18	PARKING LOT, ASPHALT
-----	----------------------

The parking lots and sidewalks are in poor condition. The asphalt walkways throughout the site are cracking and require patching and sealing. The parking lot requires sealing and striping, and some areas require cutting and patching. Site lighting is in fair condition but is inadequate. Play structures and play areas are in fair condition.
