FACILITY CONDITION ASSESSMENT

SACRAMENTO CITY UNIFIED SCHOOL DISTRICT

ALICE BIRNEY PUBLIC WALDORF

June 10, 2020

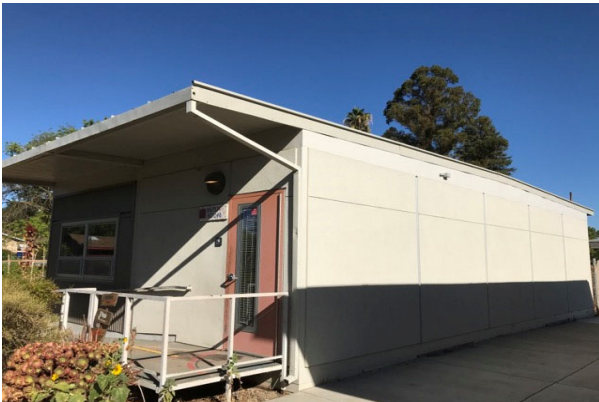
| #9 | BUILDING P06 |

The moisture issue at Building P06 may be from insufficient ventilation. The classroom has an interior fan coil unit and two gravity vents on the roof, but no outside air intake was observed. Costs are included in the cost tables for a mechanical review of the building, including amounts to remedy the problem.

Excessive moisture and humidity, Condensation and moisture collects on stringed instruments. There appears to be no fresh air intake in portable classroom. The roof has two gravity vents but apparently no fresh air. Proposed cost includes cost to fix the problem. - AssetCALC ID: 1448227
