FACILITY CONDITION ASSESSMENT

Sacramento City Unified School District
5735 47th Avenue
Sacramento, California 95824

G.W. CARVER SCHOOL OF ARTS AND SCIENCE
10101 Systems Parkway
Sacramento, California 95827

June 15, 2020

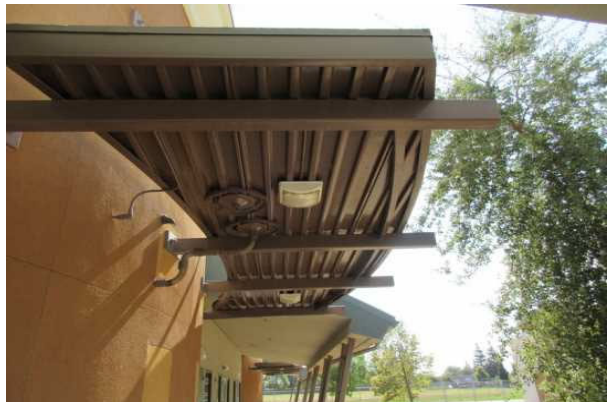
#12	METAL CANOPY
-----	--------------

Paint is peeling off metal canopies. Canopies should be repainted to prevent weather deterioration. - AssetCALC ID: 1348820
