# FACILITY CONDITION ASSESSMENT

SACRAMENTO CITY UNIFIED SCHOOL DISTRICT  
5735 47<sup>th</sup> Avenue  
Sacramento, California 95824

HIRAM JOHNSON HIGH SCHOOL  
6879 14th Avenue  
Sacramento, California 95820

June 17, 2020

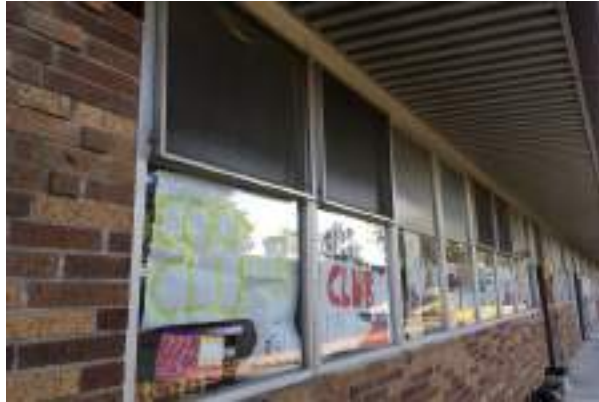
#7	C WING TO F WING, STOREFRONT, METAL-FRAMED WINDOWS
----	--

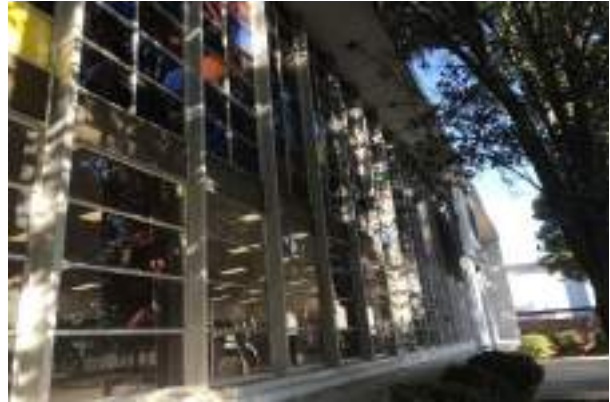
#8	015 CAFETERIA, CURTAIN WALL, ALUMINUM-FRAMED SYSTEM WITH GLAZING
----	--

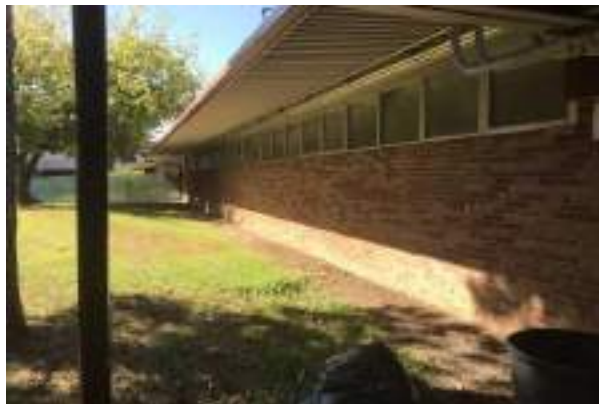
#9	C WING TO F WING, EXTERIOR WALL, BRICK, 1-2 STORIES
----	---

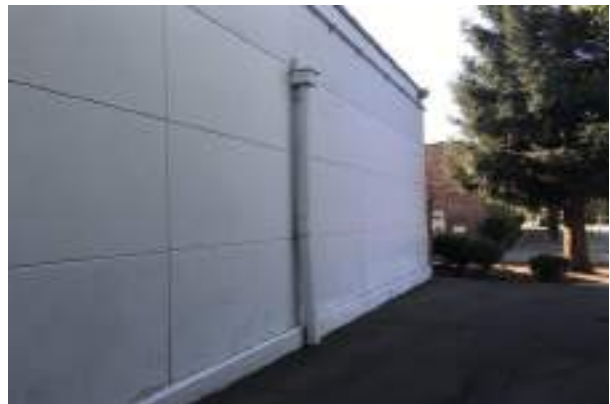
#10	015 CAFETERIA, PAINTED CONCRETE
-----	---------------------------------

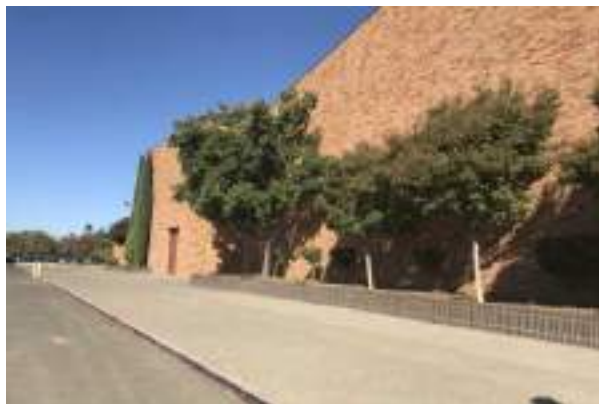
#11	16A AUDITORIUM, EXTERIOR WALL, BRICK, 1-2 STORIES
-----	---

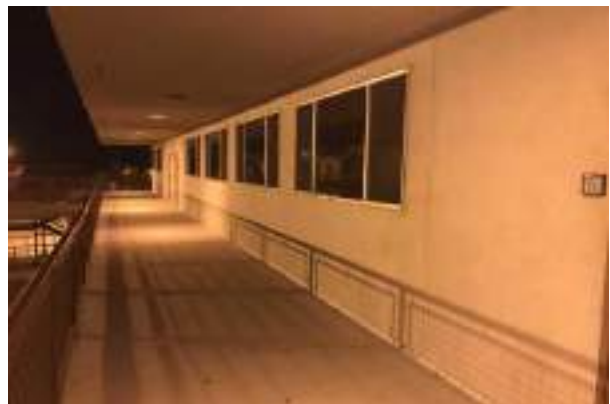
#12	P02 X04-X08, EXTERIOR WALL, STUCCO, 1-2 STORIES
-----	---

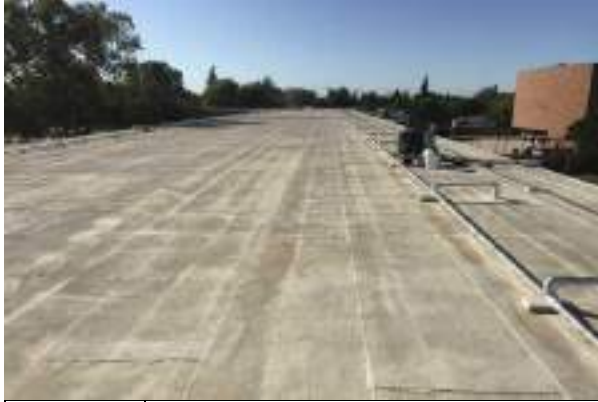
#13	001 A WING, B WING, ROOF, MODIFIED BITUMINOUS
-----	---

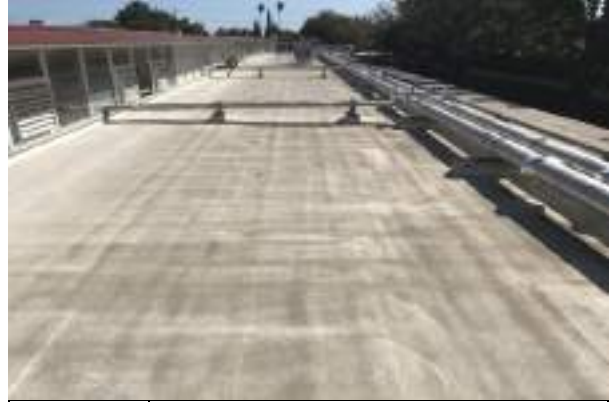
#14	011 S WING W ROOF, SINGLE-PLY TPO/PVC MEMBRANE
-----	--

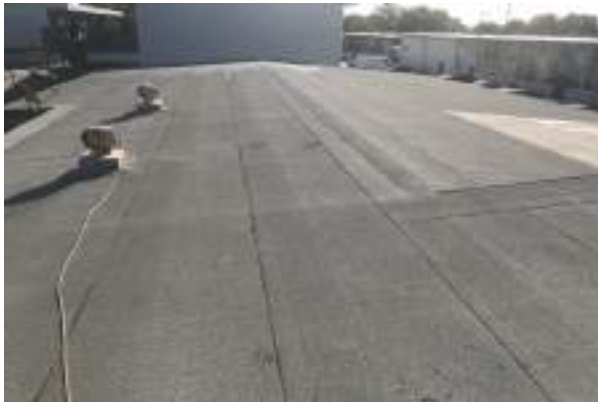
#15	013 ROTC, ROOF, MODIFIED BITUMINOUS
-----	-------------------------------------

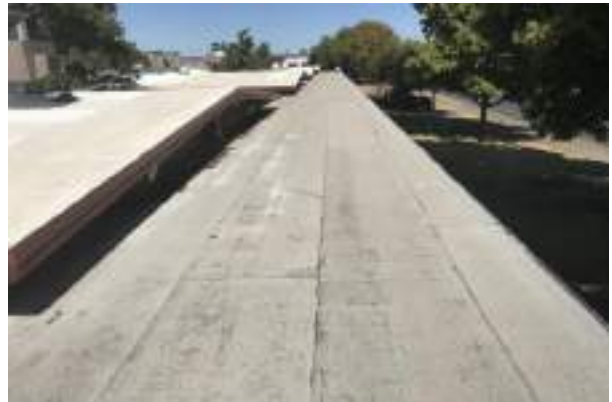
#16	SITE, COVERED WALKWAY ROOF, MODIFIED BITUMINOUS
-----	---

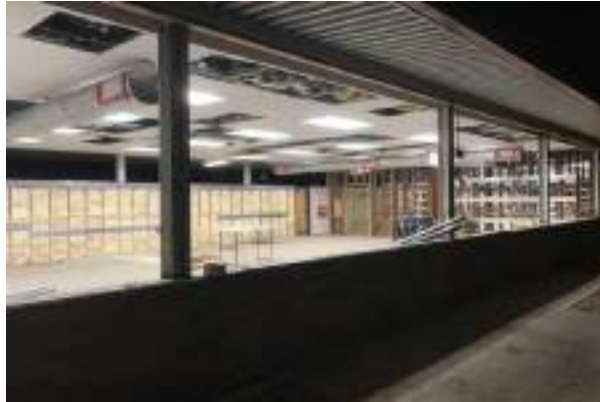
#19	E WING AND F WING CONSTRUCTION
-----	--------------------------------

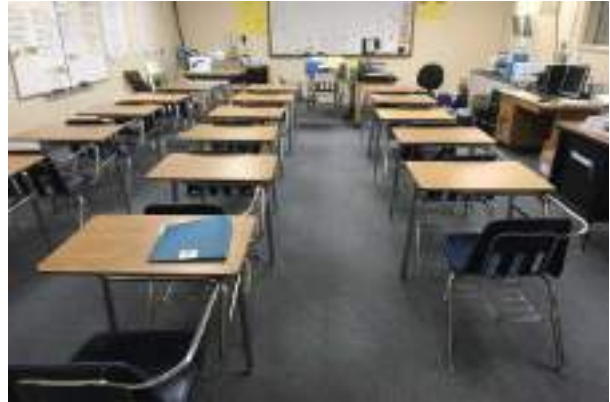
#20	011 S WING W, INTERIOR FLOOR FINISH, CARPET COMMERCIAL STANDARD
-----	---

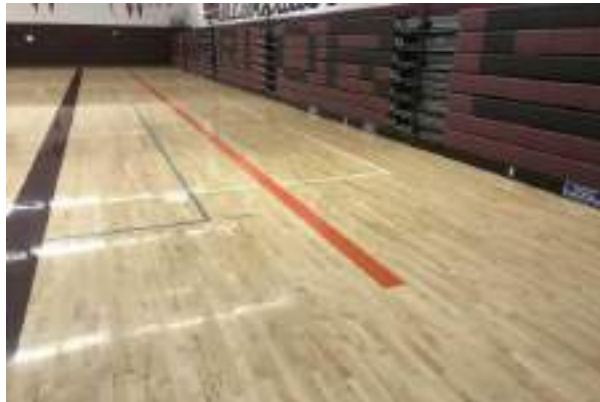
#21	014 GYMNASIUM, INTERIOR FLOOR FINISH, MAPLE SPORTS FLOOR
-----	--

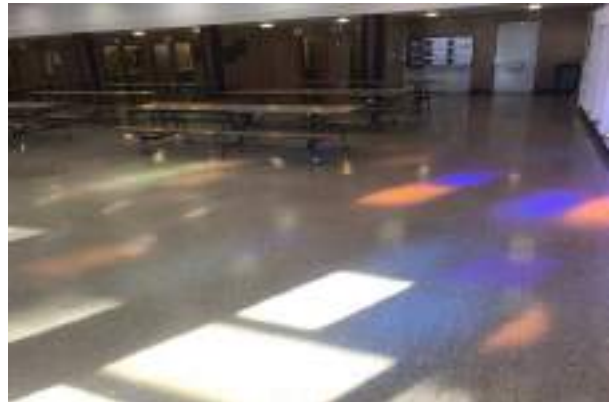
#22	015 CAFETERIA, INTERIOR FLOOR FINISH, CERAMIC TILE
-----	--

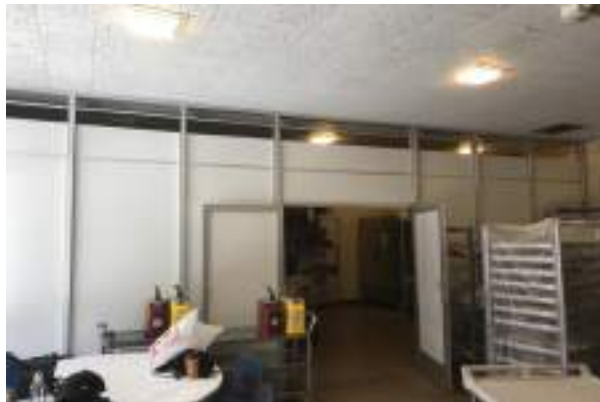
#23	015 CAFETERIA BREAK ROOM, INTERIOR WALL FINISH, PLATE GLASS
-----	---

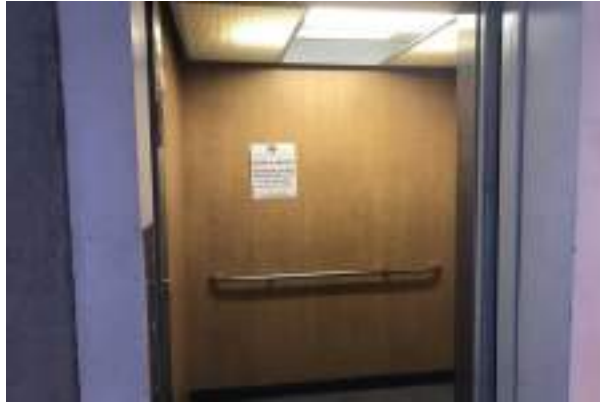
#31	P02 X04-X08, ELEVATOR CAB FINISHES
-----	------------------------------------

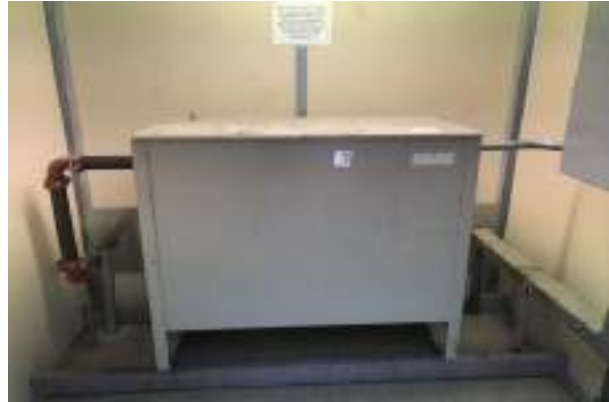
#32	P02 X04-X08, ELEVATOR, HYDRAULIC
-----	----------------------------------

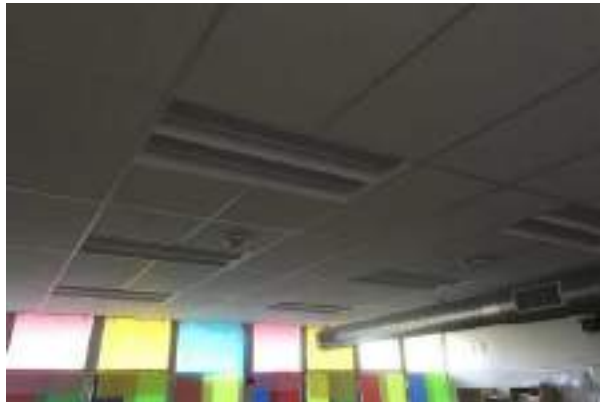
#33	C WING AND D WING, LED LIGHTING SYSTEM
-----	--

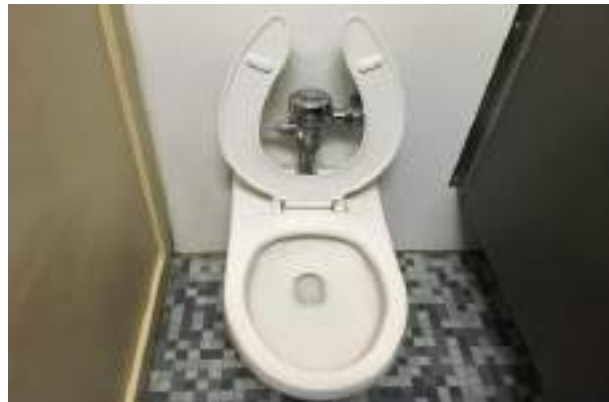
#36	TOILET, COMMERCIAL WATER CLOSET
-----	---------------------------------

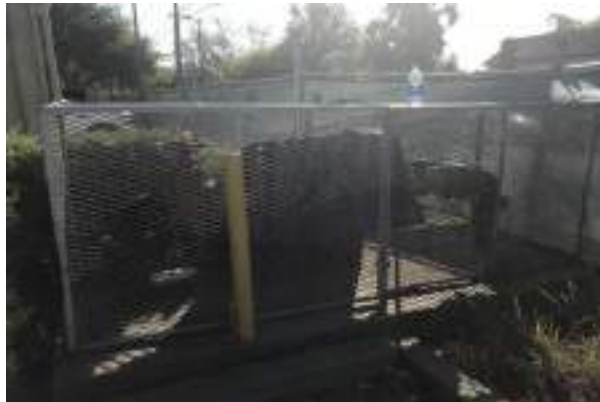
#39	BACKFLOW PREVENTER, DOMESTIC
-----	------------------------------

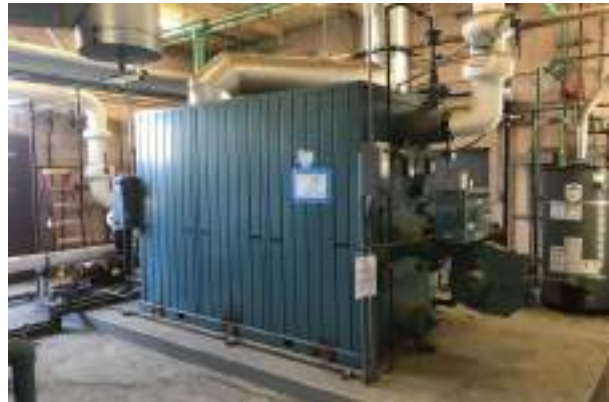
#40	013 ROTC, HEATING HOT WATER PLANT BOILER
-----	--

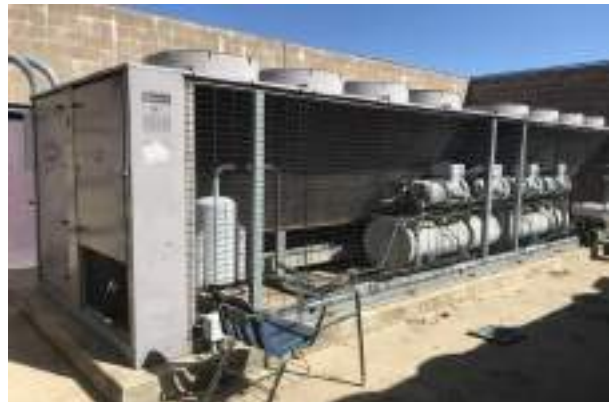
#42	013 ROTC, CHILLER, AIR-COOLED
-----	-------------------------------

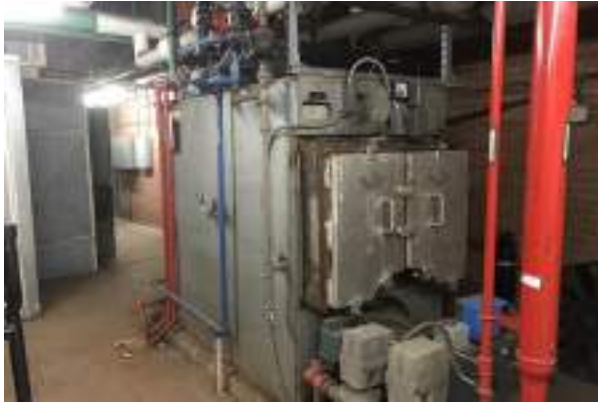
#43	16A AUDITORIUM, DOMESTIC BOILER, GAS
-----	--------------------------------------

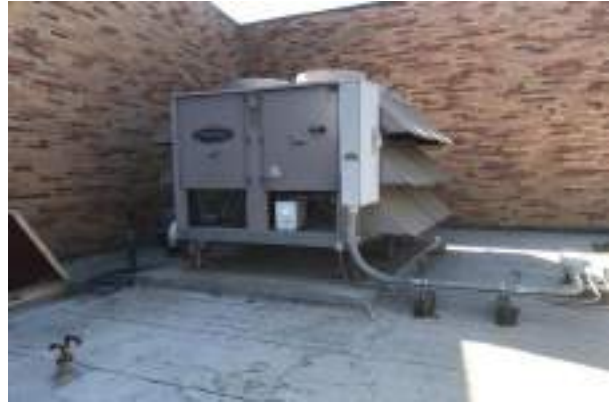
#44	16A AUDITORIUM, CHILLER, AIR-COOLED
-----	-------------------------------------

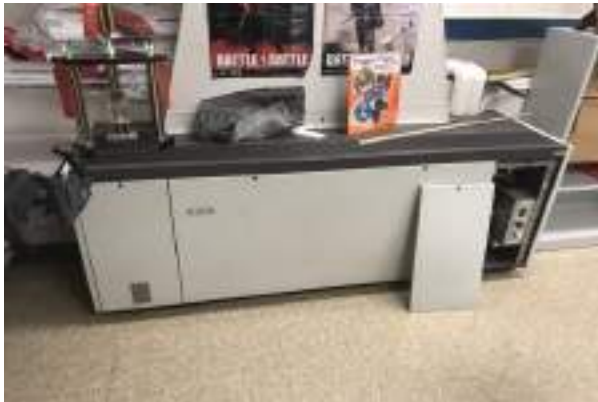
#45	001 A AND B WING, CLASSROOM UNIT VENTILATOR
-----	---

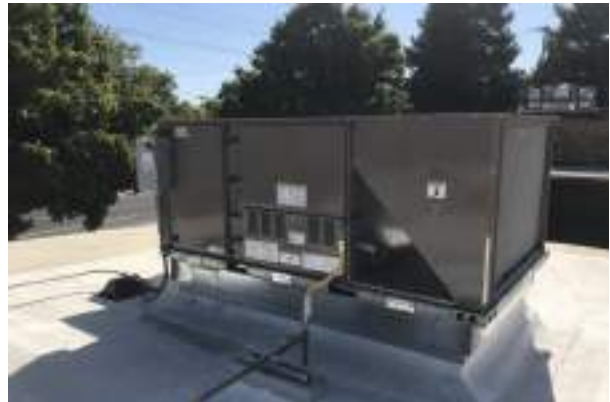
#46	C-F WING, ROOFTOP PACKAGED UNIT
-----	---------------------------------

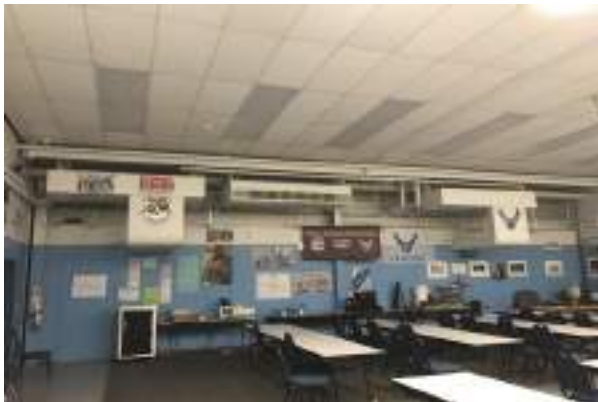
#47	011 AND 012 S WING, UNIT VENTILATOR
-----	-------------------------------------

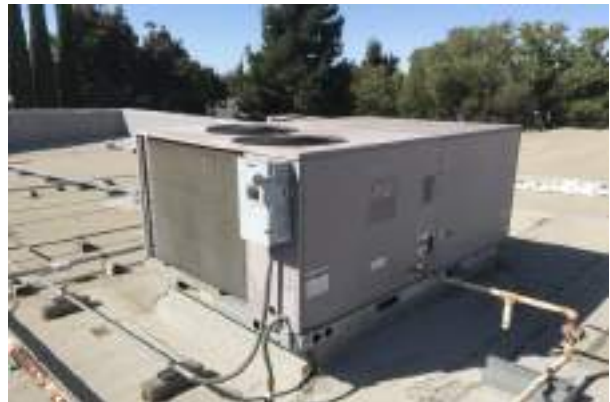
#48	015 CAFETERIA, ROOFTOP PACKAGED UNIT (RTU)
-----	--

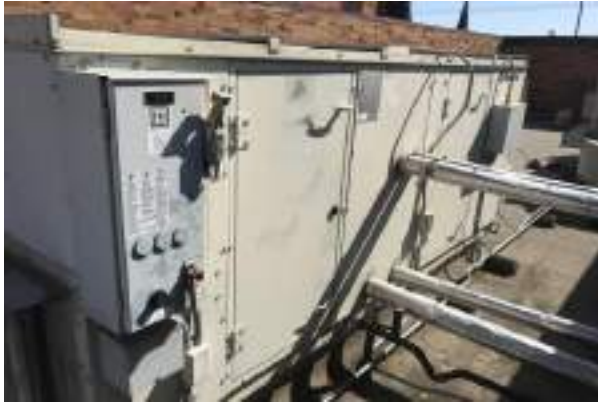
#49	16B ROOFTOP, AIR HANDLER (AHU), EXTERIOR
-----	--

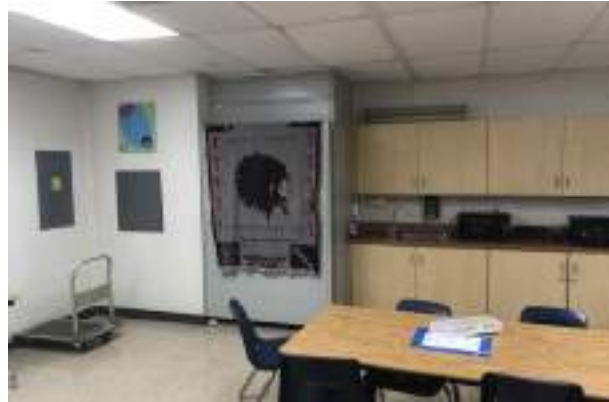
#50	P01-P03, CLASSROOM HEAT PUMP
-----	------------------------------

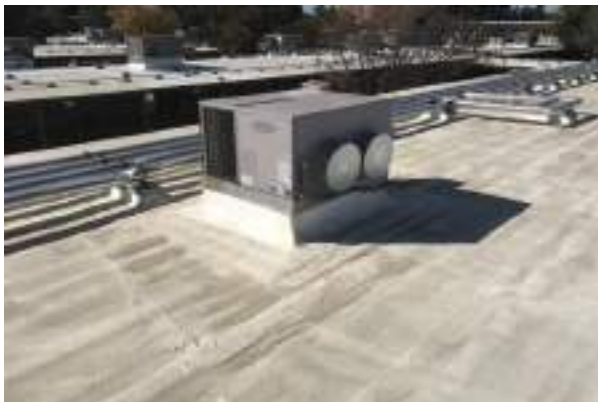
#51	HEATING AND CHILLED WATER PIPING ON ROOF
-----	--

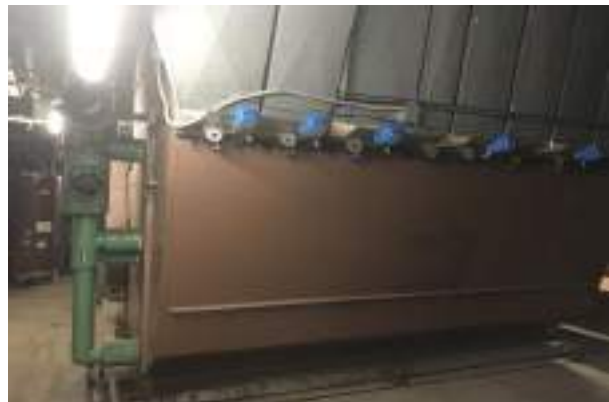
#52	16A AUDITORIUM, AIR HANDLER (AHU), INTERIOR
-----	---

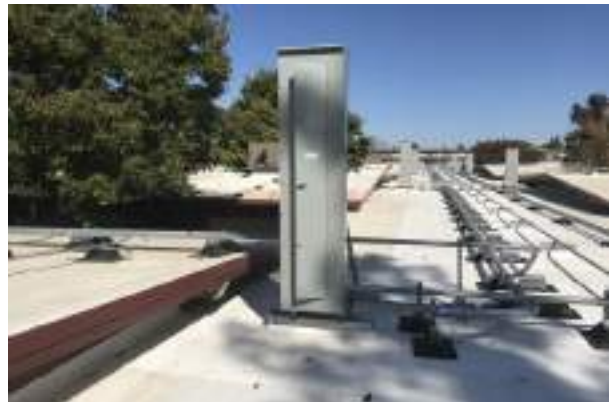
#54	C WING - F WING, ROOFTOP MAIN DISTRIBUTION PANEL
-----	--

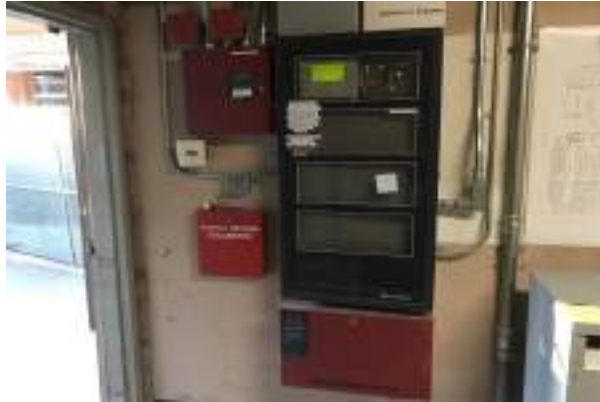
#55	001 A WING, B WING, FIRE ALARM CONTROL PANEL, BASIC/ZONED
-----	---

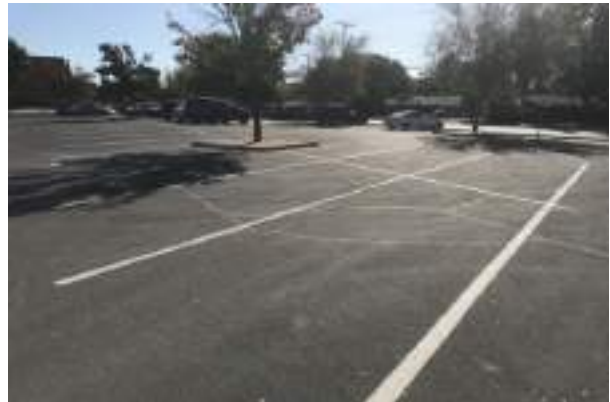
#58	PARKING LOTS, ASPHALT PAVEMENT
-----	--------------------------------
