FACILITY CONDITION ASSESSMENT

ISADOR COHEN ELEMENTARY SCHOOL
9025 Salmon Falls Drive
Sacramento, California 95826

EMG | A Bureau Veritas Company
10461 Mill Run Circle, Suite 1100
Owings Mills, Maryland 21117
800.733.0660
www.emgcorp.com

June 17, 2020

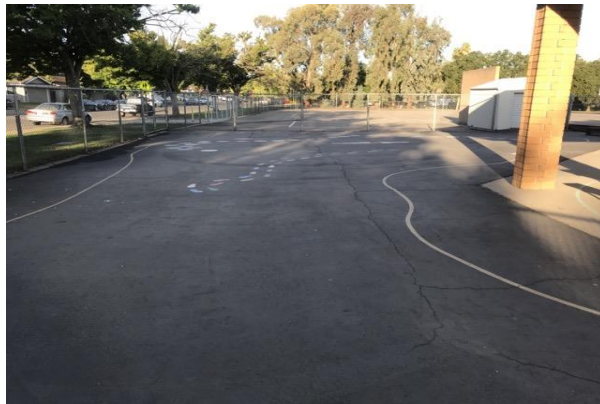
#29	PEDESTRIAN PAVEMENT, SIDEWALK, ASPHALT
-----	--

Concrete paving throughout the campus is generally in fair condition without significant cracking. The asphalt play area and parking lot are in fair condition, some longitudinal cracks that have been sealed. Seal coating appears to have been accomplished within the past three years. A recent modification is visible in the parking lot where the van-accessible parking stall was retrofitted to provide a level surface. Chain link fencing throughout the campus is in fair condition.
