FACILITY CONDITION ASSESSMENT

JOHN STILL ELEMENTARY (WEST CAMPUS)
2200 John Still Drive
Sacramento, California 95832

June 10, 2020

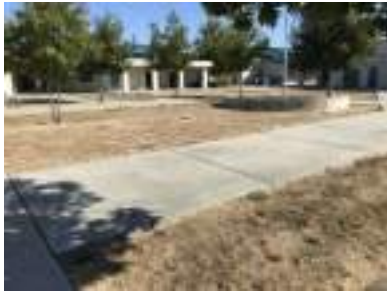
Irrigation System

Underground
Site Landscaping

The irrigation system is not operational, most landscaping areas turn brown for lack of water. - AssetCALC ID: 1469300

Uniformat Code: G2057
Recommendation: **Install in 2019**
