FACILITY CONDITION ASSESSMENT

SACRAMENTO CITY UNIFIED SCHOOL DISTRICT

LUTHER BURBANK HIGH SCHOOL

June 16, 2020

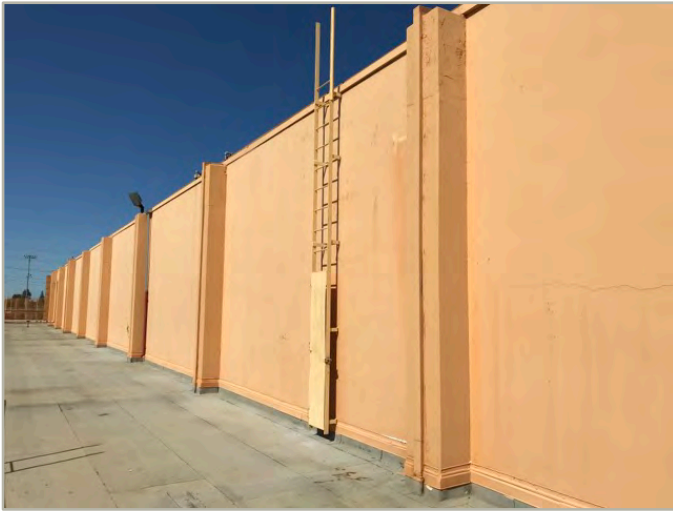
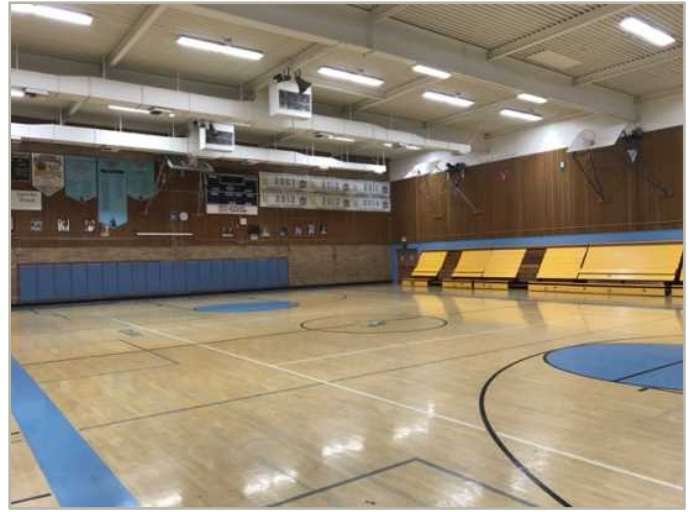
16. 014 Gymnasium

HVAC	Individual package units Supplemental components: make-up air unit	Fair
Fire Suppression	Fire extinguishers	Fair
Electrical	Source & Distribution: Main switchboard with copper wiring Interior Lighting: T-8	Fair
Fire Alarm	Smoke detectors, alarms, strobes, pull stations, back-up emergency lights, and exit signs	Fair
Equipment/Special	Swimming pool	Fair
Accessibility	Presently it does not appear an accessibility study is needed for this property.	
Key Issues and Findings	Antiquated pool heaters, damaged exterior paint

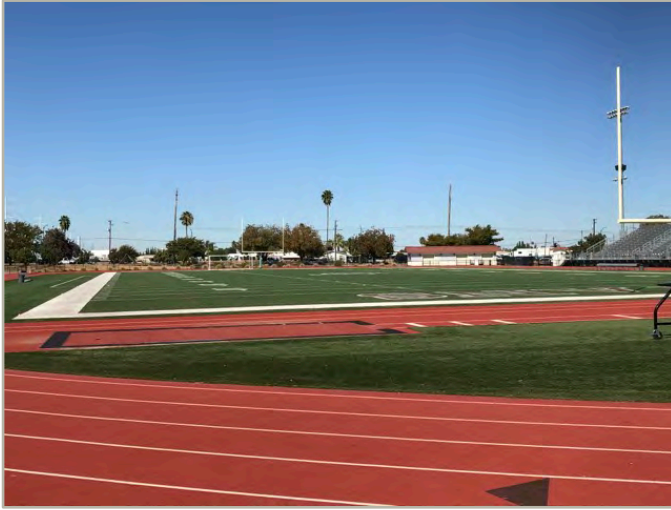
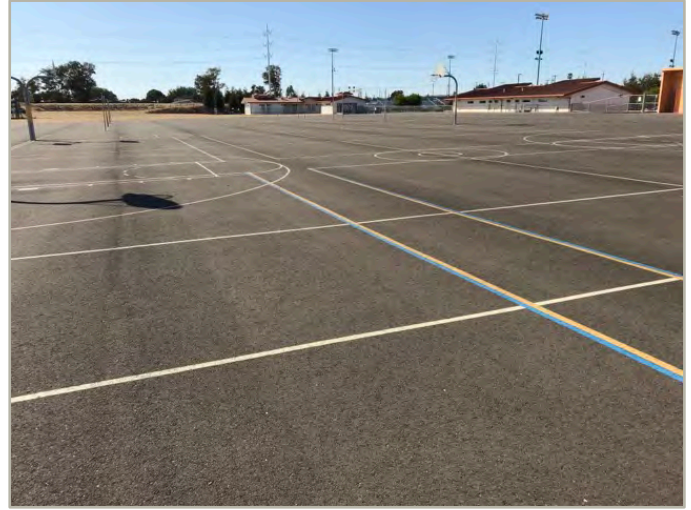
29. Site Summary

Lot Size	45.6 acres (estimated)	
Parking Spaces	172 total spaces all in open lots; 18 of which are accessible	
<i>System</i>	<i>Description</i>	<i>Condition</i>
Pavement/Flatwork	Asphalt parking lots with areas of concrete and concrete sidewalks, curbs, ramps, and stairs	Fair
Site Development	Property entrance signage, Wrought iron fencing with gates, Sports courts, and site lights Football stadium, baseball field with stands	Fair
Landscaping and Topography	Limited landscaping features Irrigation is present Flat site slopes throughout	Fair
Utilities	Municipal water and sewer Local utility-provided electric and natural gas	Fair
Site Lighting	Pole mounted light fixture	Fair
Ancillary Structures	Greenhouse structure	Fair
Accessibility	Presently it does not appear an accessibility study is needed for the exterior site areas. See Appendix C.	
Key Issues and Findings	Failing uninterruptible power supply and faulty artificial turf
