Check In

Property inspected by Azim Rahmonov

Reference: 3628

Flat 123
Sample street
London
E14 9ET

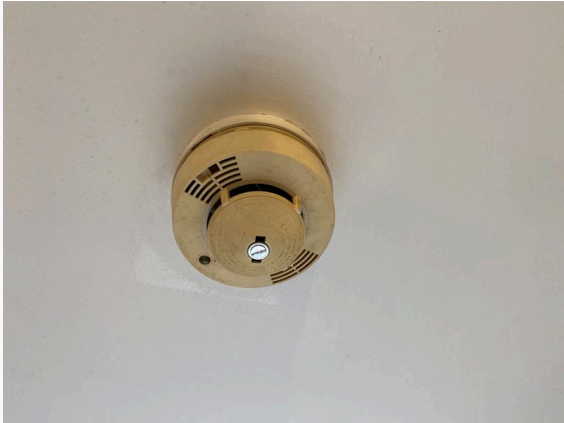
Ref # 2.1

2. ALARMS		
Item	Location	Test Result
2.1 Smoke Alarm	Entrance hall	Loose/ hanging Tested and alarm heard
2.2 Heat Alarm	Kitchen	Tested and alarm heard
2.3 Carbon Monoxide Alarm	Kitchen	Tested and alarm heard

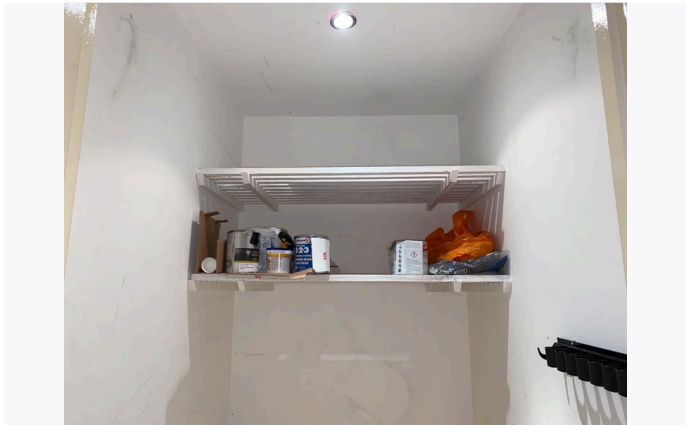
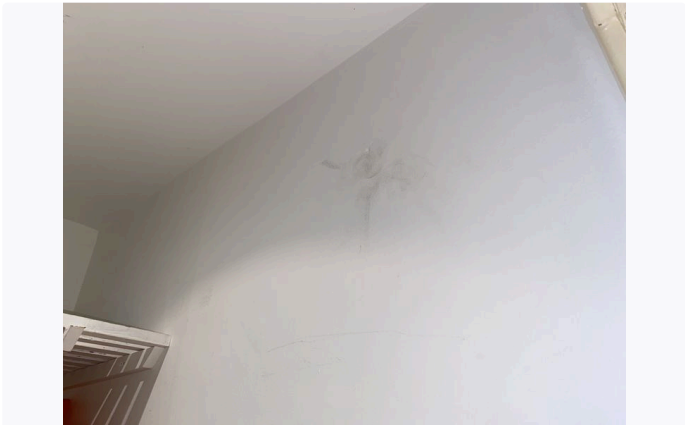
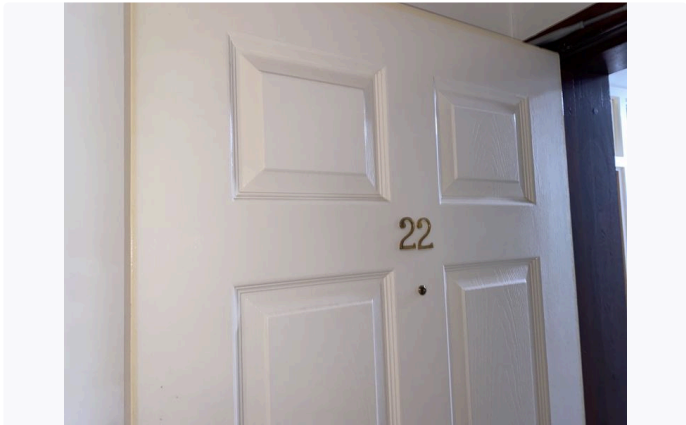
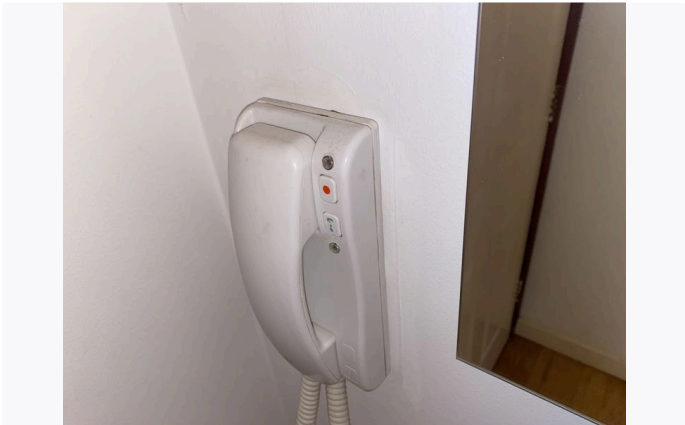
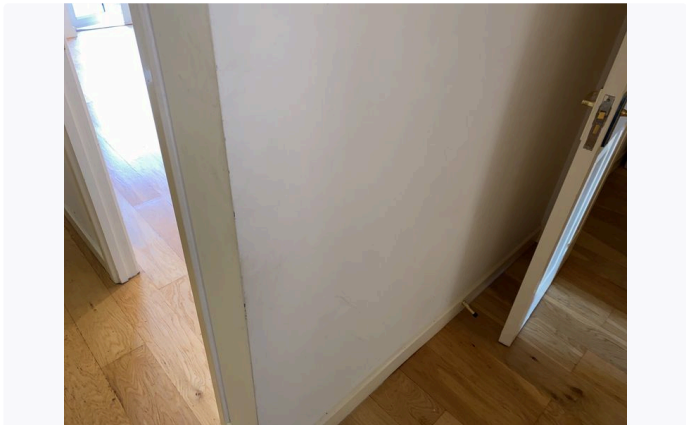
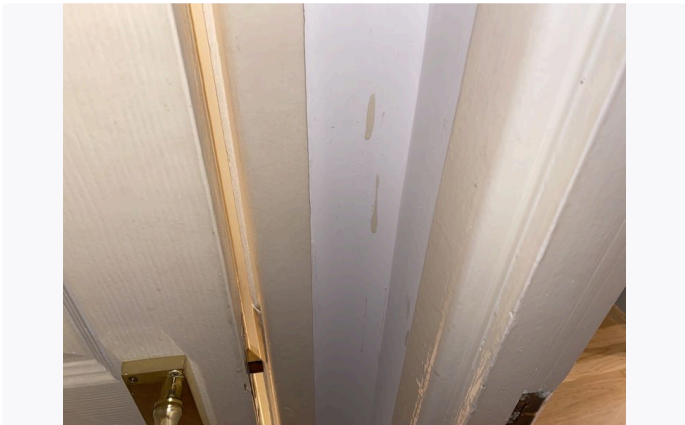
5. HALLWAY		
Item	Description	Condition
5.1 Front Door & Surround Exterior	As per supporting document	Door frame is showing small scratches and small chips to edges Cobweb at high level to exterior door frame

5.2 Ceiling	As per supporting document	Settlement crack to right hand side of reception Light cobwebs to edge of ceiling Over painted chip to edge of spotlight

5.3 Lighting	As per supporting document	Not working
5.4 Walls	As per supporting document	Nail hole at high level right hand side of entrance Light settlement crack above bedroom Light cobwebs at high level in places Settlement crack at high level to right hand side of kitchen 2 x filler holes between reception and kitchen

5.5 Skirting Boards / Woodwork	As per supporting document	Cable clipped to top edges of skirting board to left hand side of entrance and either side of kitchen Crack to top edges to right hand side of bedroom Light dust to top with some debris Further cracks to top edge left hand side of reception Both doorstops are loose

5.12 Smoke alarm	As per supporting document	Hanging/ loose

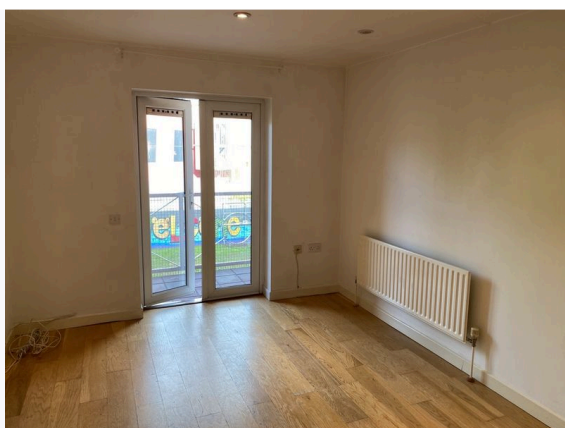
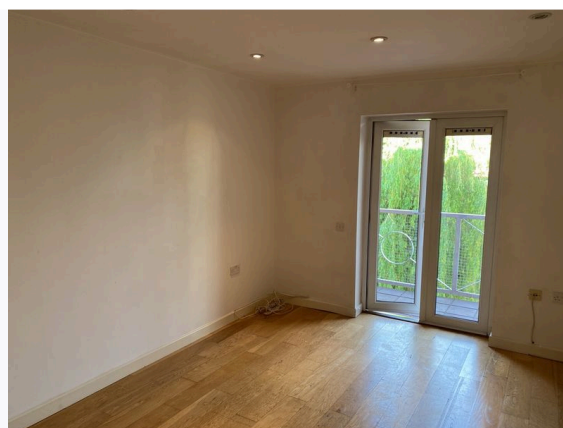
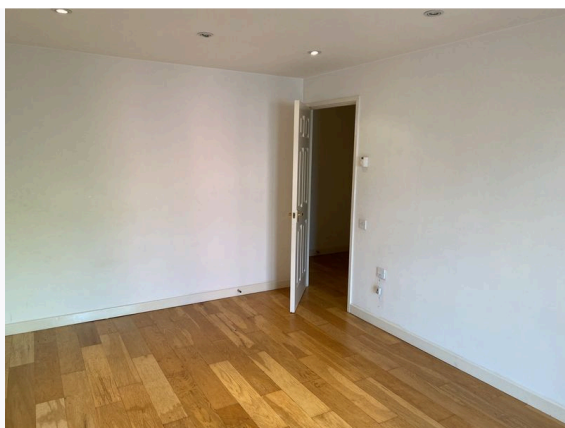
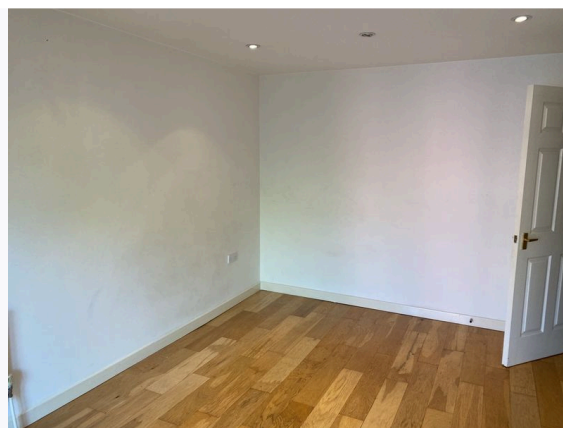
6. RECEPTION ROOM		
Item	Description	Condition
6.1 Door	As per supporting document	<p>Small black mark at mid level to exterior door</p> <p>Light beige mark at high level above handle to exterior door</p> <p>Further scuffs seen mid to low level to exterior</p> <p>Touch-up mark and 4 x filler holes at high level above handle to interior</p> <p>Light dust to door panels</p>

6.2 Door Frame	As per supporting document	<p>1 x small angle chip and 1 x noticeable angle chip at mid level left hand side interior</p> <p>Further light scuffs seen in places to door and frame</p> <p>Light chips to edges</p> <p>Over painted detached fire chain seen to hinge edge</p> <p>Touch-up mark and 2 x over painted filler holes at high level left hand side of interior</p> <p>Over painted angle dents at high level to interior</p> <p>Dust to top edge of door frame</p>

6.6 Skirting Boards / Woodwork	As per supporting document	<p>Light cracks to top edges and to joins</p> <p>Cable clipped to left hand side of window and left hand side wall when facing the windows</p> <p>Cut-out section/noticeable gap between floor and skirting board to left hand side balcony door</p> <p>Cable protruding with cable hole to bottom edge right hand side of balcony door</p> <p>Light dust to top in places</p>

6.7 Flooring	As per supporting document	Light dust/debris to floor White marks to left hand side of balcony door Left hand side forward from balcony door Sticker residue to left hand side of heating Floor requires further cleaning Light paint speckles seen near right hand side edge of floor
6.8 Heating	As per supporting document	Black scuffs to front with scratches Noticeable paint chipping to front
6.9 Switches / Sockets	As per supporting document	Paint marked to sockets Light dust to top Grubby mark to light switch
6.10 Windows/Balcony Door	As per supporting document	Not clean Further cleaning required Handles are loose Grey shaded mark and cracking to edge of frame
6.11 Thermostat	As per supporting document	Noticeable dust top top
6.12 Additional Items at Check-In	Wall mounted white metal curtain rail with matching finials	No curtain seen

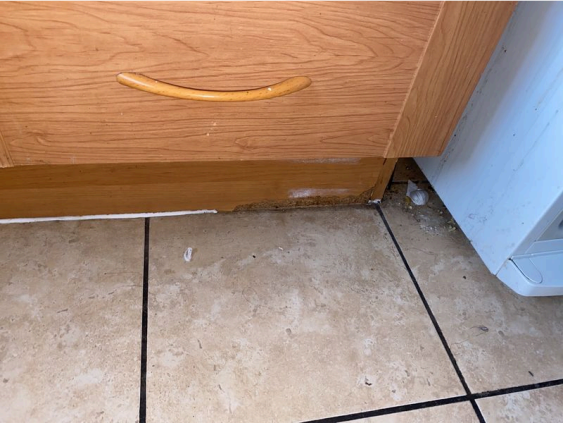
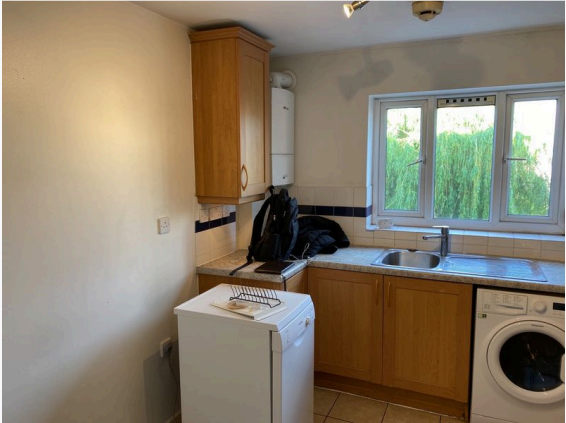
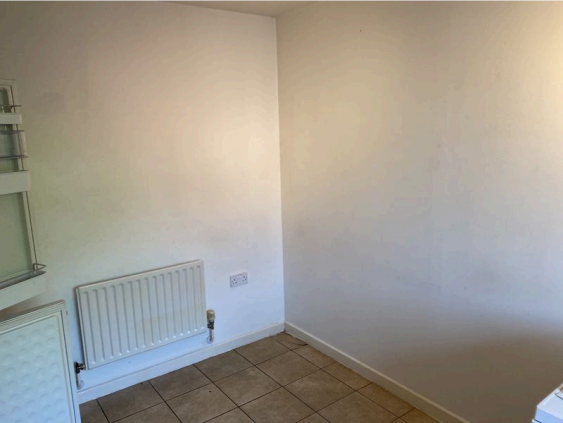
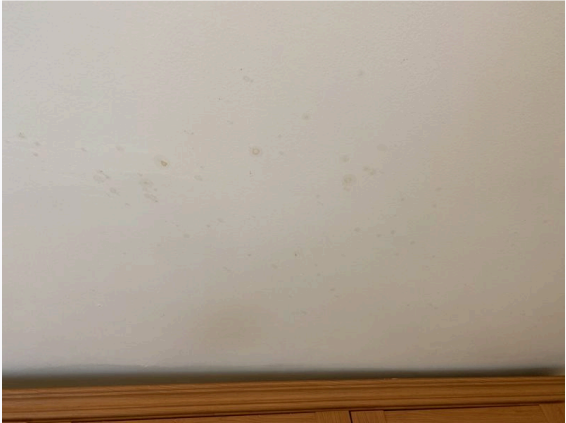
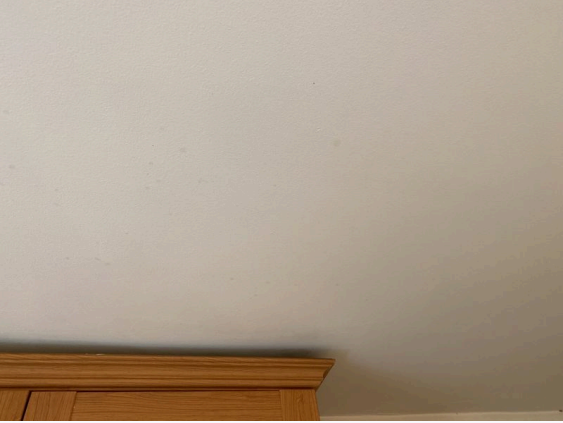
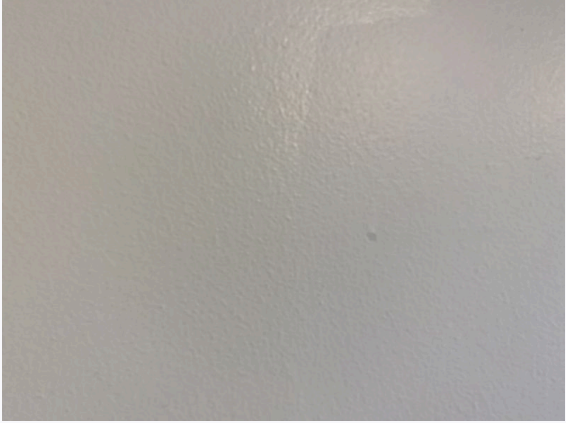
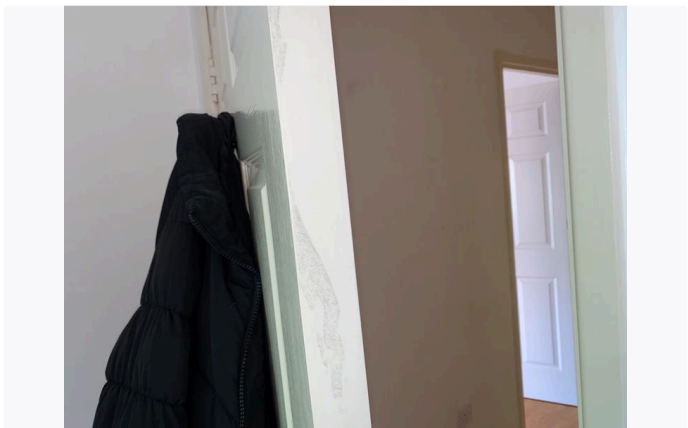
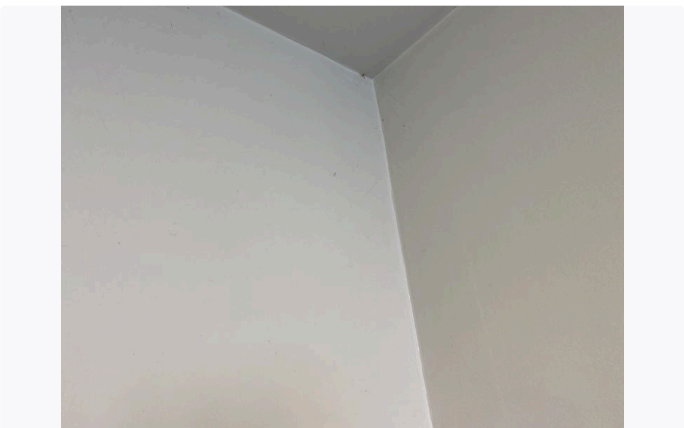
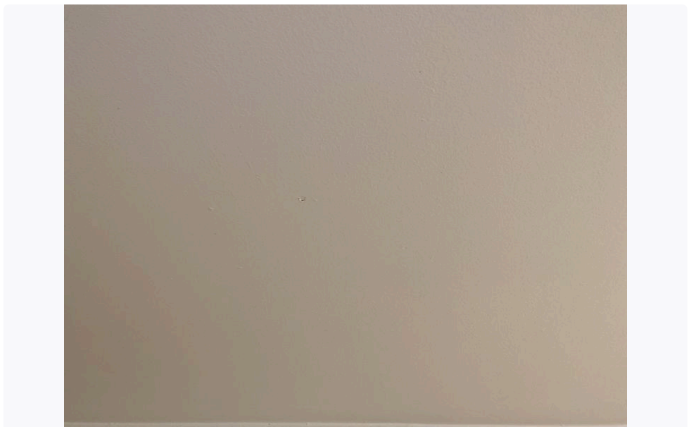
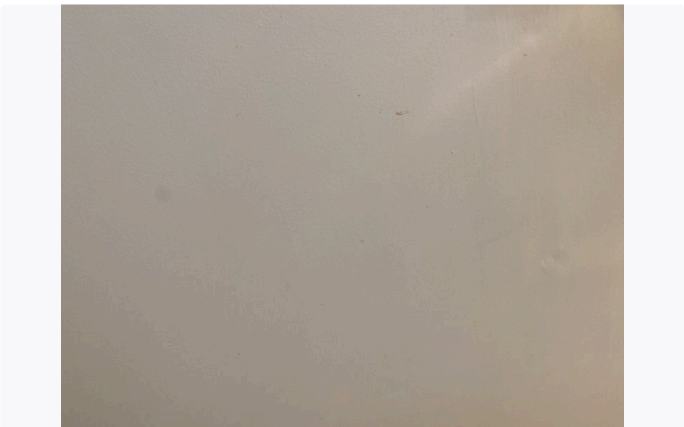
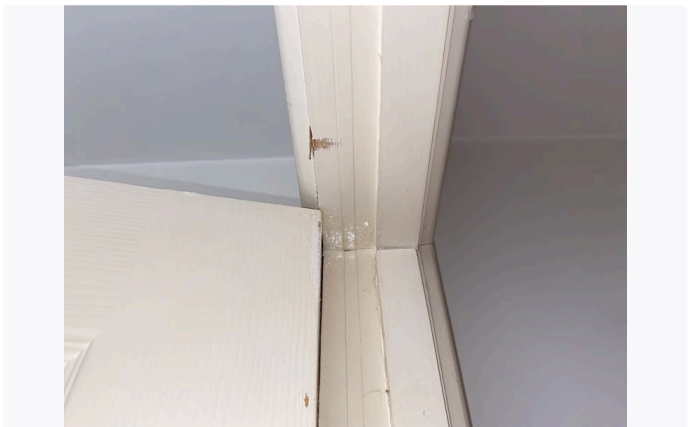
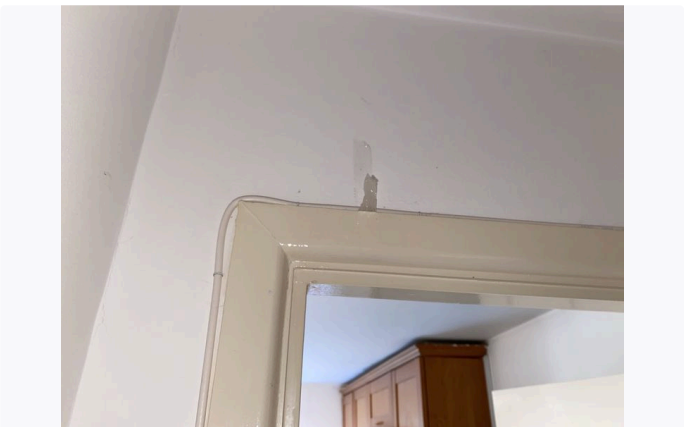
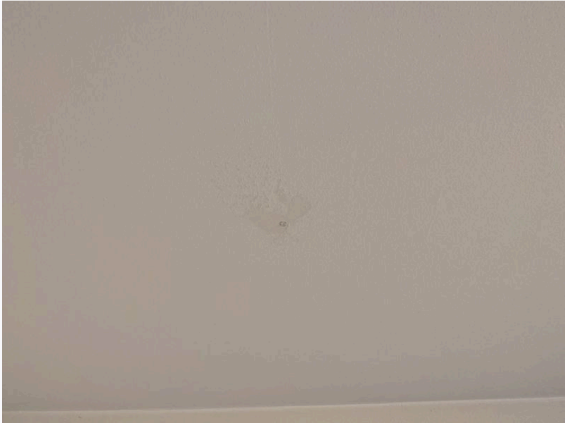
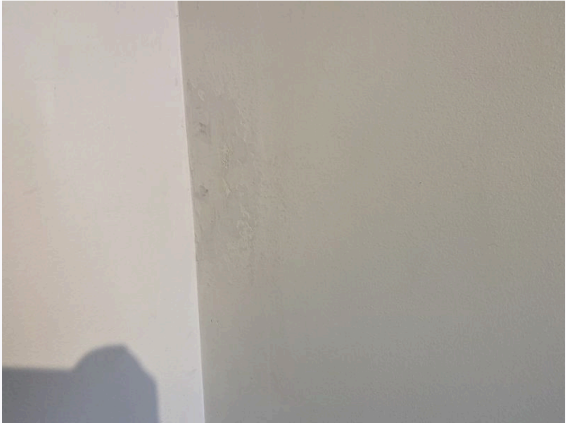
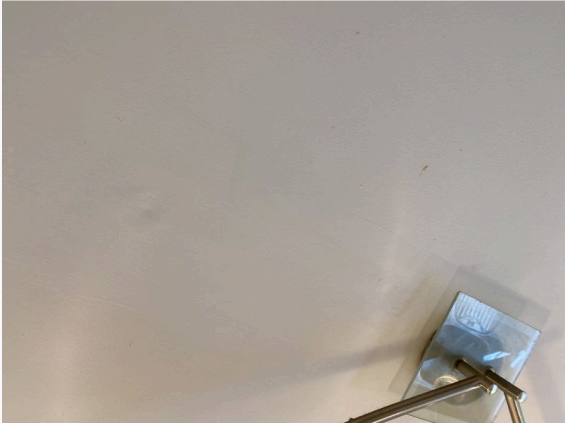
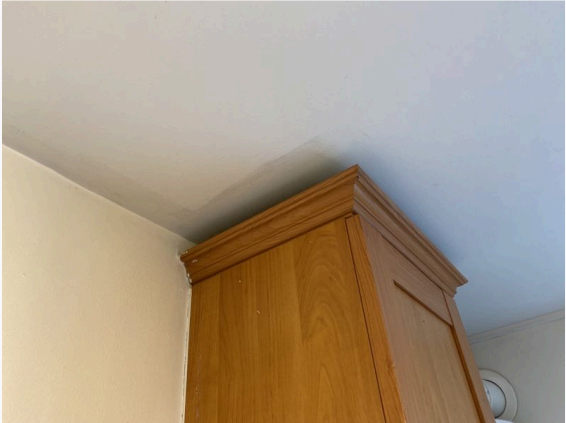
7. KITCHEN		
Item	Description	Condition
7.1 Door	As per supporting document	Fire chain detached Over painted to hinge edge Chip at high level right hand side of exterior Light dust to door panels and grubby mark above handle to exterior door Heavy purple/grey marks above handle to interior door Drip marks at low level to interior door

7.2 Door Frame	As per supporting document	Over painted fire chain removal mark right hand side inner edge of door frame Chips to edges Cable clipped to edge to exterior door frame Crack to joins at high level right hand side Light rub marks seen Noticeable angle chips/scratch to top inner edge of door frame right hand side

7.3 Ceiling	As per supporting document	Filler hole to far left hand side corner Noticeable patchy paintwork to edge of kitchen units Further over painted noticeable defect near light fitting Splash mark to centre and above hob Cobwebs to corners

7.4 Walls	As per supporting document	Part white painted - light splash mark above heating Noticeable over painted repair/filler hole mark at chest level to left hand side corner 2 x noticeable over painted defects at chest level left hand side wall when facing the windows Drip marks at low level to left hand side wall Greasy splash mark at high level right hand side of entrance Part tiled walls - black plastic bracket to right hand side of window

7.5 Skirting Boards / Woodwork	As per supporting document	Light dust to top more noticeable behind dishwasher Over painted screw visible right hand side forward from entrance and light crack to top edges

7.6 Flooring	As per supporting document	Debris and dust to floor Cracking to sealant to edges Floor requires further cleaning Tiles are slightly shaded in places Blue mark in front of heating

7.7 Heating	As per supporting document	Off-white/cream shaded mark at low level to front Light dust to top Paint marks to right hand side valve cap
7.8 Switches / Sockets	As per supporting document	Paint marks to edges Light debris type dust to top Crack to double socket to right hand side hob

7. KITCHEN (CONT.)		
7.10 Kitchen Units	As per supporting document	<p>Base of under sink unit now brown painted over painted defects seen Staining remains Water damage expanded/chipping to bottom edge of both doors to under sink unit and top edge of left hand side door under sink unit and bottom edge to floor unit left hand side of sink Water damage expanded to laminate base to front edges Floor unit to left hand side of sink Kick board showing noticeable chips to edges and cracking to edges More heavier chips to right hand side oven to bottom edge to kick board Further splitting/expanded to bottom edge of floor unit doors and edge of drawers to bank of drawers Laminate is missing partly to top edge of top drawer to back of drawer to left hand side edge Expanded to bottom edge laminate splitting to exterior panel right hand side of extractor hood Both doors of wall units left hand side extractor hood</p> <p>Kitchen units now with 3 x white plastic spotlights - 2 x not working</p>

7.11 Worktop	As per supporting document	<p>Light debris and light dust to top Cracking to sealant to edges Slightly splitting laminate to underside front edge above oven</p>

7.14 Hob	As per supporting document	<p>Greasy burnt on deposit to burners and trivets Controls possibly being replaced during the tenancy Ignition on constantly, doesn't turn off</p>

7.15 Oven	As per supporting document	<p>Rubber trim is loose and hanging White marks to interior door and interior oven Unable to test oven</p>
7.16 Washing Machine	As per supporting document	<p>Now is replaced to white Hotpoint washing machine Tested for power Washing machine not clean 1 x scuff to kick board</p>

7. KITCHEN (CONT.)		
7.18 Fridge / Freezer	As per supporting document	Noticeable 2 x angle cracks to front edge of fridge section Cracks to both salad crisper to exterior and interior Requires further cleaning mortise noticeable drip marks to left hand side exterior panel Light dents to freezer door to exterior Crack and screw head visible and chip to plastic trim to leading edge and bottom edge of fridge door Chip to plastic trim at low level/bottom edge to freezer door Discolouration to door seals
7.19 Smoke alarm	As per supporting document	Greasy throughout and shaded
7.20 Additional Items at Check-In	1 x freestanding white plastic CO alarm seen	Tested and alarm heard

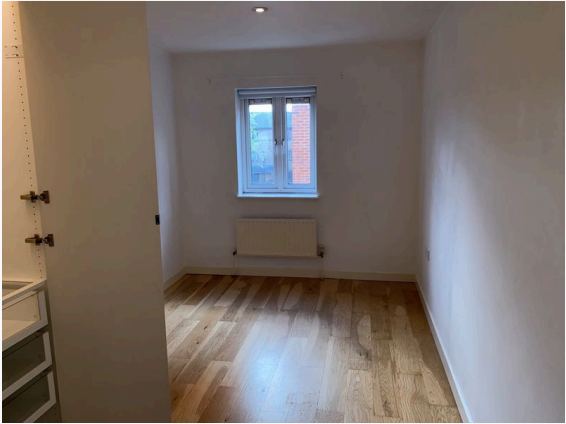
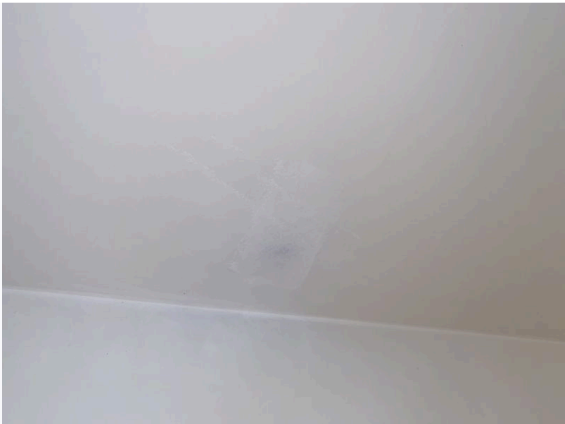
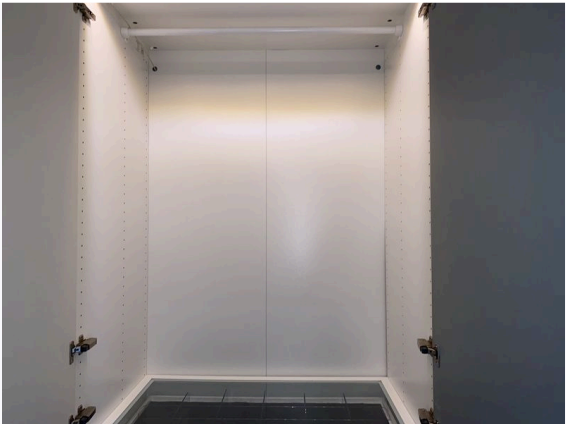
<div>Ref #8</div></div><div>

8. BEDROOM		
Item	Description	Condition
8.1 Door	As per supporting document	Fire chain removed and over painted Paint marks to hinges Angle chip at high level right hand side exterior Black mark and angle wear mid level leading edge to door Dust to door panels Brown grubby mark at eye level to interior door Door would benefit with further light cleaning

8.2 Door Frame	As per supporting document	Over painted fire chain removal marks seen to inner edge of door frame Angle chips to edges Light angle rub marks seen to low level

8.4 Walls	As per supporting document	Patchy paintworks Noticeable to over painted repair mark/filler holes at high level right hand side wall 3 x pinholes at high level right hand side of window Light stress cracking seen at high level left hand side of window Noticeable grubby finger marks above heating/ below window sill Over painted defects/chip at high level left hand side corner of the window Approximately 8 x pinholes at high level left hand side wall when facing the windows 2 x noticeable over painted paint chips and 1 x paint chip at right hand side wardrobe Further finger marks type shaded usage marks at mid to low level

8. BEDROOM (CONT.)		
8.9 Windows	As per supporting document	Not clean Shaded and discolouration to frames Caps to screws are missing to both handles Paint marks to frames Ring marks and spot marks to window sill

8.10 Curtains/Blinds	As per supporting document	Heavily black marks, drip marks and spot mark seen Dust seen to blind Cleaning required
8.11 Built-In Wardrobe	As per supporting document	Exterior doors are not clean Mirrored doors to interior Now grey painted and showing patchy paintworks Over painted defects Paint marks to hinge edges to interior doors Bottom hinge to second from left hand side door Detached/damaged Black line scuffs to interior of first left hand side door Cleaning smear and light dust to interior Light hair debris and dust to interior drawers
<div><div>

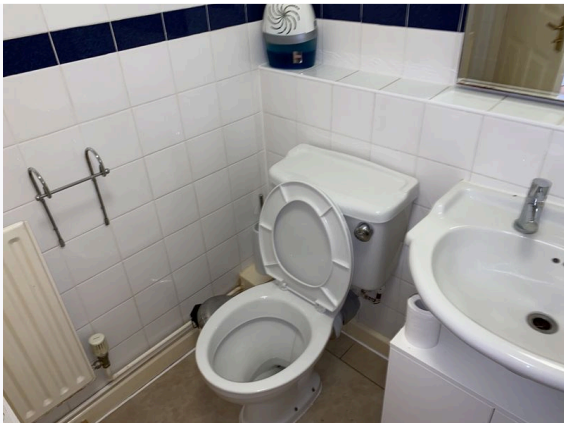
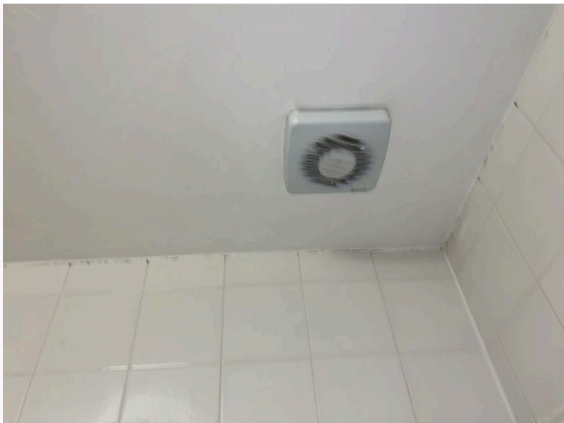
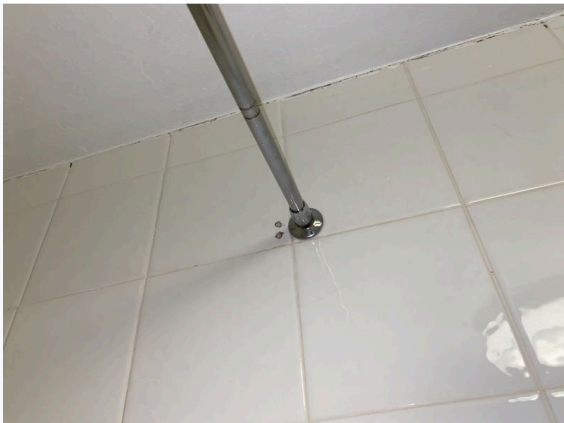
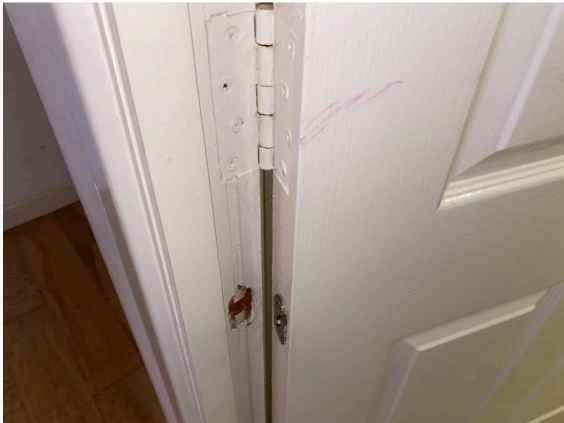
<p>Ref #9</p>

9. BATHROOM		
Item	Description	Condition
9.1 Door	As per supporting document	Door lightly expanded to bottom edge to interior door Fire chain detached Scuff at mid level left hand side exterior

9.2 Door Frame	As per supporting document	Fire chain removal mark mid level left hand side inner edge of door frame Cable clipped to exterior door frame

9.4 Walls	As per supporting document	Cracks to grouting above bath Drip marks behind sink Further 2 x screws/filler hole at high level right hand side above skirting board Black mark to top edge right hand side of sink Noticeable chips to bottom edge right hand side of sink

9.5 Skirting Boards / Woodwork	As per supporting document	Doorstop - slightly loose
9.6 Flooring	As per supporting document	Light debris and dust seen to floor Spot marks to right hand side of WC Purple/blue marks seen to right hand side of sink Cracking to sealant to edges Further blue/purple spot mark in front of bath

9.7 Heating	As per supporting document	Few drip marks and to front
9.8 Switches / Sockets	As per supporting document	Paint mark to light switch
9.9 Bath	As per supporting document	Water marks to bath Further water marks to sealant behind bathtub Tarnished to showerhead hose and slightly to showerhead Shower rising rail is loose Water marks to chrome ware Bath panel is loose and not flush to bath panels around shower screen Water mark and historical cleaning smear seen

9.10 Sink	As per supporting document	Water mark to sink Scales underside of mixer tap White mark to pop-up plug
9.11 WC	As per supporting document	Seat and lid loose Lightly dusty to toilet around bowl Light rub marks around seat and lid hinges

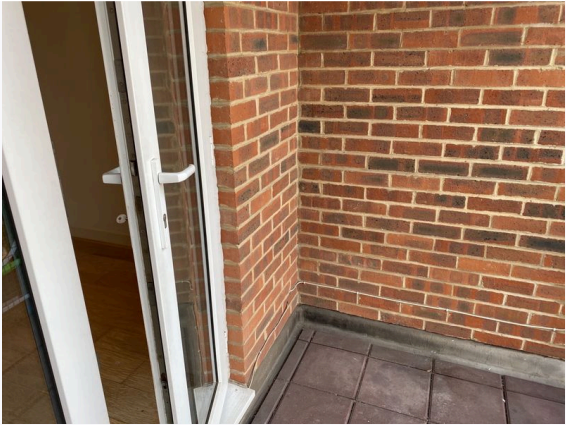
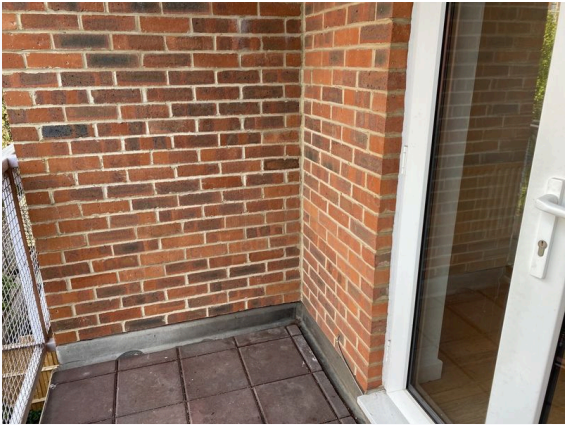
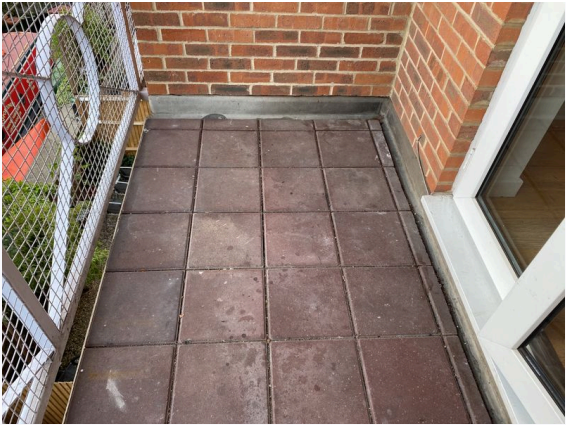
<p>Ref #10</p></div><div>

10. BALCONY		
Item	Description	Condition
10.0.1	As per supporting document	
<div><div>
