REPORT ON – "BUSHFIRE BEHAVIOUR AND HOUSE DAMAGE AND DESTRUCTION DURING THE PARKERVILLE. MT HELENA & STONEVILLE BUSHFIRE ON THE 12 JANUARY 2014"

ENVIRONMENTAL PROTECTION BRANCH

AUTHOR: RALPH SMITH

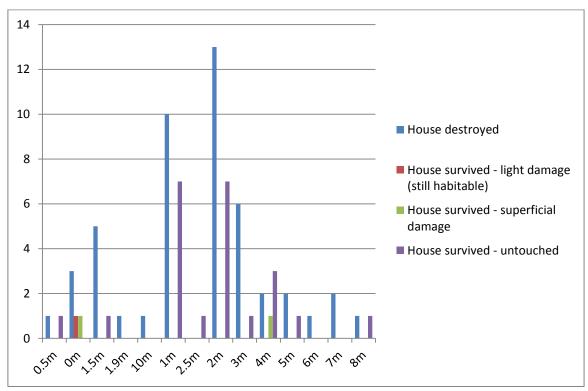
There were 48 homes that were destroyed with tall vegetation within 20 metres (most were within 8 metres) of the home. There were also 25 homes damaged to varying degrees within the BPZ and tall vegetation. Therefore there were 73 homes damaged or destroyed with a fuel load or fuel structure that was not within the criteria advocated by DFES.

Figure 8: Vegetation distance from the house.

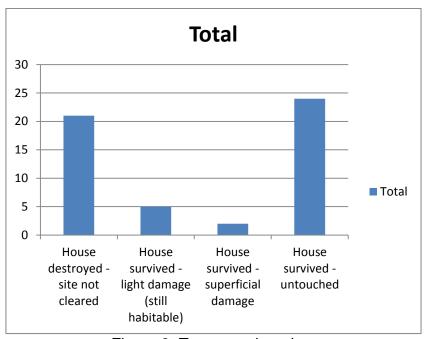
There were 17 homes that were destroyed with tree crowns overhanging the house. There were also 2 homes that suffered a range of damage, from heavy damage to superficial damage, that had a tree overhanging the house. One home had a tree overhanging it and suffered no damage.

Figure 9: Trees overhanging.

Trees overhanging a house make a significant contribution to the potential damage or destruction of the house. Where a stringy barked tree has limbs overhanging the house, it drops embers from that crown onto the roof of the house. If there are gaps in the roof then these embers can be blown into the roof space and cause damage or destroy the house. Low intensity fires, including backing fires, can cause significant damage through this process.

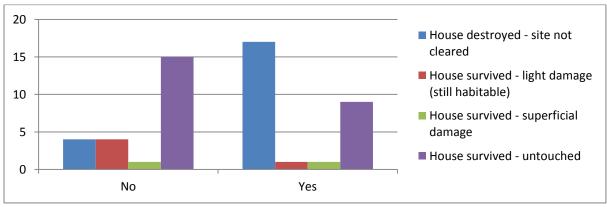
Figure 10: Tree crowns less than 10-15 metres apart

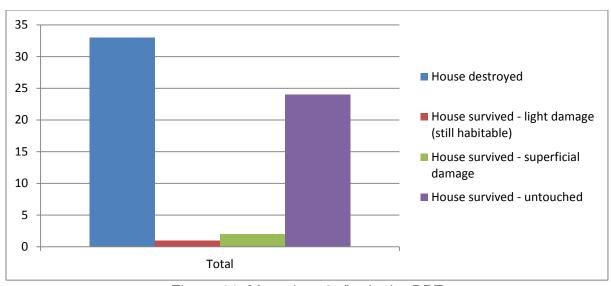
The available fuel load is significant to the level of damage that occurs when a fire runs through a development site. 32 homes had greater than the prescribed 2 t/ha in the BPZ and the houses were destroyed. There were 15 homes with a fuel load less than 2 t/ha that were also destroyed.

Figure 11: More than 2 t/ha in the BPZ

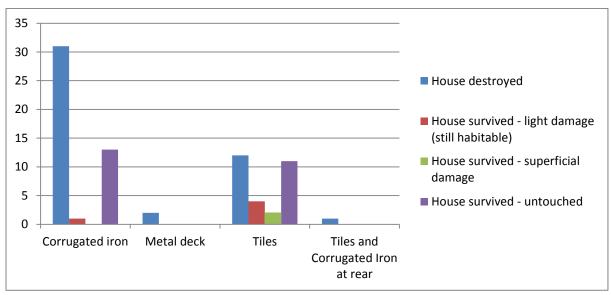
The house roof construction materials in the houses that were destroyed appear to be dominated by corrugated iron. As can be seen in the figure 23, houses constructed using tiles and corrugated iron were basically equally affected by the fire or not affected. The survey data includes houses that were not in the fire zone and the houses surveyed that survived untouched may have been outside the fire zone. The houses destroyed without sarking in both corrugated iron and tiles are very similar. It is highly probable that the houses in general regardless of whether they were constructed with either corrugated iron or tiles did not have sarked roofs.

Figure 22: Roof construction material.

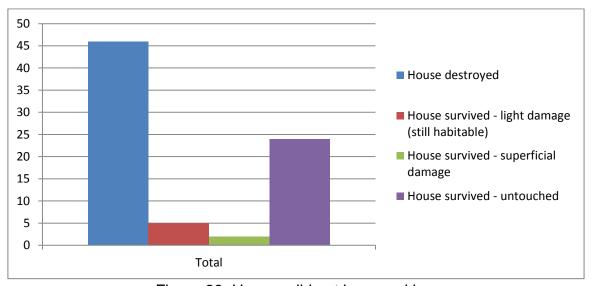
Australian Standard 3959 – Construction of buildings in bushfire-prone areas, identifies that houses that will potentially be attacked from embers should have sarking applied to the roof to prevent embers entering the roof space. Most houses destroyed by this fire did not have the ember protection sarking in place. By not having sarking it is possible for embers to be carried into the roof space; fires in this space may take some time to ignite and be visible from the outside. The construction standard for tiled roofs requires that virtually no gaps remain post construction. As time progresses, it appears that the gap proofing of the houses is diminishing, or was not present at the time of construction.

Figure 23: Houses did not have sarking.

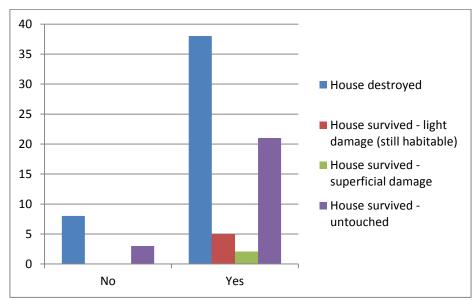
of a house being destroyed or damaged during the bushfire, but houses in general without boxed eaves feature significantly in house losses and damage. In this fire the number of houses with boxed eaves and destroyed was significant. The high number of houses with boxed eaves and survived untouched in this bushfire is in part due to the survey technique, which included houses on the edge or periphery of the fire run to also be assessed.

Figure 24: Houses with boxed eaves and unboxed eaves and the impact of the fire?

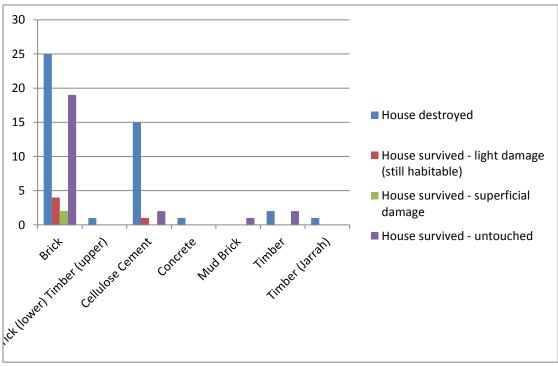
The high number of houses that were destroyed and constructed from brick is not surprising, as it is a primary construction material in this region and during the era that the bulk of the hoses were constructed. Again, cellulose cement features prominently in the houses destroyed. This has been a feature in virtually all recent significant bushfire events that have caused a number of destroyed houses. It appears that the fixing mechanism/process where the cellulose cement sheets are fixed to study does not appear to maintain its integrity, and as a consequence it is failing, resulting in the internal building being exposed to direct flame and radiant heat.

Figure 28: External construction wall materials.

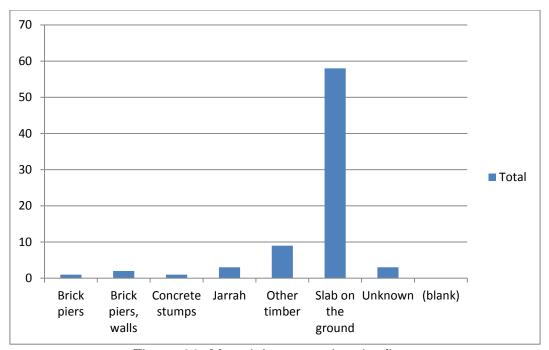
The materials supporting the floor do not appear to have been a significant contributor to the house damage or destruction. The vast majority of the houses were concrete slabs on the ground.

Figure 29: Materials supporting the floor.

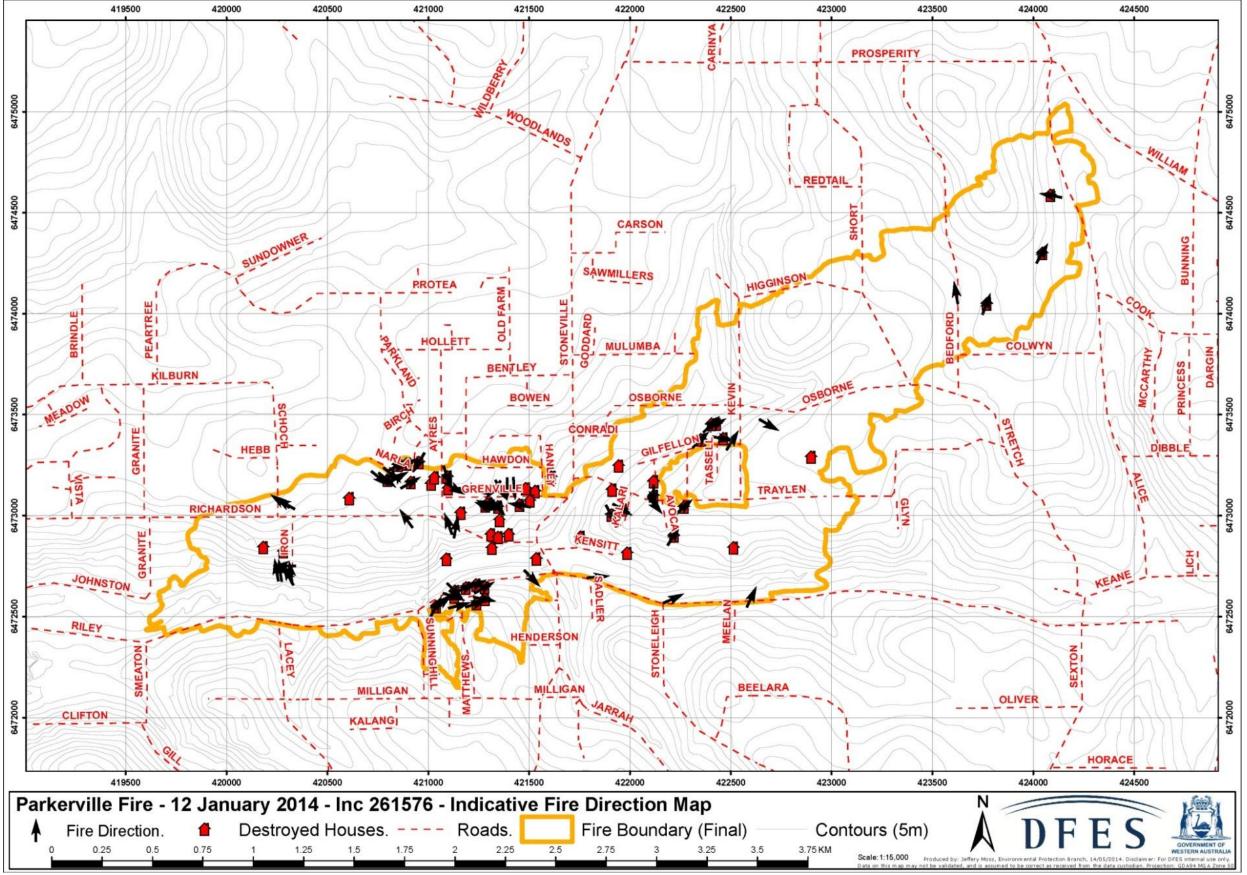
The appendices demonstrate the bushfire's growth during the day and the direction of the head fire in relation to a number of the destroyed houses. The houses directly in line with the head fire showed the greatest damage from the range of impacts whether ember attack, radiant heat or direct flame contact. An interesting feature is the micro-changes to the prevailing head fire run that resulted in house damage. This component requires further investigation at future fire events.

Figure 30: Head fire direction and houses destroyed by the fire.
