# SAMPLE REPORT

## MAINTENANCE INSPECTION REPORT

Sample Report Address  
Lower Hutt, Wellington  
New Zealand

Inspected by: Kieran Long | Inspection Date: 14 Apr 2022 | Ph: 0212621120

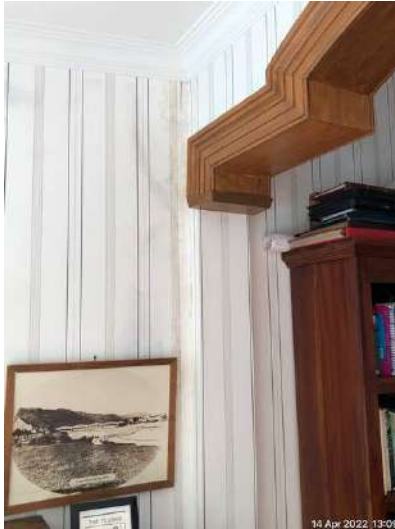
- Mould was sighted to the ensuite bathroom wall linings, I recommend this cleaned and removed with a sufficient product. A cleaning or mould specialist would be engaged to clean.
- Moisture staining was detected to the hallway archway wall linings. Elevated moisture readings were detected. External roof repairs would be required to reduce this. Replacement of the defective wall linings should take place once repairs take place. Any wet or damp framing should be dried.

Photo Ref #6: Moisture staining to hallway archway

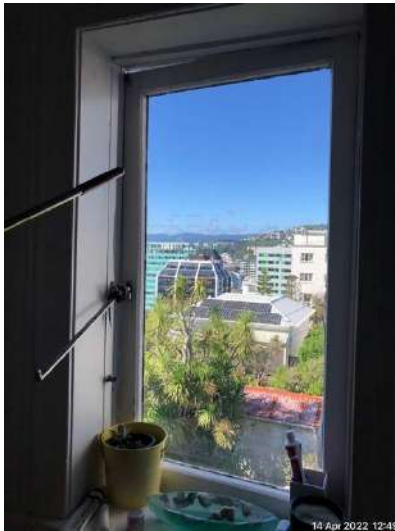
- The main bathroom window was catching/binding on the frame. Adjustment is recommended to allow the unit to open and close freely. This is an easy repair for a builder/joiner. The hinges may also require replacement.

Photo Ref #9: Main bathroom window binding

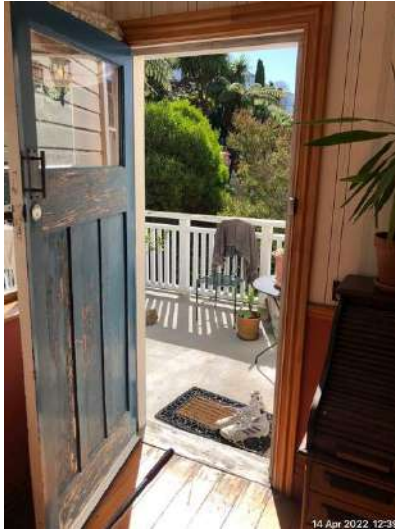
- The upstairs hallway door leading to back deck: High-risk door junction due to the door being internally opening, making it hard to prevent water ingress. Some moisture damage to the timber floorboards below. Recommend improving the door seal to help reduce potential water ingress or upgrading to make externally opening.

Photo Ref #10: Upstairs door leading to back deck: High risk door as it is internally opening, making it hard to prevent water ingress. Some moisture damaged to floor below.

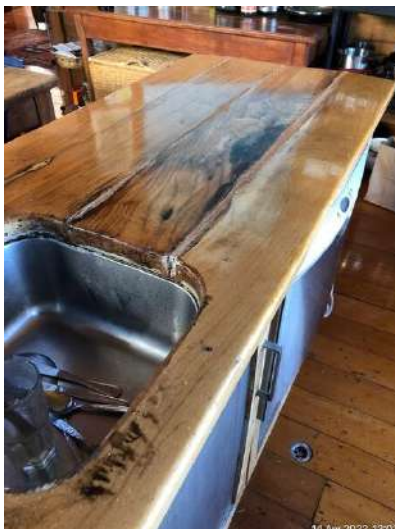
Photo Ref #11

The bench-top appeared in below-average condition for its age. The timber benchtop has two cracks running through it, replacement would be recommended. This appears to have caused the sink to be detached.

Rating:	Minor Maintenance
Repair Priority:	4 (12 to 36 months)
Trades Required:	Joiner

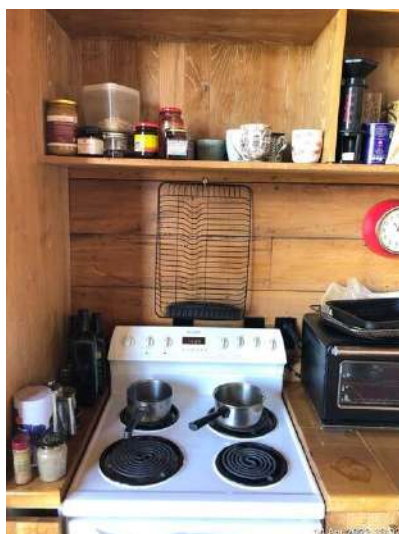
Photo Ref #13

No extractor fan was in place. Although not a requirement for an existing owner-occupied dwelling, the installation of a sufficient range hood would help reduce moisture in the kitchen.

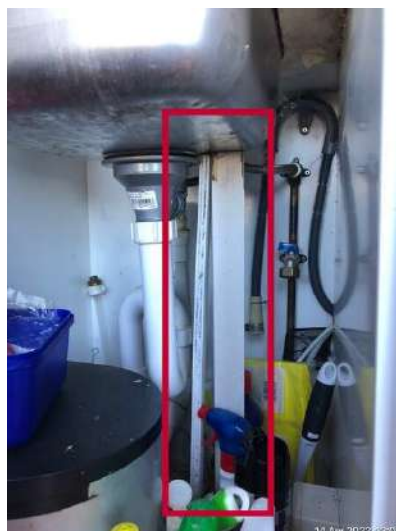
Photo Ref #17: Timber holding up sink

- The sink should be upgraded to suit the new benchtop when replaced.

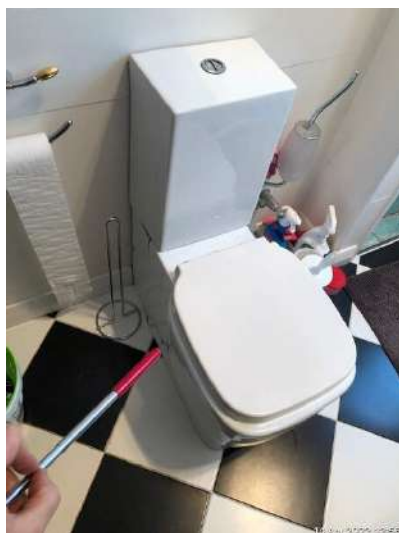
The toilets were operating correctly with no leaks detected. Movement was detected to the ensuite toilet pan, refer to details below.

Photo Ref #18: Movement detected to ensuite toilet

- Securing the pan to the floor is recommended to help prevent further movement or potential leaks, engage a licensed plumber to complete.

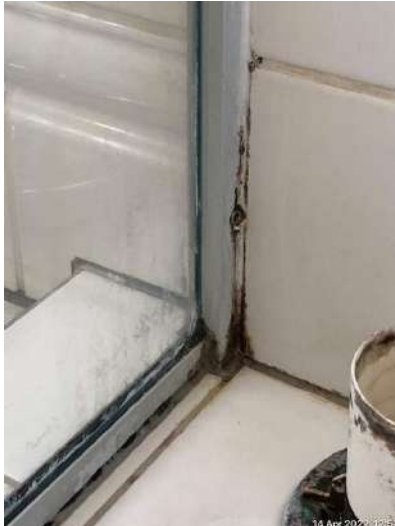
- Mould build-up was detected to the sealant at the shower liner to bath junction, recommend scraping out and replacing.

Photo Ref #27: Mould build-up

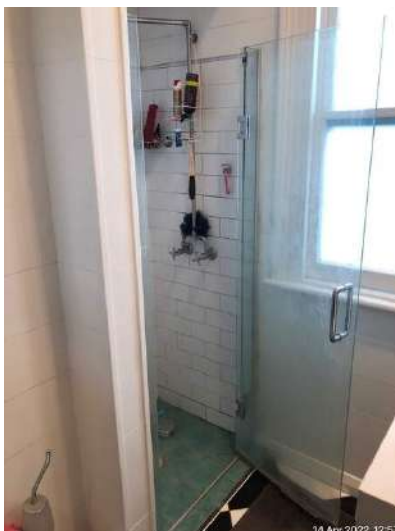
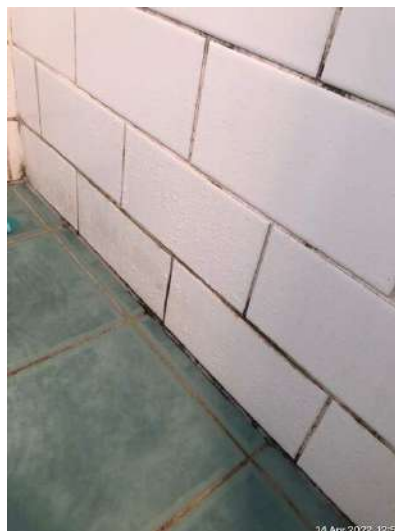
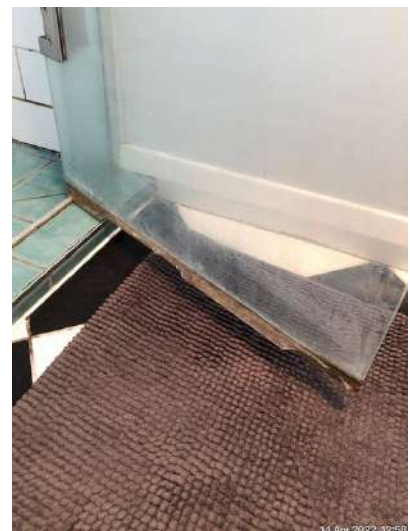
- Mould build-up was detected to the sealant at the shower liner to bath junction, recommend scraping out and replacing.

- The shower door was missing a seal strip, installation would help keep water in the shower unit.

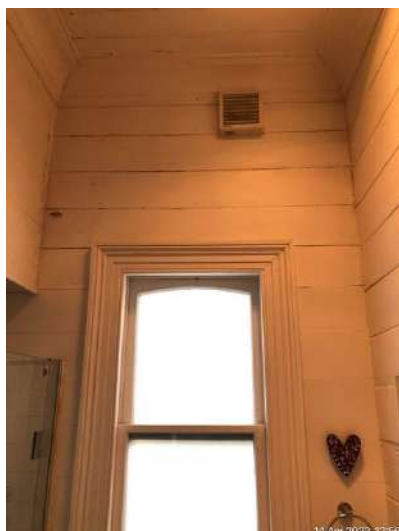
- I recommend installing a more powerful vented extractor fan to reduce moisture damage and help with ventilation, an extractor fan can be installed by a registered electrician.

Photo Ref #35: Ensuite bathroom

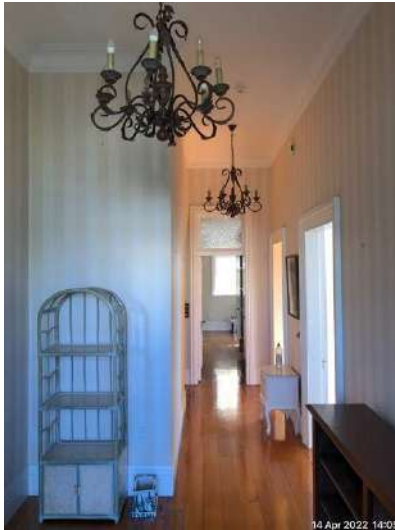
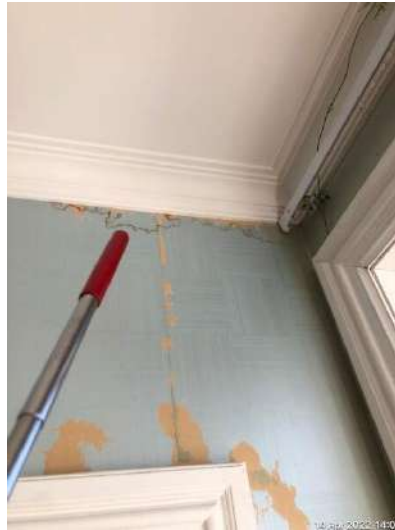
- Cracking was evident in the plasterboard wall linings, this is commonly due to movement and settlement over time, some wallpaper & paint blemishes were sighted also. Engage a plasterer and painter to improve these areas if desired.

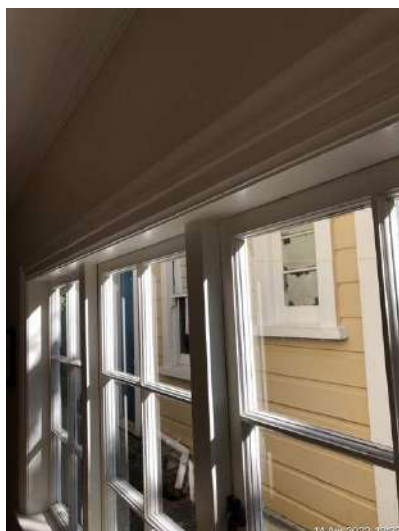
Photo Ref #52

- The front sunroom window was catching/binding on the frame. Adjustment is recommended to allow the unit to open and close freely. This is an easy repair for a builder/joiner.

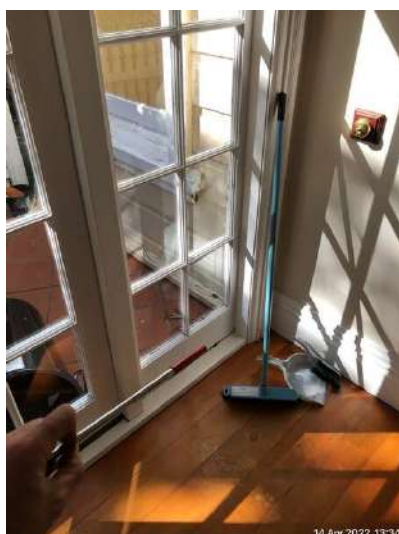
- Timber decay was detected to the kitchen right-hand northern door, as photographed below. Replacement of the defective door is recommended.

Photo Ref #55: Kitchen right hand door

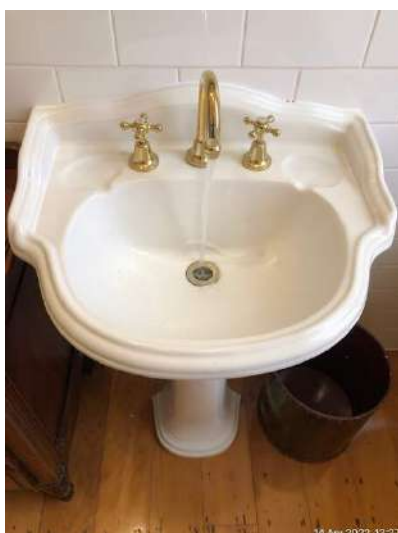
Photo Ref #78: Movement to tap

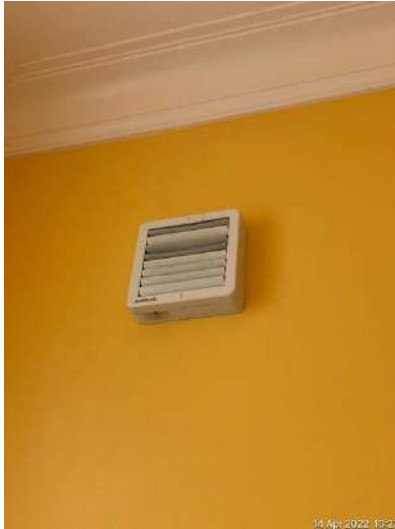
Photo Ref #79: Main bathroom

- A licensed electrician should be engaged to assess and upgrade if recommended.

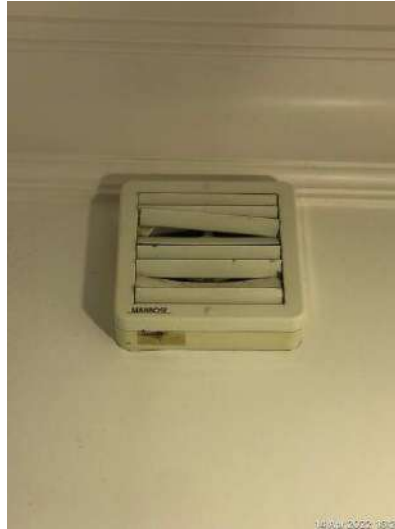
Photo Ref #80: Ensuite fan

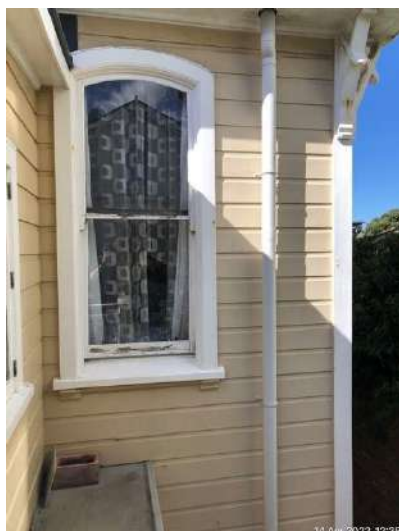
Photo Ref #93: Timber weatherboard cladding

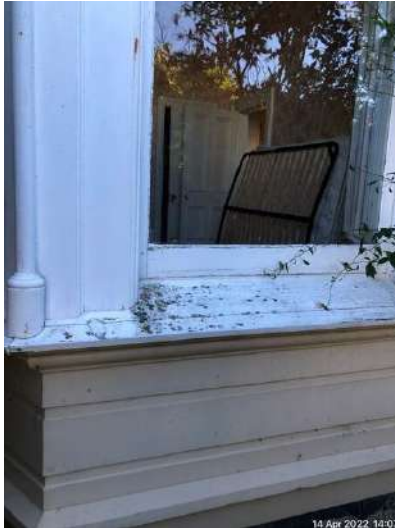
- Deterioration to the paint coating was sighted to the majority of the joinery as photographed below. The units require a full repaint to ensure they are sealed to help prevent further deterioration. A trade qualified painter should be engaged to complete.

Photo Ref #110: General paint deterioration to window unit

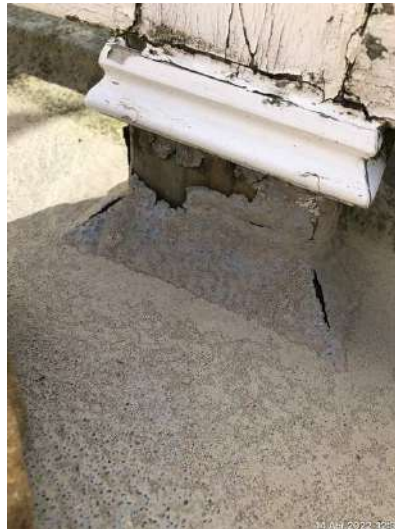
Photo Ref #120: Deterioration to waterproof coating around balustrade post penetration

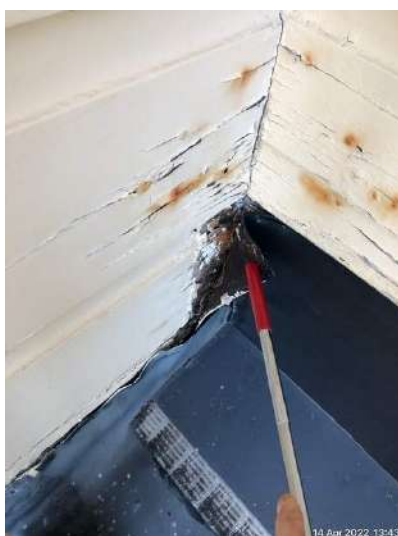
Photo Ref #144: Gaps to apron flashing at cladding junction

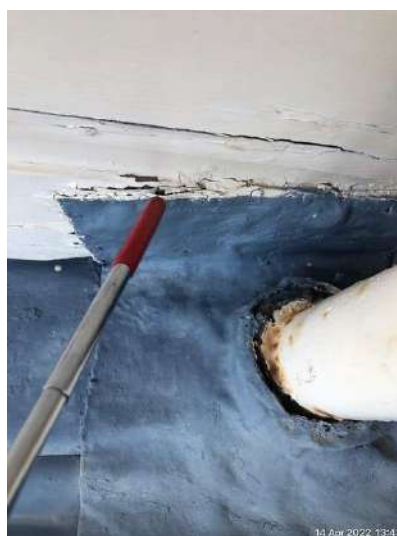
Photo Ref #145: Gaps to apron flashing at cladding junction

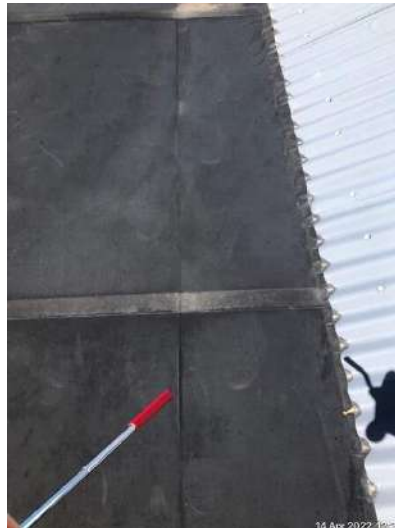
Photo Ref #158: Minor deterioration detected to the membrane in place at location of timber sheet joins below.

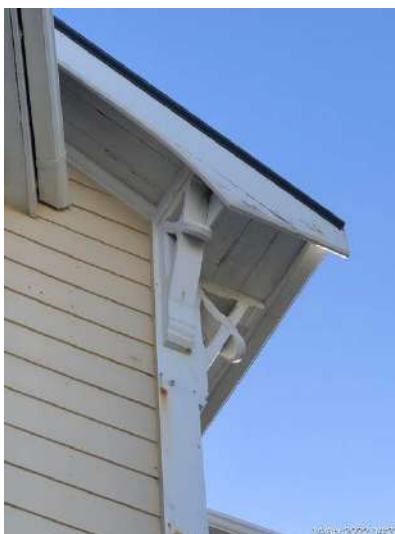
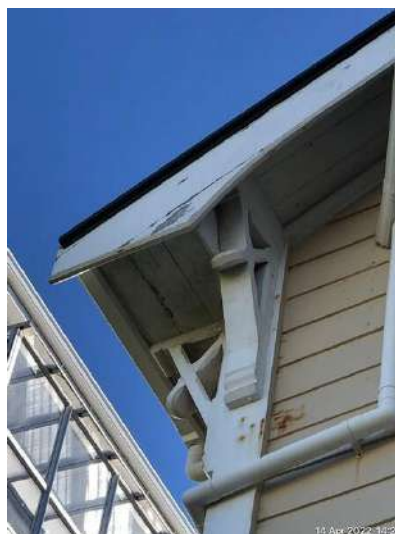
The eaves/fascias/barges appeared solid. Some paint deterioration was detected. Refer to the photographs and details below.

- Paint maintenance is recommended to ensure the timbers are sealed. This is an easy job for a painter.

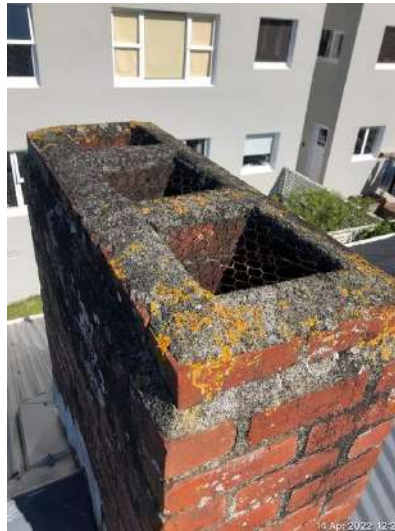
Photo Ref #162: No chimney cap in place

- Brick chimneys are a recognised hazard in the event of an earthquake, due to the movement detected, we recommend engaging a specialist now to determine if strengthening or removal is recommended.

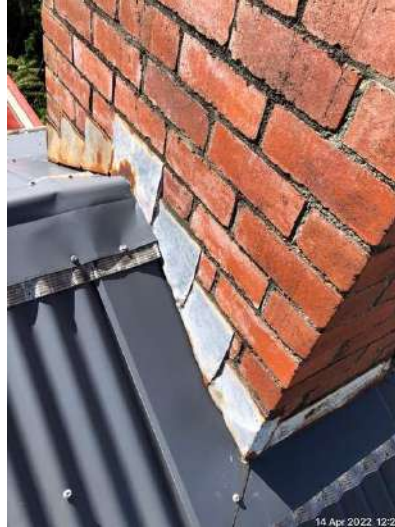
Photo Ref #166: Rust deterioration and gaps at chimney roof penetration flashings

- Brick chimneys are a recognised hazard in the event of an earthquake, we recommend engaging a specialist to determine if strengthening or removal is recommended.

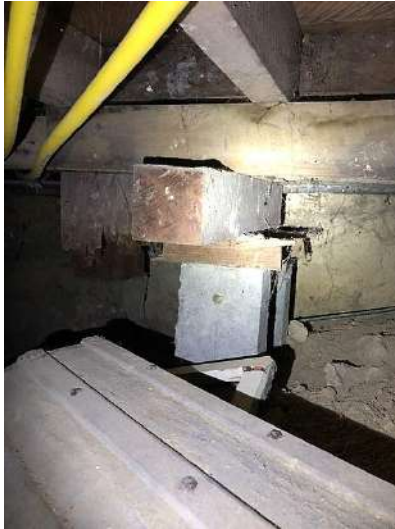
- A number of piles have been overpacked in areas, this appears to have taken place to help level the floor due to settlement over the years. A general rule of thumb is that any pile that is packed over 100mm should be replaced with a new longer pile to provide sufficient support. Engage a licensed builder or piling specialist to improve these areas.

Photo Ref #185: Unconventional piles in place

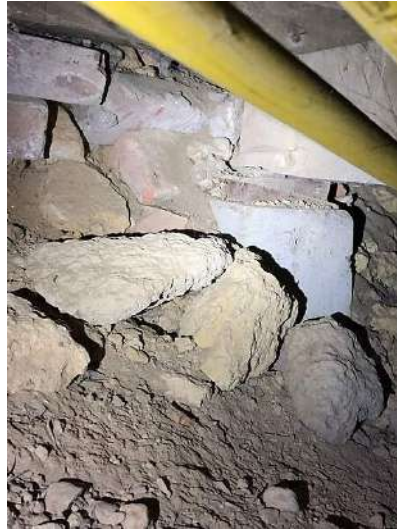
- No pile/foundation connectors were sighted. Pile connectors anchor the pile to timber subfloor framing to help prevent potential movement which is particularly important during earthquakes. A licensed builder or piling specialist should be engaged to assess and determine if the installation of new pile connectors is recommended.

Photo Ref #186: No pile connections were in place

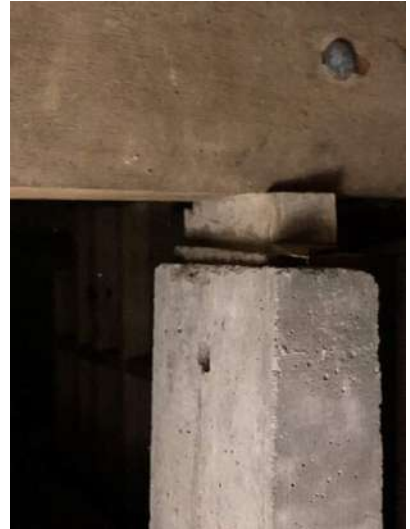
Photo Ref #187: No pile connections were in place

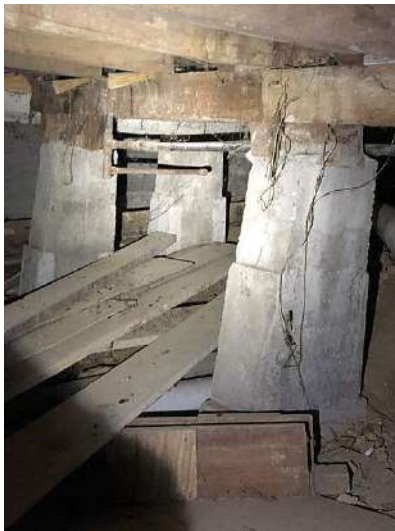
Photo Ref #188: No pile connections were in place

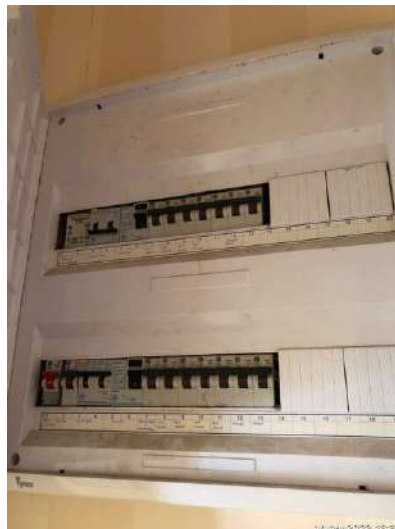
Photo Ref #219

The fuse switchboard appeared in good condition with RCD's in place.

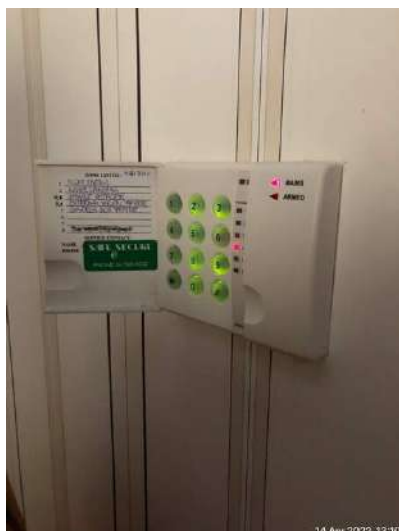
Photo Ref #221

An alarm system was in place. Please note: Alarm systems will never be tested.

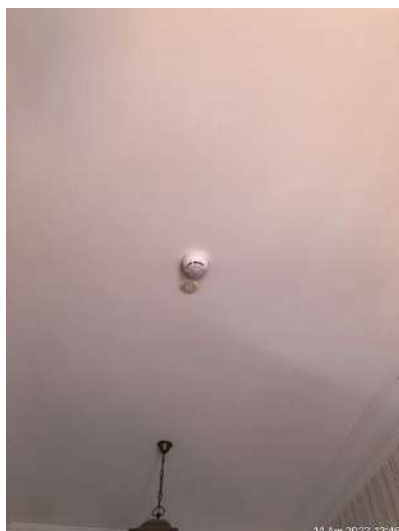
Photo Ref #223

There was an inadequate number of smoke alarms. Refer to details below.

I recommend installing more smoke alarms as this can be a safety risk without them. There must be at least one working smoke alarm in within 3 metres of each bedroom door or every room where a person sleeps. In multi-storey or multi-level homes (including split levels) there must be at least one smoke alarm on each level or storey.

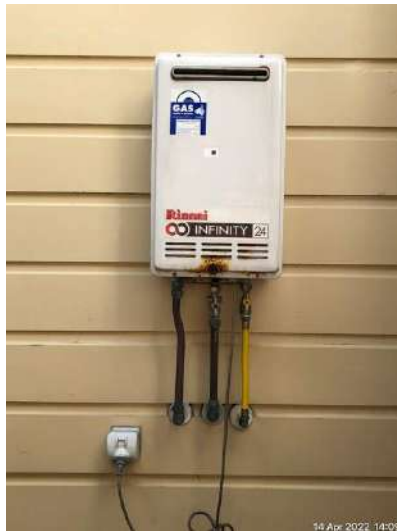
Photo Ref #226

An instantaneous hot water system generally has a lifespan of around 20 yrs, this however is dependent on water quality, service intervals and for externally mounted units location, all gas appliances should be serviced every 18 months - 2 yrs or in accordance with the manufacturers specification.

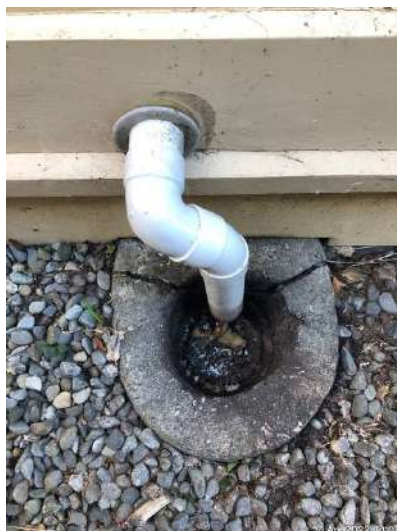
Photo Ref #227

The gully traps were free of movement/cracking and no blockages were sighted.

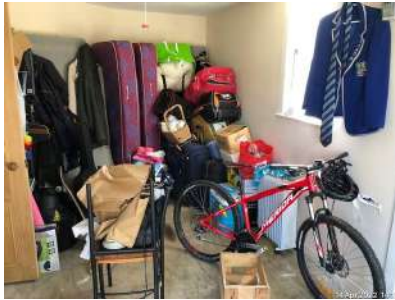
The garages had storage against wall that restricted views of some wall and flooring areas. Vegetation restricted some access and views of walls and fencing

Photo Ref #232: Storage restricted access

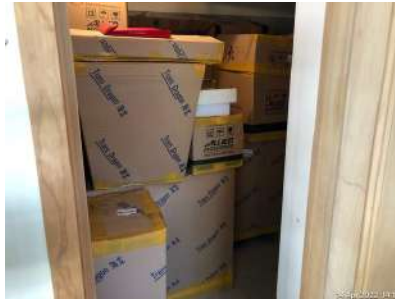
Photo Ref #233: Storage restricted access

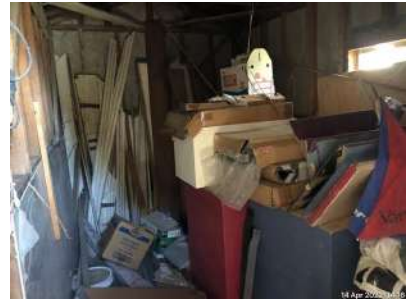
Photo Ref #234: Storage restricted access

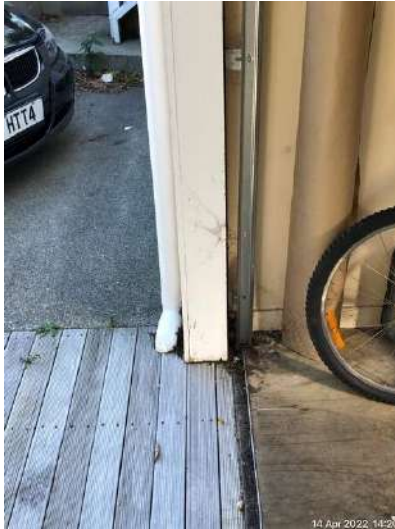
- Timber deterioration was detected to the garage side entrance door, replacement is required by a joiner/builder.
- Moisture damage was sighted to the ceiling linings below the membrane deck.
- Minor decay was sighted to the garage door facings at ground level. A small gap should be installed.

Photo Ref #238: Minor decay to garage door facings

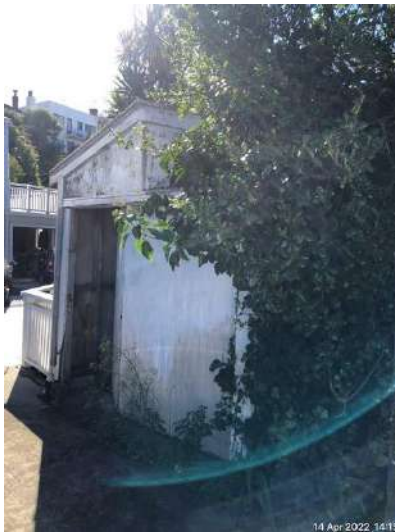
The garage appeared in a below-average condition. Refer to photographs and details below.

Photo Ref #248: Garage

- Due to the condition of the garage, consideration should be made to whether repair or replace the garage. A licensed builder and architect should be engaged to assess and determine the best solution.

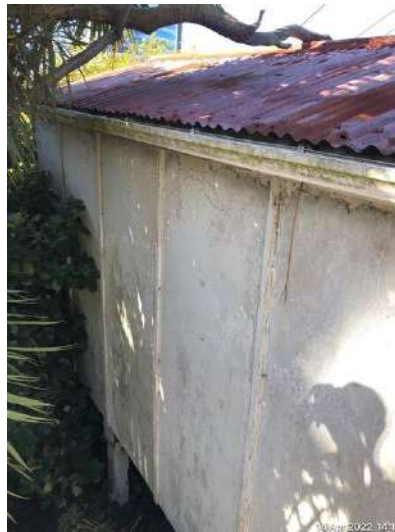
*Due to the age of the dwelling, the fibre cement sheeting used for the cladding could contain asbestos, this is unknown without lab testing. CheckHome recommends keeping the product painted and sealed, we recommend testing prior to any remedial works taking place.*

Photo Ref #249: Fibre cement sheet cladding - possible asbestos

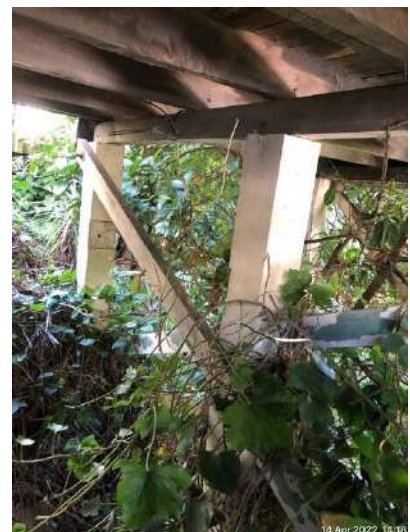
Photo Ref #253: Pile foundations

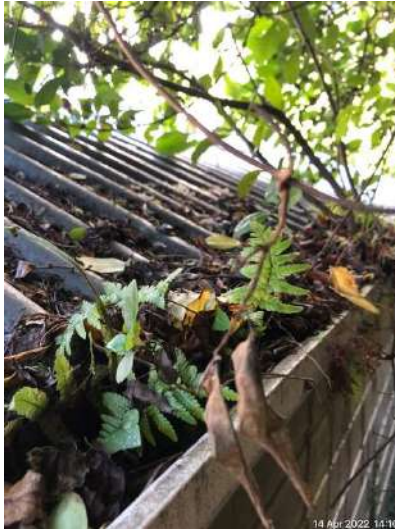
The garage appeared in a below-average condition. Refer to photographs and details below.

Photo Ref #255: Rust deterioration to roofing

- Due to the condition of the garage, consideration should be made to whether repair or replace the garage. A licensed builder and architect should be engaged to assess and determine the best solution.

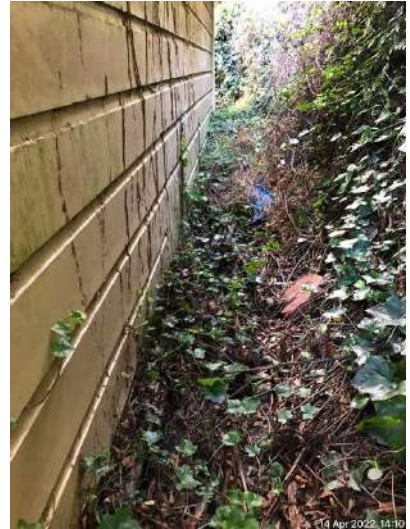
Photo Ref #257: Vegetation built-up against cladding

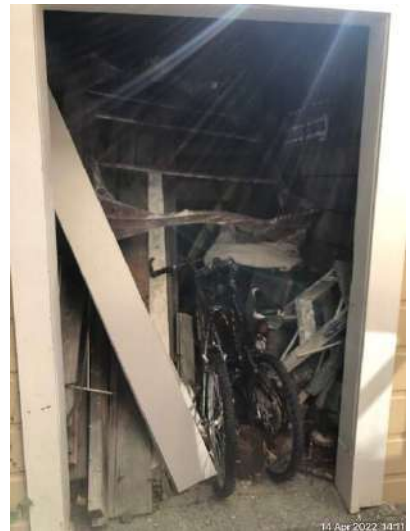
Photo Ref #260: Storage restricting access

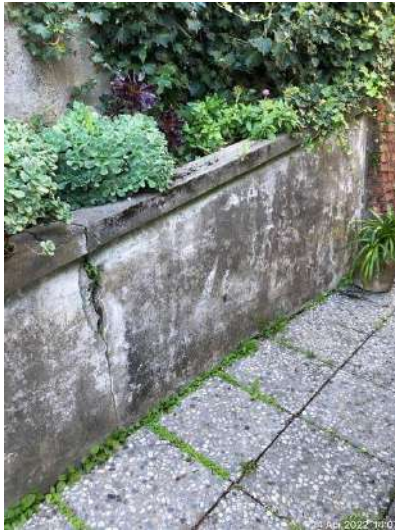
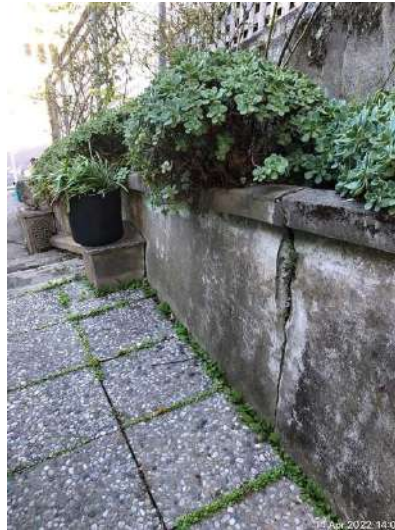
The small concrete retaining wall appeared in reasonable condition for its age. Minor defects were sighted, refer to the details below

- Minor cracking was sighted to the concrete retaining wall. I recommend regular monitoring of this area and if worsens engage with a licensed builder or concrete specialist to provide the best repair solution.

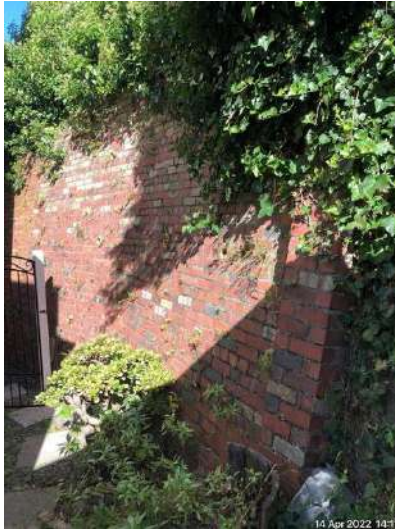
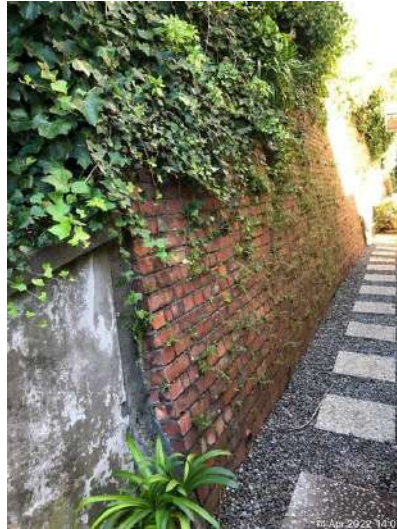
The brick retaining walls appeared well-formed and in reasonable condition for their age. Refer to photographs and details below.

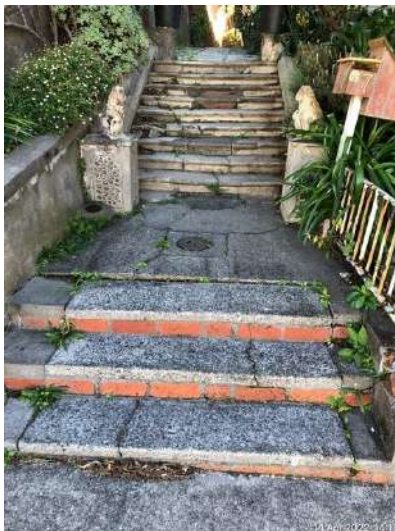
Photo Ref #266

General settlement and unevenness were observed to the entrance concrete steps. Refer to photographs and details below.

- Laise with a concrete specialist to determine the best repair solution.
