PRE-PURCHASE BUILDING INSPECTION REPORT

Sample Address

Inspection Date: 09 Mar 2021

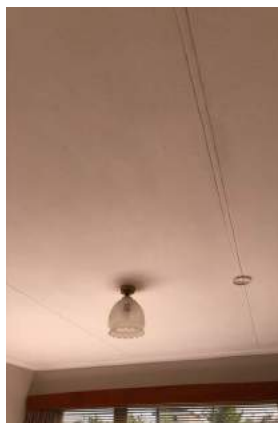
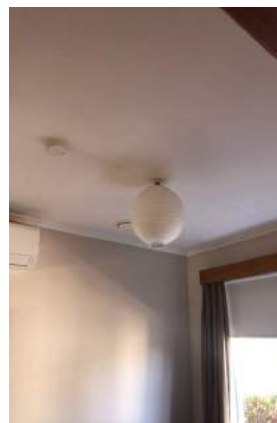
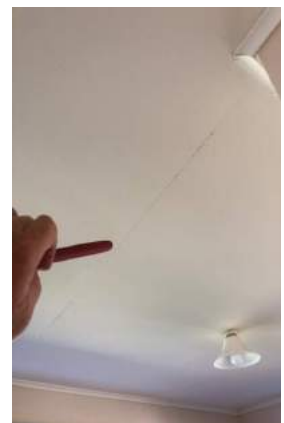
A mixture of plasterboard and softboard ceilings were in place, these appeared well painted and in good condition with minor plaster and paint imperfections sighted.

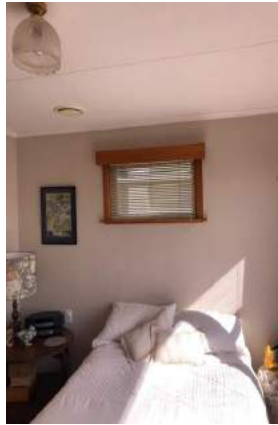
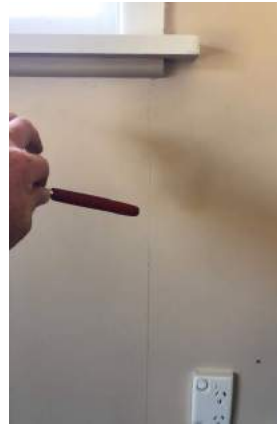
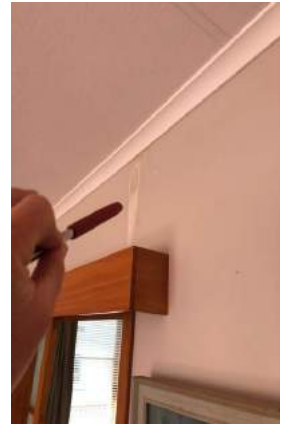
Plasterboard wall linings were in place, these appeared in good condition with some plaster imperfections noted in areas.

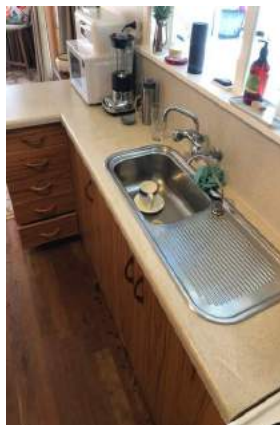
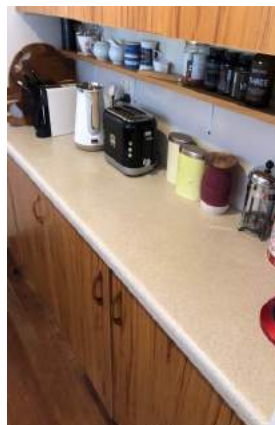
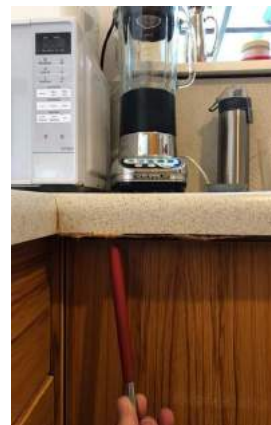
✓ Yes - The benchtop appeared in reasonable condition for its age and was well sealed at wall junction.

- Some minor water damage was noted to the front edge of the benchtop. Improvement can take place if desired.

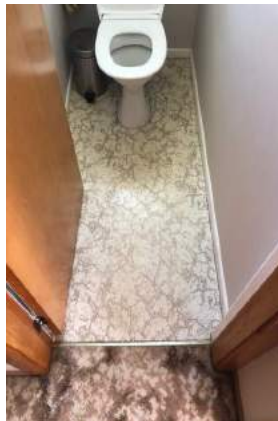
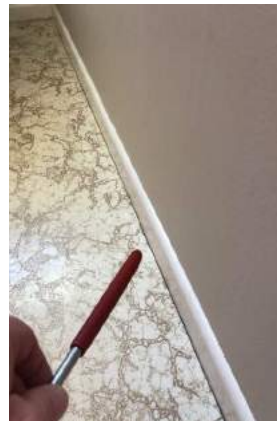
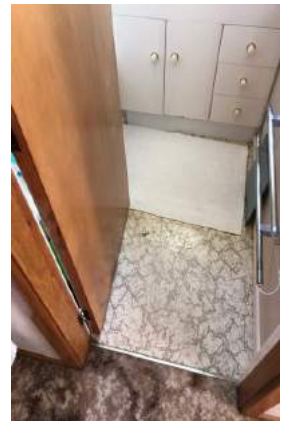
Rating: Minor Maintenance

The vinyl floor coverings require sealing around the perimeter so they are watertight and to prevent floor damage and the vinyl up lifting.

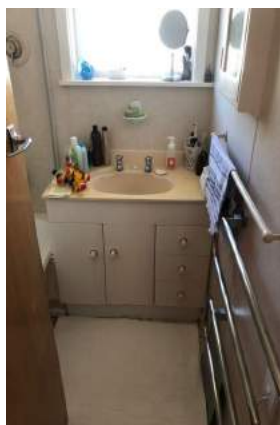
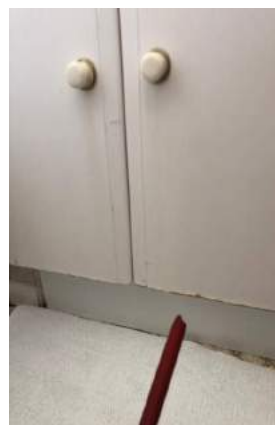
✓ Yes - The vanity appeared in reasonable condition and in working order with some minor wear noted to the bottom of the doors.

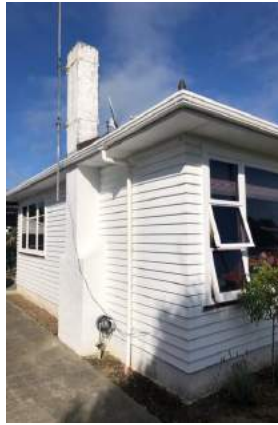
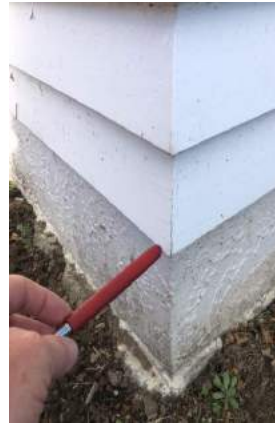
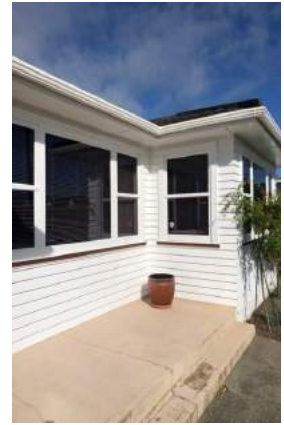
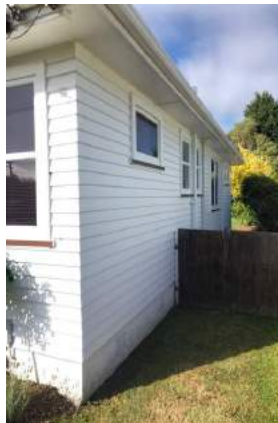
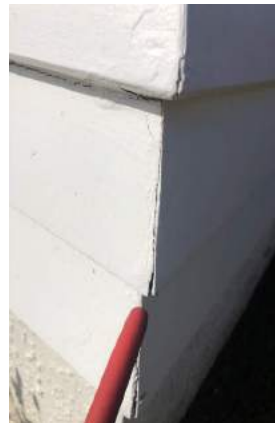
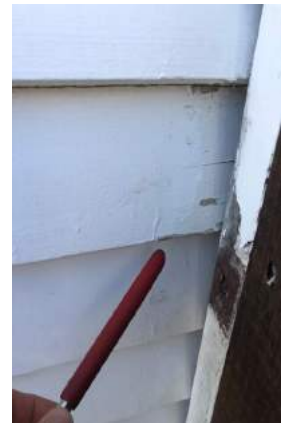
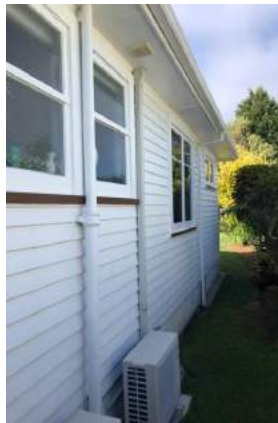
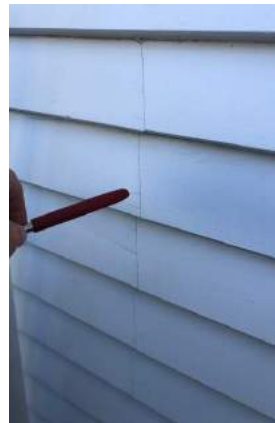
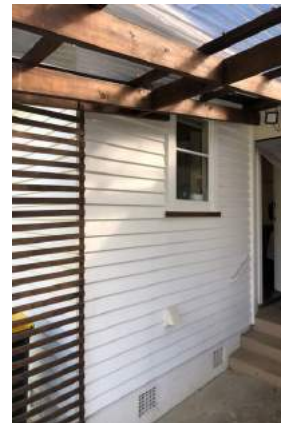
✓ Yes - The timber weatherboards appeared solid, well painted and in good condition for their age.

The dwelling is clad in a bevel back timber weatherboard directly fixed to framework, overall the weatherboards appeared well painted and of sound condition. However minor improvements are recommended in areas. Refer to details below.

- I recommend installing corner soaker flashings to the external corners, this will help prevent the chance of moisture ingress and keep these joins well sealed.
- Minor paint imperfections were noted to the bathroom wall, I recommend touch ups take place.

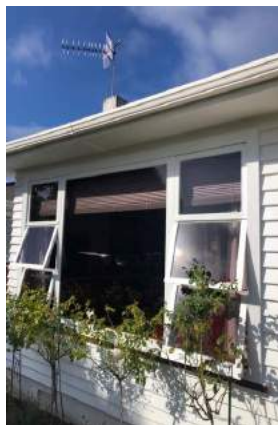
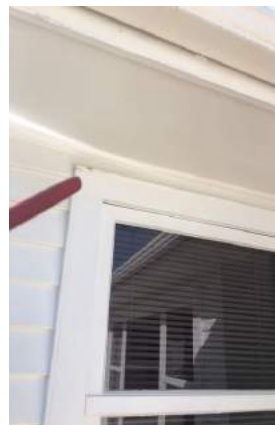
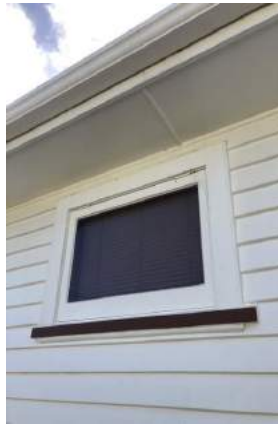
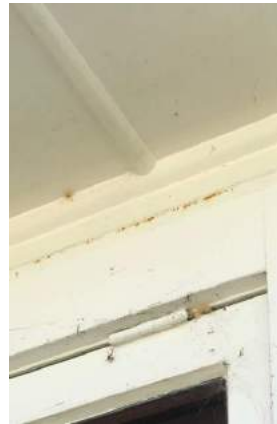
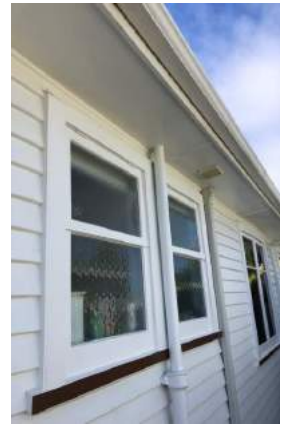
✓ Yes - Overall the window and door units appeared well painted and in good condition for their age. However a handful of rusted head flashings were sighted

The rusted head flashings sighted above the windows & doors will require rust treatment repair work to ensure a weathertight barrier and prevent water ingress. This is a simple task for a licensed painter.

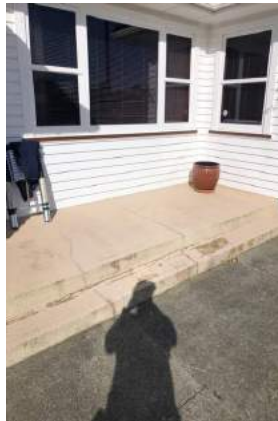
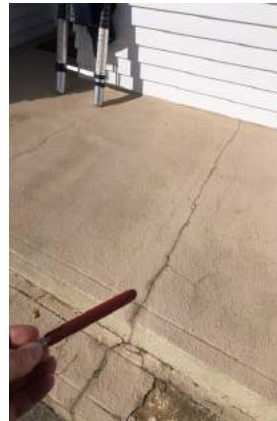
✓ Yes - The patio appears structurally sound and in reasonable condition for its age with some typical cracks sighted.

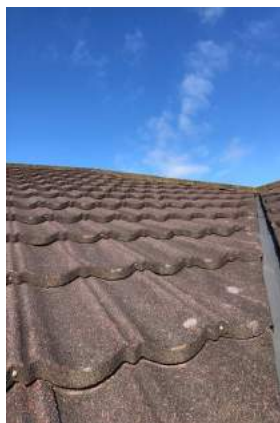
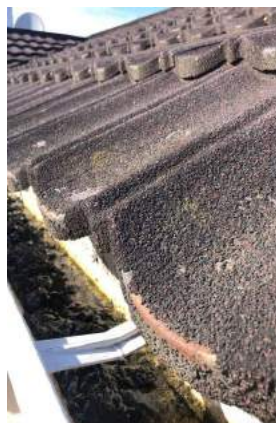
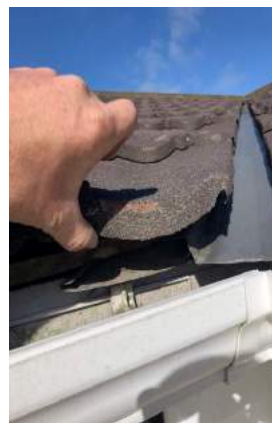
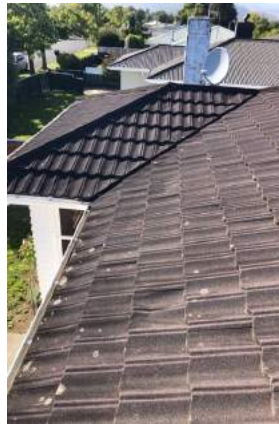
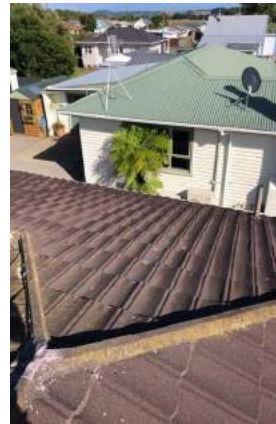
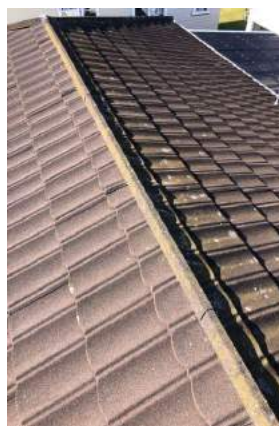
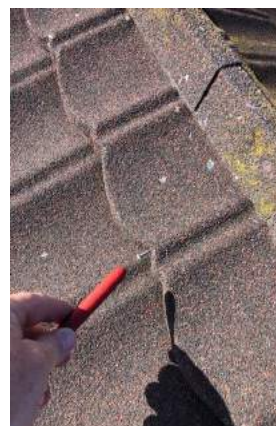
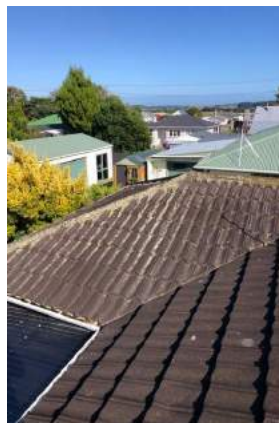
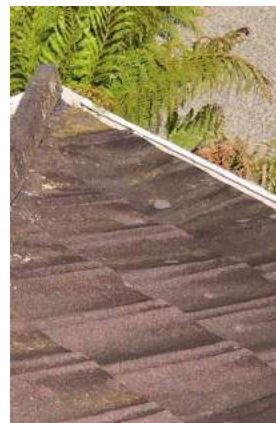
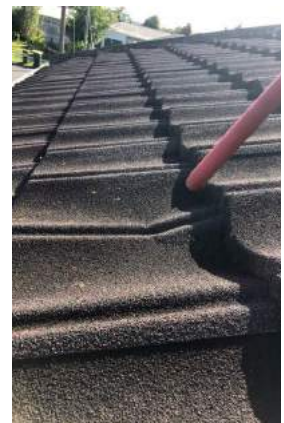
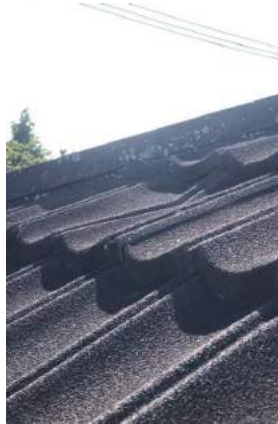
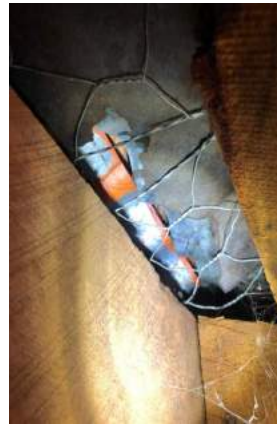
✗ No - Dented and loose tiles were noted

A metal tiled roof was in place. Some deterioration was sighted due to age, the metal tile roof requires minor re coating and painting on the front section of the roof to prevent rusting and also ensure it is watertight. Replacement is required of all dented tiles as this will allow water to sit in the tile and cause rust, further investigation is required by a licensed roofing specialist.

- Take note this metal tiled roof appears too have been installed over the top of the original corrugated iron roof. The condition of the corrugated iron below and how the metal tiled roof is connected to the below roof is unknown without an invasive inspection, also take into consideration should a re roof take place to the metal tiles it is more than likely the corrugated iron will also need replacement.

Take note the coating on the metal tiles may contain asbestos due to age however this is unknown without lab testing, I recommend testing takes place prior to any remedial works.

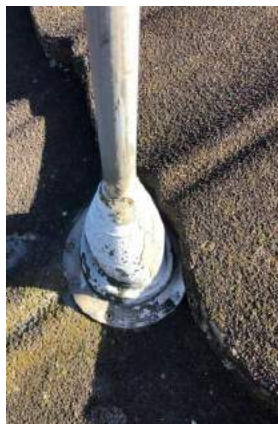
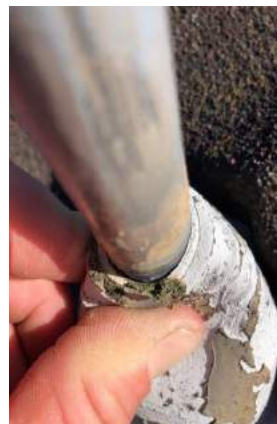
✗ No - Seal deterioration detected

I recommend upgrading the vent seals with a water tight seal, this can take place by a licensed plumbing or roofing contractor.

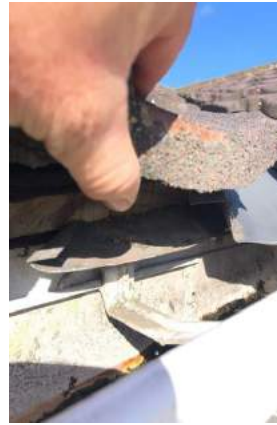
Photo Ref #111 :

✓ Yes - The valleys appeared functional with no major deterioration or blockages sighted at the time of the inspection.

- Take note the original corrugated iron valley tray is still in place below and rust deterioration was noted.

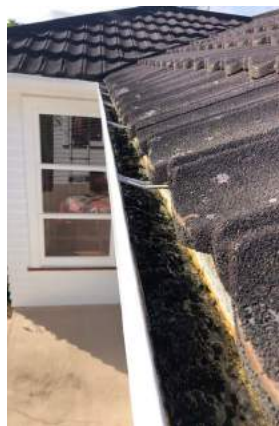
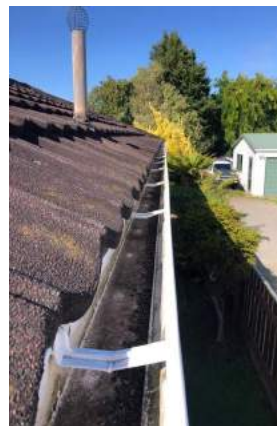
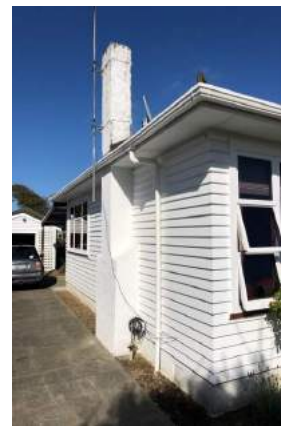
✓ Yes - The gutters & downpipes appeared functional with no major blocking sighted.

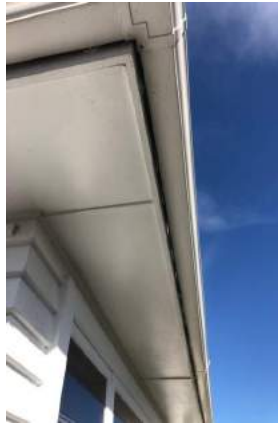
Photo Ref #116 :

✓ Yes - No visible damage and appear to be in reasonable condition for the age of the building.

Be aware that due to the age of the eave product there is a chance it contains asbestos, this is unknown without lab testing. CheckHome recommends keeping the product painted and sealed, we recommend testing prior to any remedial works taking place.

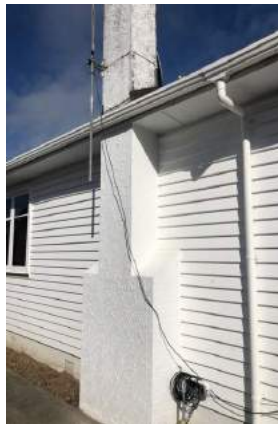
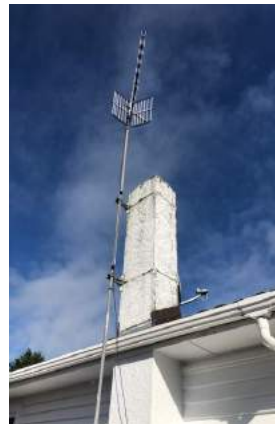
✗ No - Chimney cracks were detected

Chimney cracks were sighted, this style of chimney is a safety hazard in the event of an earthquake. I recommend repairing or removing now, seek further advice from a structural engineer.

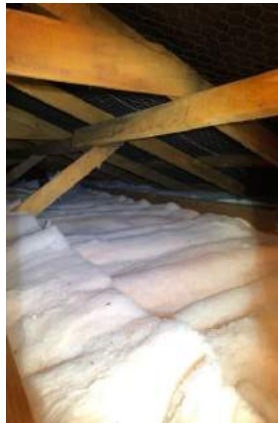
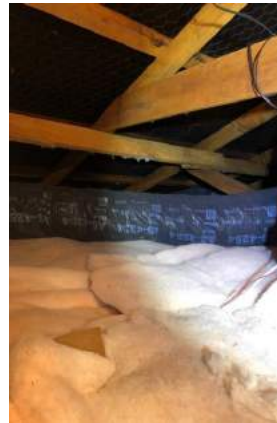
○ The roof space was only inspected from the man hole and no ceiling joists were inspected as these were covered by insulation

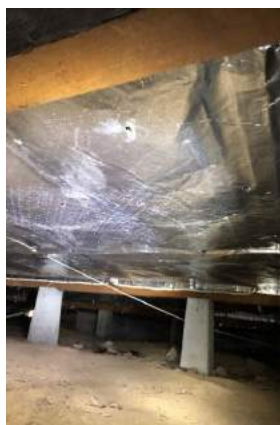
Photo Ref #131 :

○ The floor joists or flooring was not visible at time inspection as this was covered by foil which was restricting the view

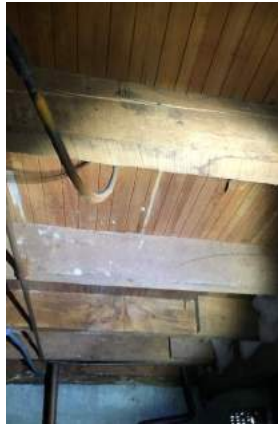
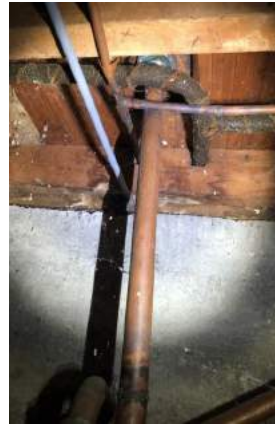
Photo Ref #133 :

Due to limited access in the subfloor space not all can be visibly seen, further investigation will be required.

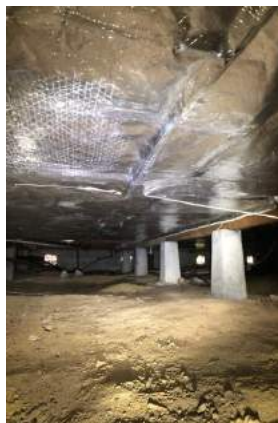
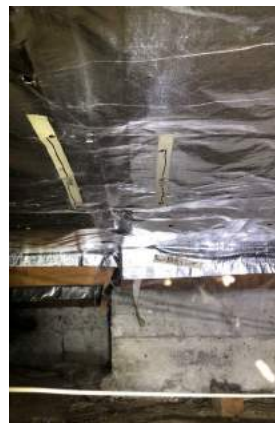
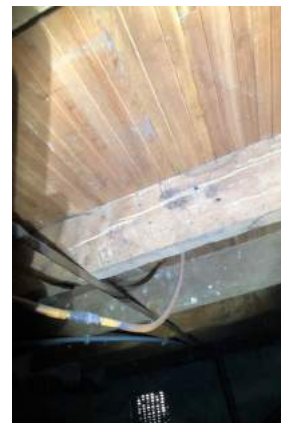
Photo Ref #136 :

Older style foil was in place, improvement can be made by insulating this area. Take note this style of insulation can be a safety hazard, This product has the potential of becoming live if wires are in contact with the foil. Removal is highly recommended by an insulation specialist or licensed builder when power is disconnected.

Rating: Minor Maintenance

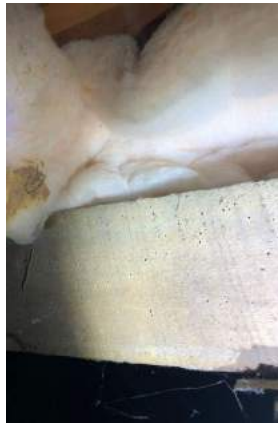
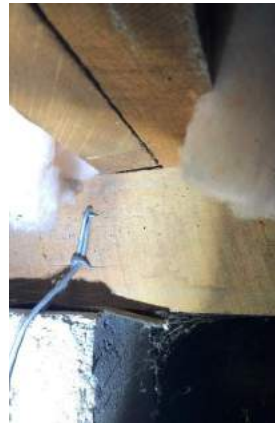
Photo Ref #139 :

Rating: Further investigation

Treatment is required now by a specialist to prevent deterioration. Further investigation is required by a specialist,

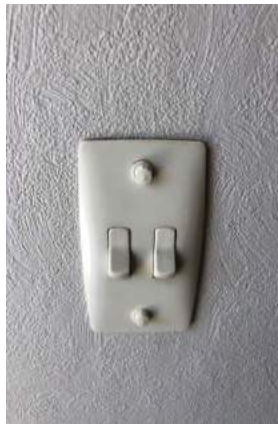
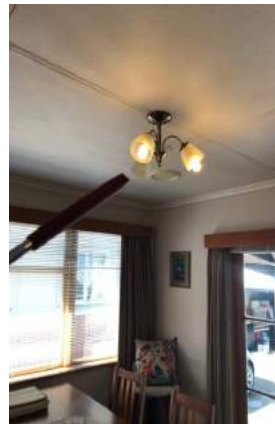
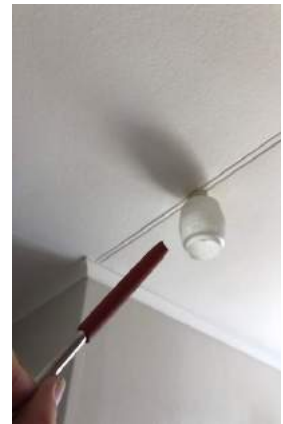
Photo Ref #181 :

Location :
- Hallway
- Dining room
Rating: Minor Maintenance

Upgrades to the switches are recommended in the near future. It is recommended the bulbs are tested prior to settlement, further investigation is required by a licensed electrician.

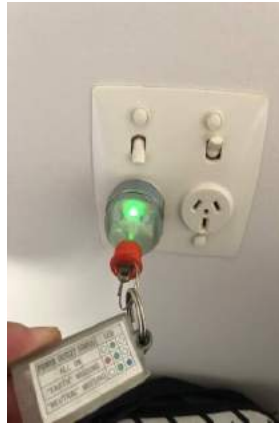
Photo Ref #184 :

Rating: Recommendation

Upgrades are recommended to the older hot points in the near future.

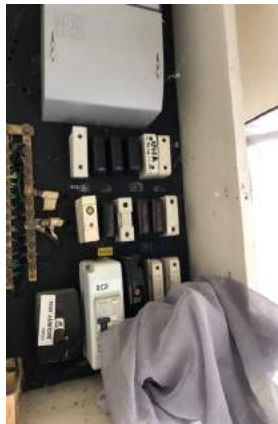
Photo Ref #189 :

☐ Some older porcelain fuses sighted and some newer sighted, I recommend having a licensed electrician inspect this fuse board to see what fuses are in use. I recommend all fuses are circuit breakers, upgrades are recommended on this style switch board in the near future to keep up with current safety standards.

Action Required

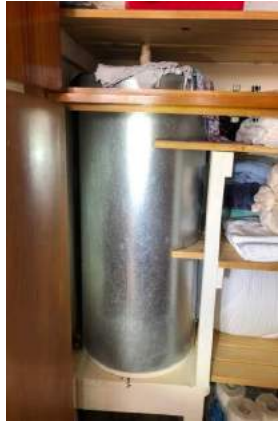
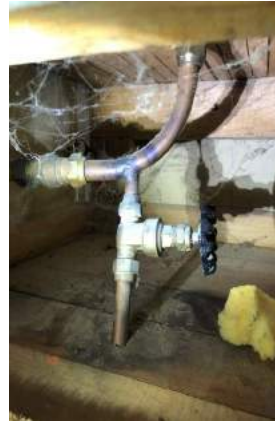
The age on the cylinder was not visible, further investigation is recommended.

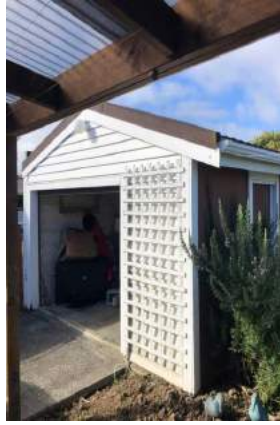
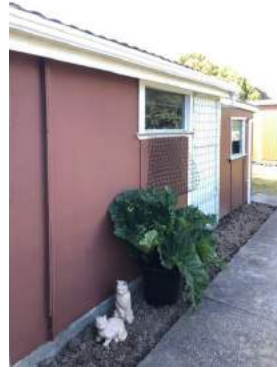
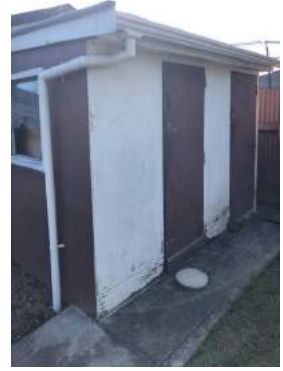
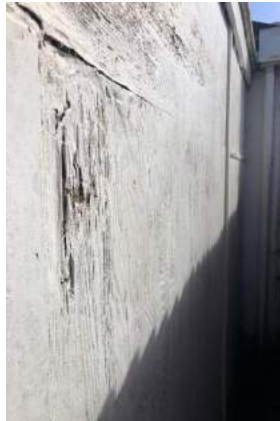
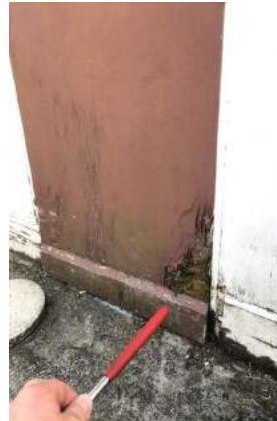
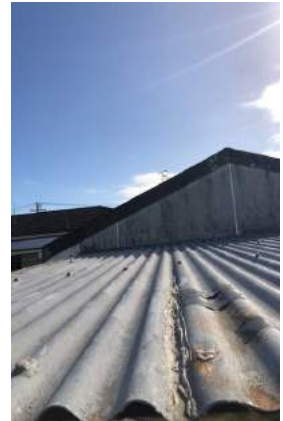
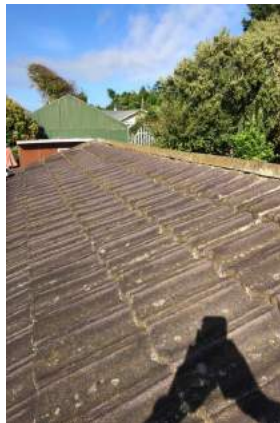
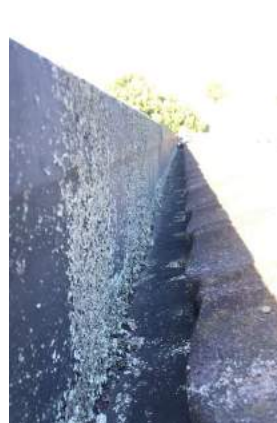
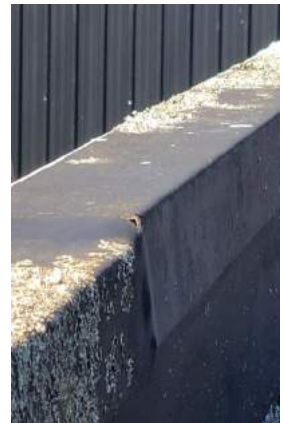
✗ No - Deterioration detected due to age

- Take note the roof coating and some of the garage cladding may contain asbestos due to age however this is unknown without lab testing. I recommend testing takes place prior to any remedial works

Repairs are required by a licensed building and roofing contractor as deterioration was detected to the garage due to age, improvement should be made to prevent further deterioration.

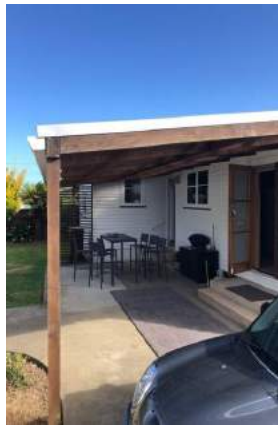
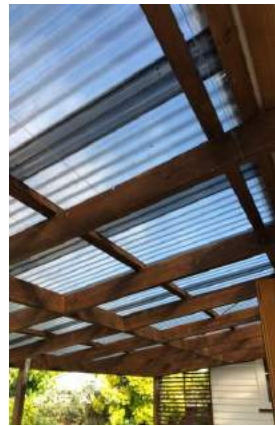
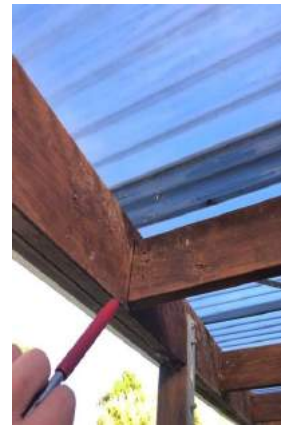
✓ Yes - The carport appeared structurally sound and free of defects/damage. However one improvement is recommended.

- It is recommended that multi grips are installed to the rafter to beam junction to ensure this connection does not pull apart in the future.

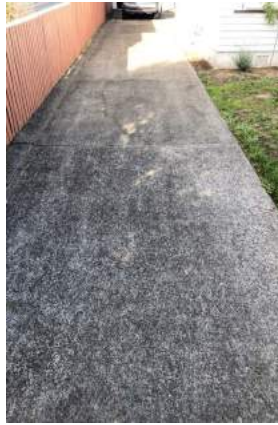
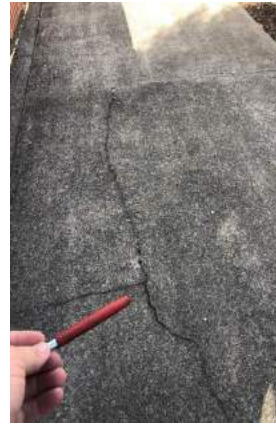
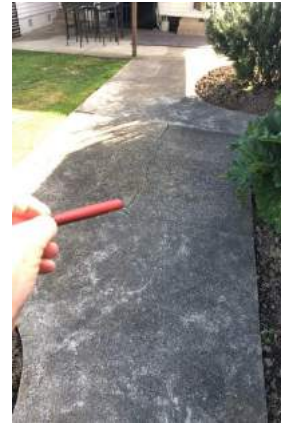
✗ No - Cracks were sighted

Cracks were sighted from general settlement and movement over the years, improvements can be made if desired.

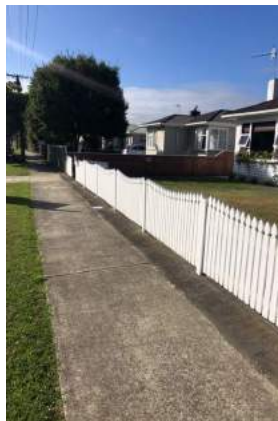
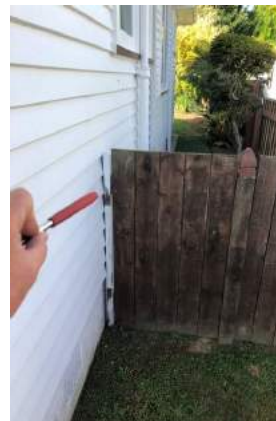
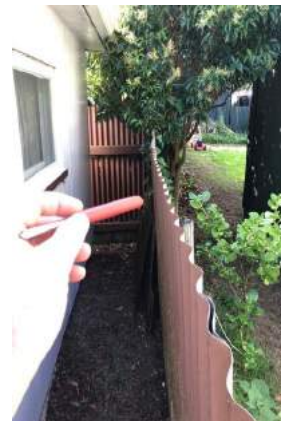
- The fence at the back of the section is leaning over. Repairs are recommended.

I recommend there is a gap of at least 15mm where the fence meets the dwelling to prevent water ingress.
