**UNITED TESTING
SERVICES**

CPSC REPORT NO. 20180519-A9E35-2147387862
Recall Number 12-117
UL 147 Compliance Failure Submission
February 14, 2019

Hand-Held Torch Failure and Injury Study

**Related Brands Including: BernzOmatic, Medina,
Worthington, Sears, Ace, and Lenox**

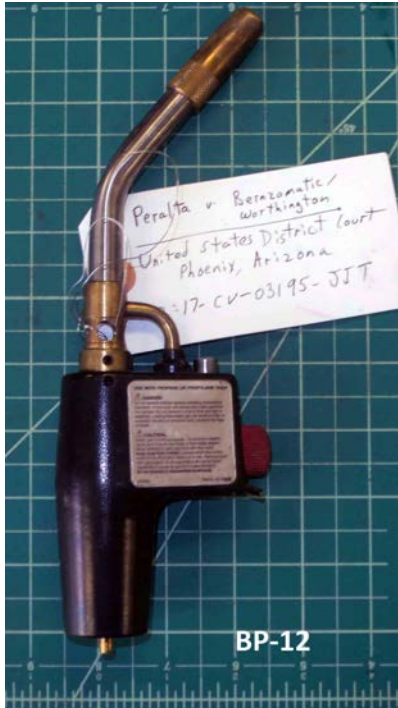
Peralta torch attachment

The Peralta and Bailey cylinders evidenced failures at the neck in the area of the brazed joint and were nearly identical.

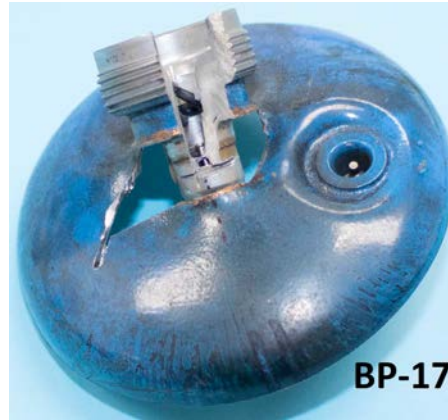
BP-17

test sections were taken from the center valves of Bailey and Peralta cylinders

The impermissible voids noted on the Bailey and Peralta cylinders evidence a compliance failure with [DOT 39](#) and [UL 147](#), and are generally identical to voids noted by an expert witness metallurgist [Dr. Robert Anderson in his study of another injury case in the year 2008](#).

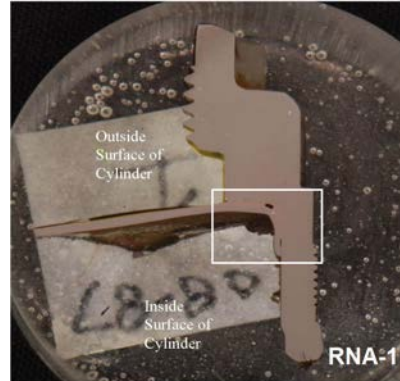
RNA-1

Expert Anderson’s cross-section photo evidence an identical manufacturing defect on another NRT cylinder in relation to [Plaintiff] v. Worthington, et al., 07-cv-2107-MMA.

Dr. Anderson identified the test cylinders as: W10G57E, W11G152W, and W8G230E, and noted that “[T]he brazing materials have large voids in the bulk and smaller voids in the interface between the cylinder walls and the valve housing.”

Dr. Anderson pointed out that the voids are at the brazed bushings near the points of failure, and evidence a compliance failure with the Federal Government’s manufacturing requirements, commonly known as the Dept. of Transportation “DOT 39” requirements, which are found in Title 49, Chapter I, subchapter C, Part 178 of the U.S. Federal Register, cited as [49 CFR 178.65](#). The requirements are found at the following link:

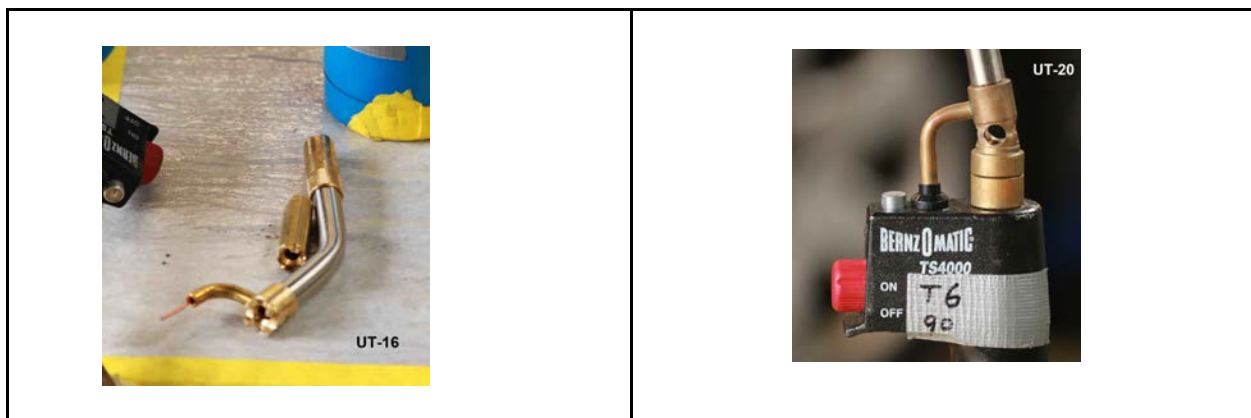
The manufacturer changed the Fracture groove design over the years.

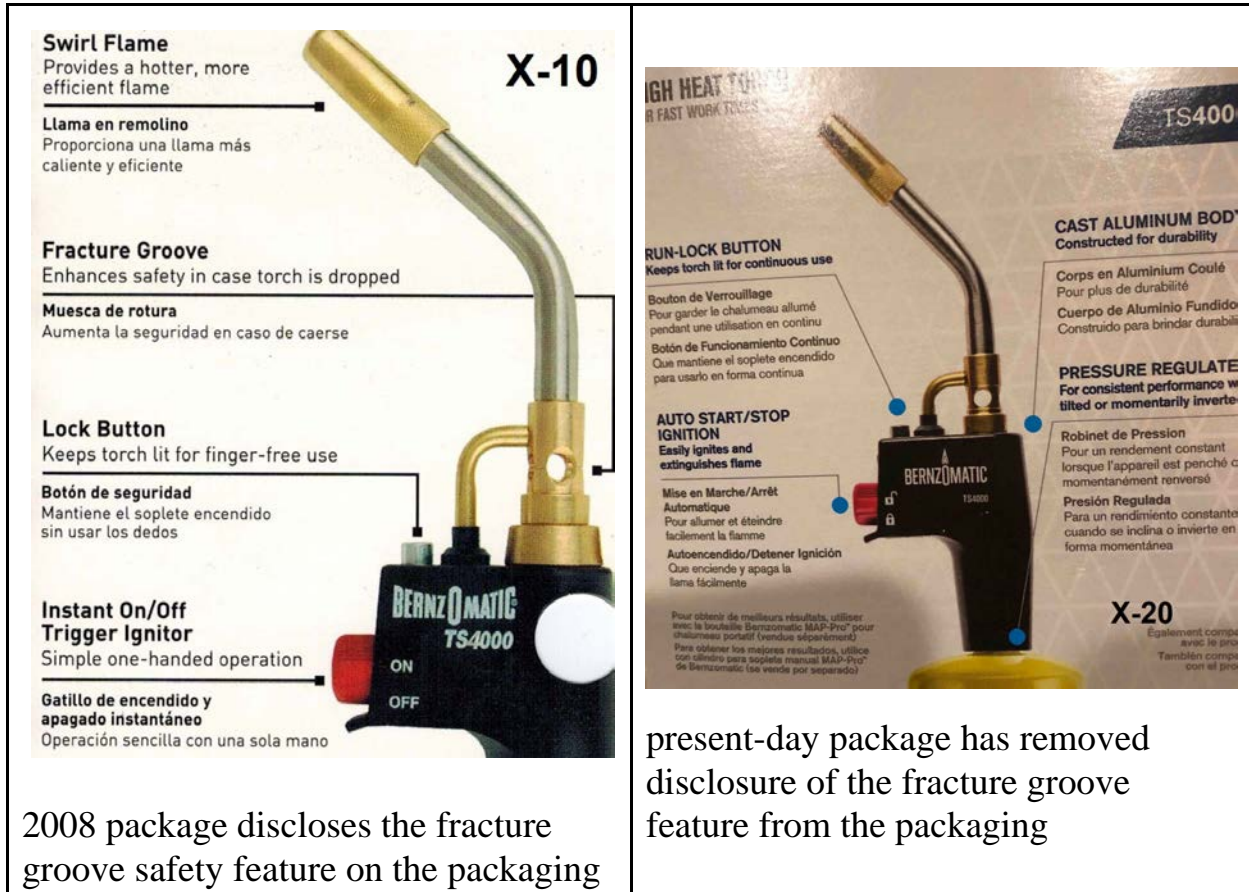
In addition, the manufacturer did not only delete the words, “extremely large” from its posted description of the [Fracture groove](#) feature, but it also removed the description of the [Fracture groove](#) feature from the packaging:

deletion of the words “extremely large” and removal of the [Fracture groove](#) description from the package suggest the manufacturer (presently Worthington) was aware of the defects described above, drawing focus to the need for testing of the [Fracture groove](#) feature in the manner described by Worthington’s [Mr. Gentry](#) and Newell’s [Mr. Ridley](#).

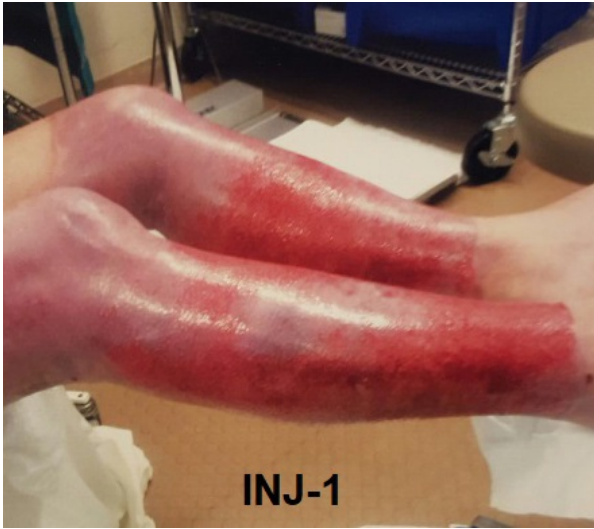
Mr. Bailey

In both instances the product was held at the lower portion of the cylinder, and light force was applied to the fracture groove-equipped torch attachment, insufficient to cause fracture. Nevertheless both cylinders failed identically at the area of known vulnerability, the center valve brazed joint area.

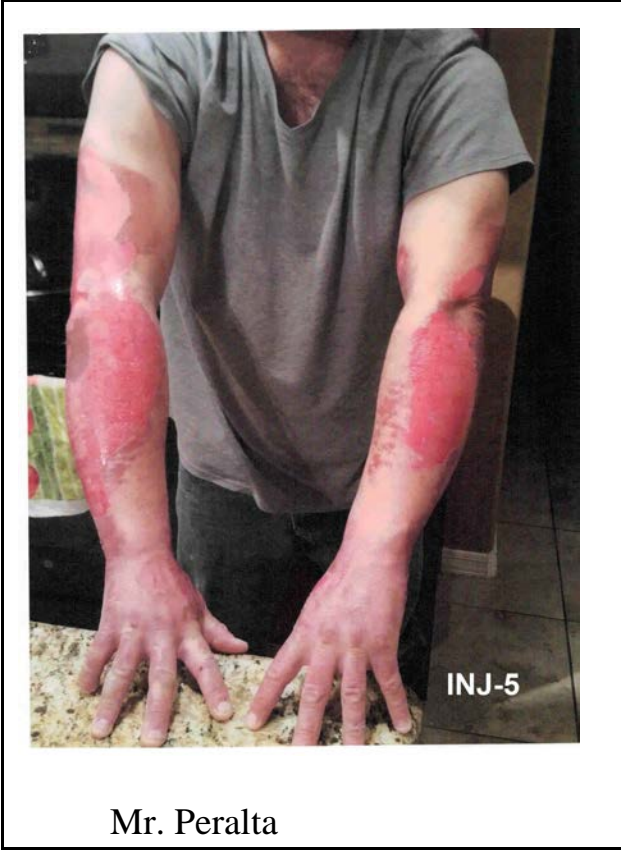
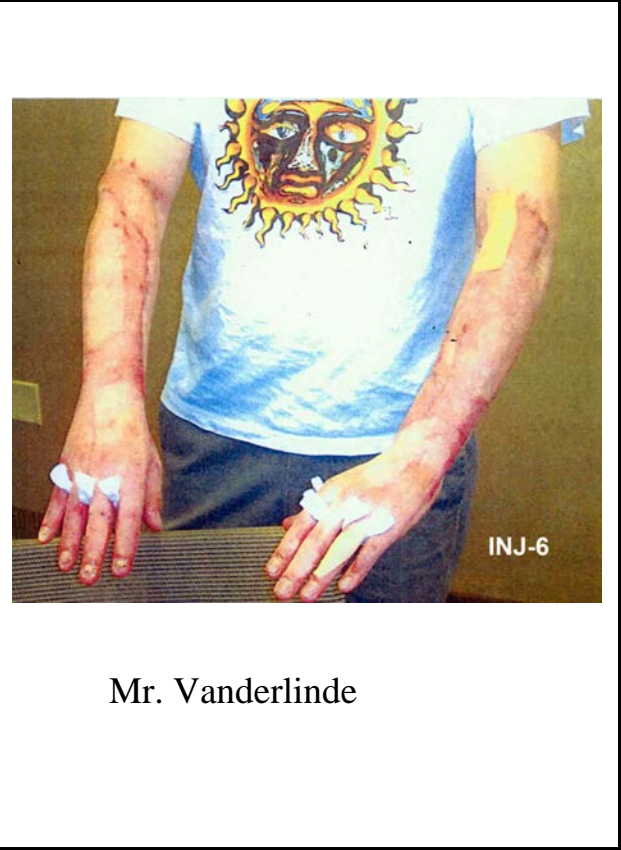
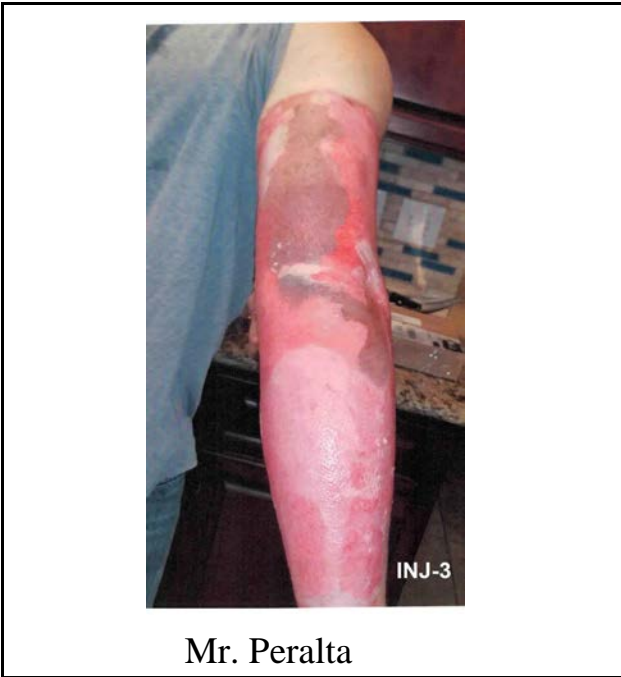
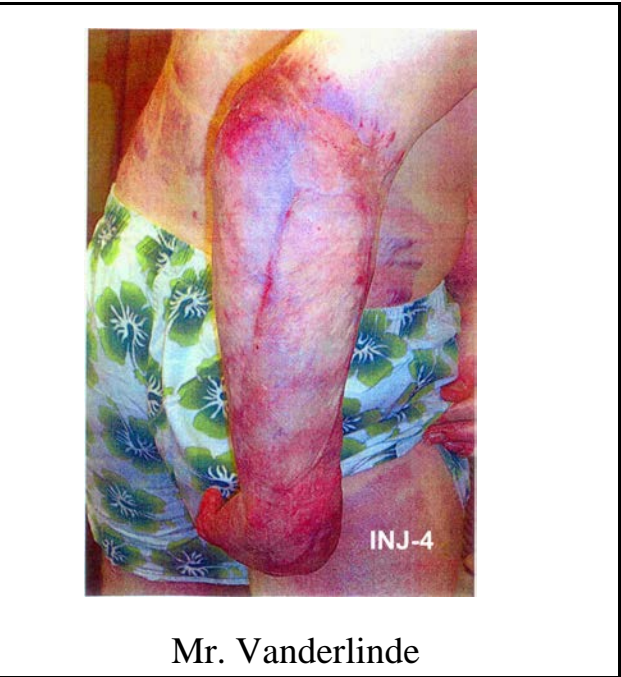
Mr. Peralta's and Mr. Vanderlinde's injuries were nearly identical:

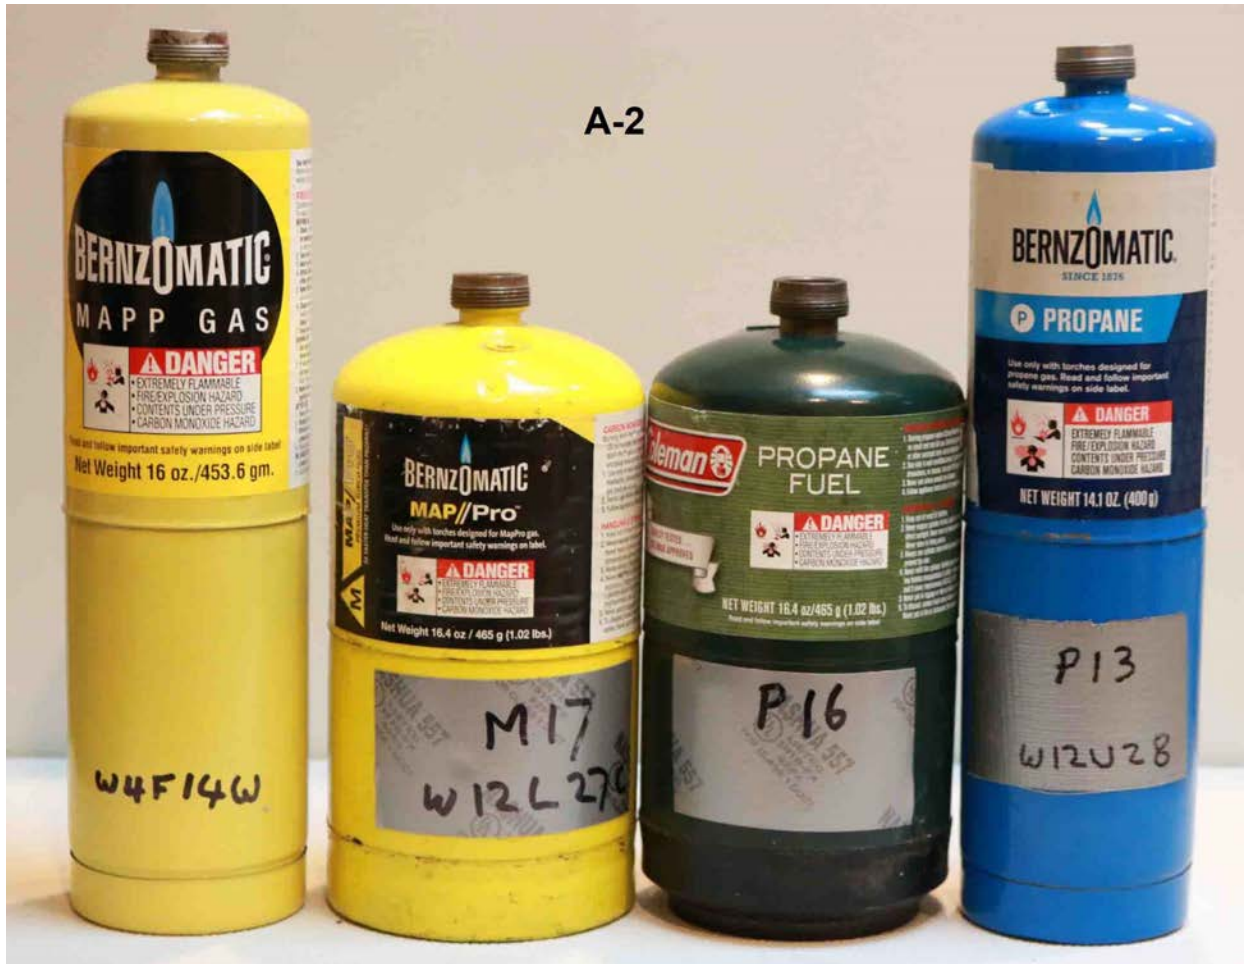
A-2

The non-refillable short cylinders show no signs of failure. Of all the lawsuits found on the Court's PACER system, only one was found in which the center bushing of the NRS cylinder allegedly failed. However, the recessed valve design would also make the NRS cylinder safer. An expiration date may prevent failures related to rust or flexing and mounting-dismounting of the torch attachments.

By recessing the center valve and tapering the torch attachment to allow for insertion and attachment into the center valve, the brazed joint is protected from lateral forces, and the [Fracture groove](#) will fracture upon application of force to the tip of the torch without breach of the cylinder.
