# Engineering Meeting

Wednesday 16th December 2020

# **LOWER SEVERN (2005) INTERNAL DRAINAGE BOARD**

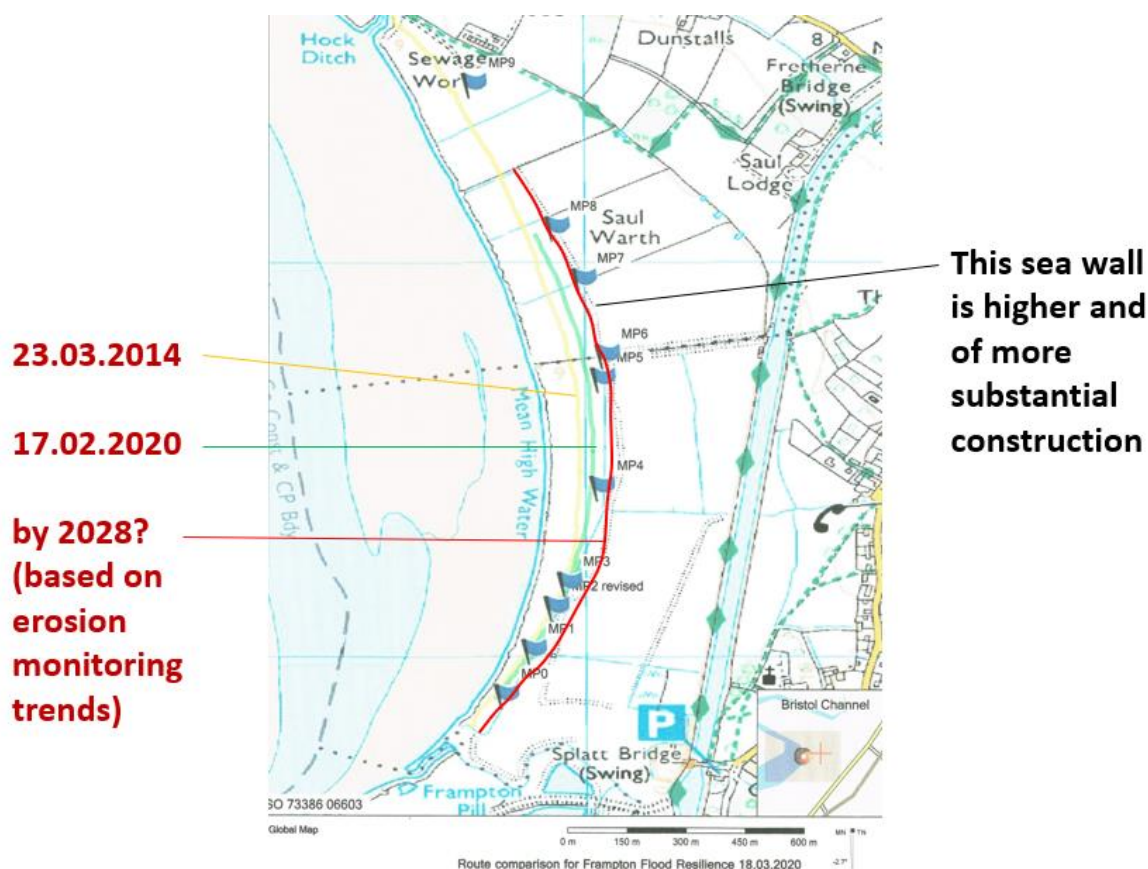
**Fig. 1 – Warth edge mapping**

ATL maps a line 1m from the edge of the warth periodically. The erosion noted between 2014 and 2020 can be extrapolated to suggest where the warth edge might be in 2028.

Although the formal erosion monitoring protocol started in 2014, some information is available from informal monitoring at the same points from 2011. The most recent monitoring was undertaken on 17 February 2020.

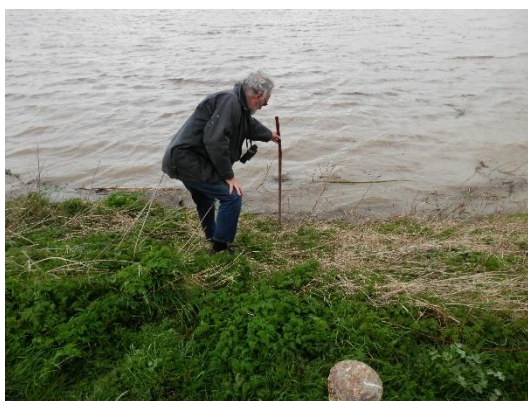
**Fig. 5 – High water at OP5 on the morning of 11 March 2020.**

The strand line at OP5 (indicated by the bottom of the stick) was 20cm vertical height below the top of the towpath edge after the evening tide of 11 March 2020. Note that the towpath then slopes upwards towards the canal edge.

Visual estimates suggest that high water came within 1m vertical height from the top of the towpath edge on the previous tide. The EA's recent coastal defence projects in the south west have been based on designs assuming a 1.1m rise in sea level by 2100.<sup>16</sup> It follows that the canal embankment will not only be subject to more and more tidal action and saturation, but will likely be overtopped by the end of this century.

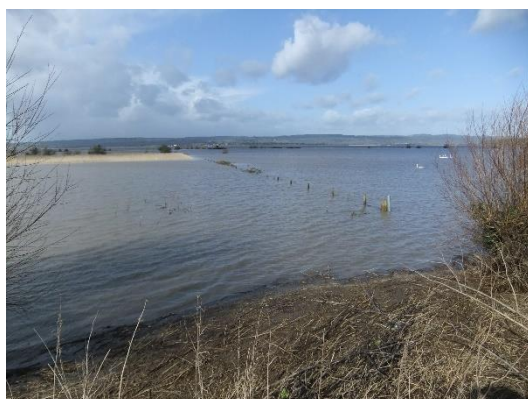
**Fig. 6 – Just after high water at OP4 on the morning of 12 March 2020**

The height of the tide can be seen on the fence posts.

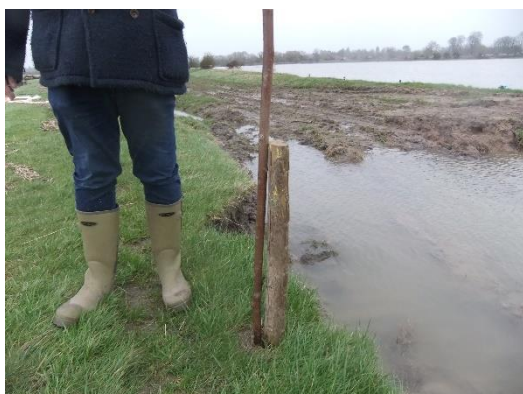
**Fig. 7 – Marker Post (MP) 2 on the outer warth is 65cm in height**

The top of MP2 was just visible from the towpath during high water on the morning tide of 12 March 2020.

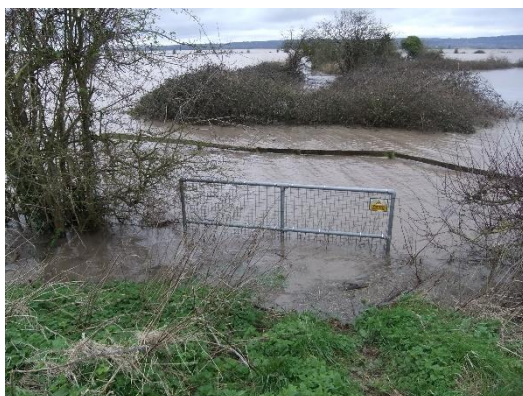
**Fig. 8 – High water at the Buckholdt siphon (OP6) on 11 March 2020**

The Buckholdt siphon takes a substantial percentage of Frampton's surface water under the canal.

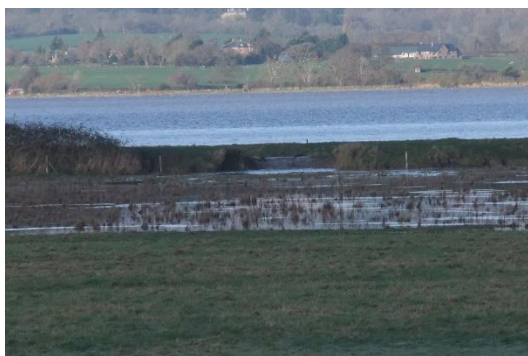
**Fig. 9 – 23 January 2019 at high water**

On 23 January 2019, water came through a breach in the old sea wall at MP2 on an observed tide of 9.64m at Sharpness (to Sill Datum). Since then, erosion has lowered parts of the warth, particularly around the two main embayments, and ATL have studied the flows of tidal water into the inner warth.<sup>17</sup> Extraction of the excavator in December 2019 caused further localised lowering at MP2.<sup>18</sup>

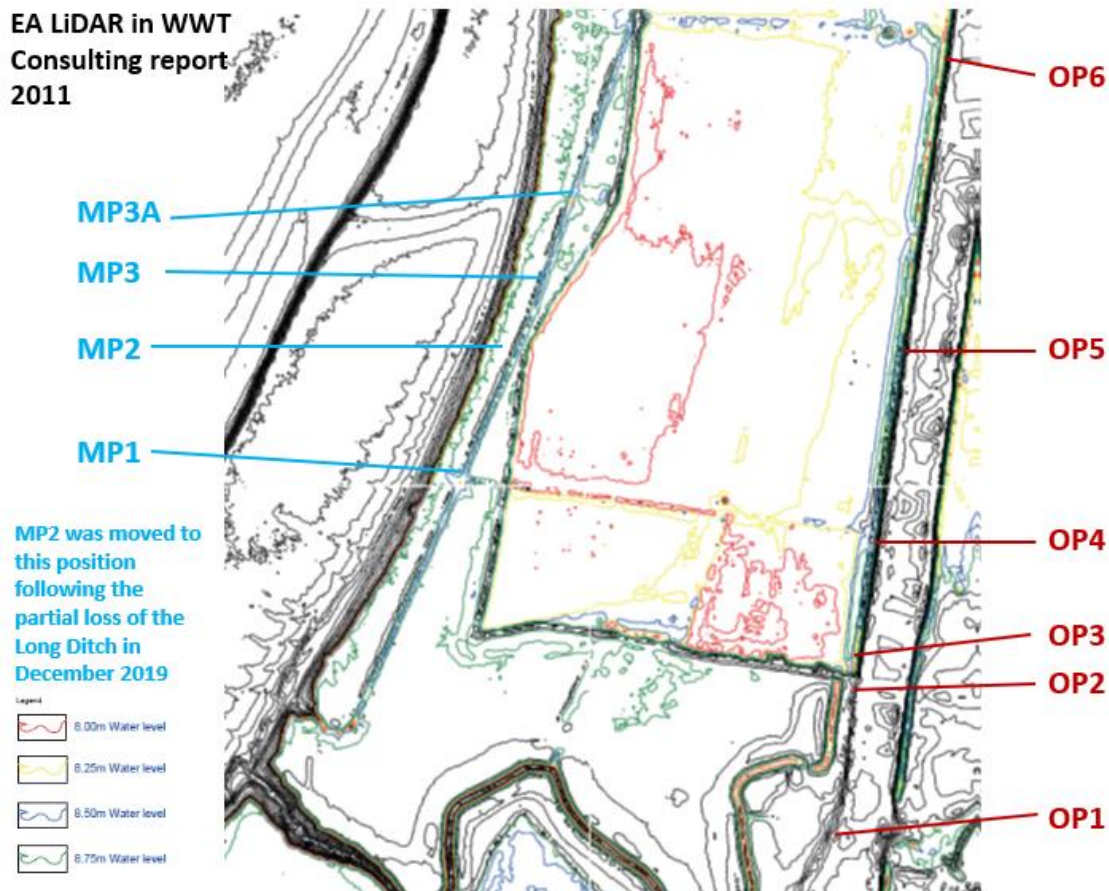
**Fig. 12 – LiDAR from Buckholdt siphon to Frampton Pill**

LiDAR between Buckholdt siphon (at OP6) and Frampton Pill demonstrates the low spots

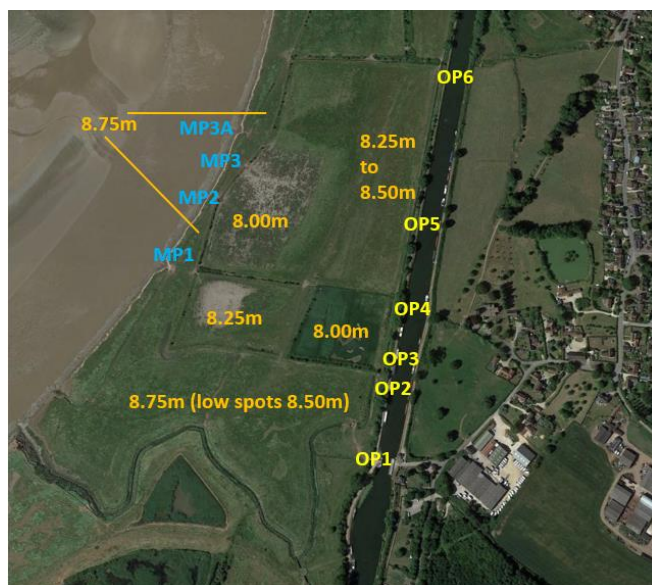
**Fig. 13 – Ground heights from Buckholdt siphon to Frampton Pill**

ATL and the LSIDB have observed the draining of the warths in 2020. It is apparent that a substantial amount of water from these warths initially drains into the canal-side ditch (which was primarily designed to take Frampton's surface water from the Buckholdt siphon to Frampton Pill). Frampton was therefore effectively tide-locked for the best part of a week in March even when the warths adjacent to the ditch were not inundated and the tide was out. The satellite imagery at Fig. 13 shows where the water settles for long periods of time. The rest currently disperses within days.

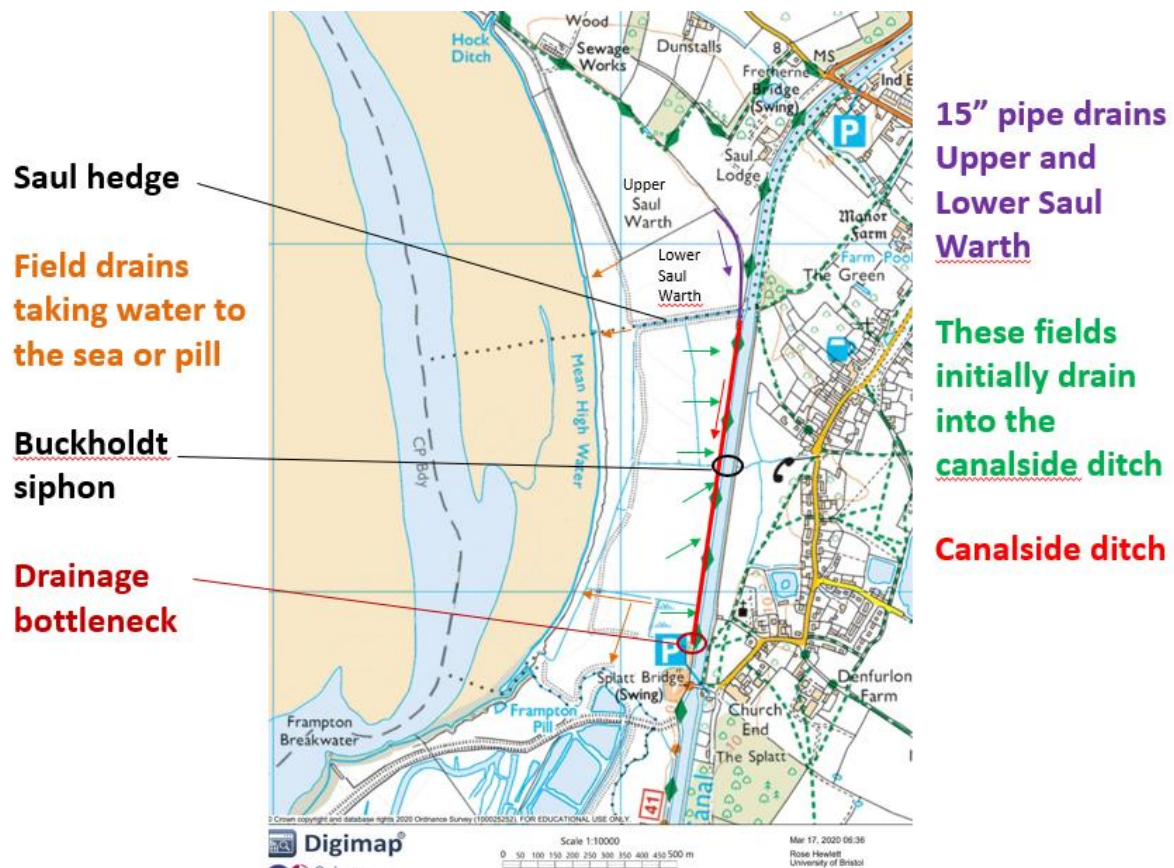
**Fig. 14 – Main lines of drainage**

Figure 14 shows some main lines of drainage. Victorian field drains are presumed to have mostly silted up, but a few still operate well and take water out to sea. Modern field drains (some also probably silted up) direct water to main ditches or Frampton Pill. This system works reasonably effectively until repeated inundations from big spring tides. Clearly, with greater tidal inundation expected, this situation will extend to a far greater number of tides.

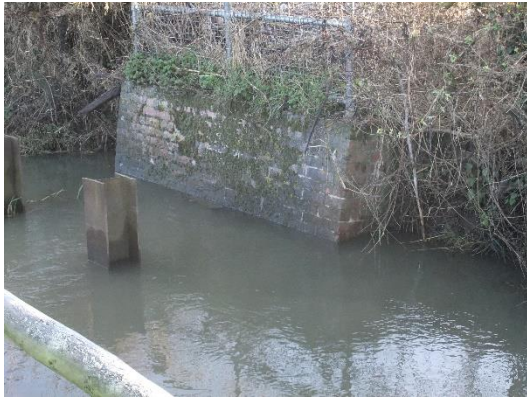
**Fig. 16 – The Buckholdt siphon at 9am on 16 March 2020**

The fields immediately to the south of the Saul hedge also drain some of their initial water into the canal-side ditch, as do the fields between the Buckholdt siphon and the drainage bottleneck, including the particularly low-lying reed bed. All of this keeps the water level in the canal-side

ditch high, sometimes for several days, as witnessed between at least 10 March (but probably from 9 March) until at least 16 March when the apparatus above the tide flap on the Buckholdt siphon finally became visible.

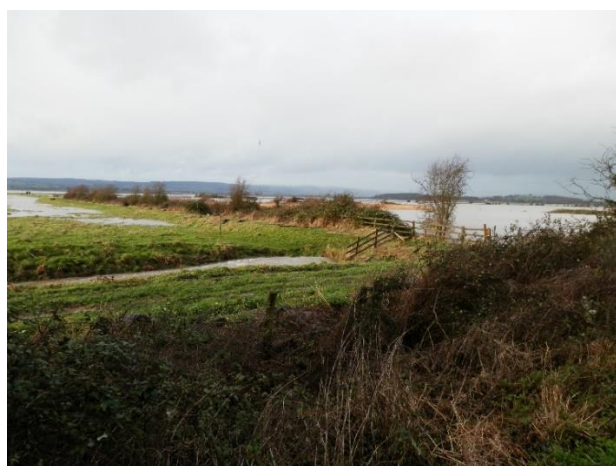
**Fig. 20 – Five hours after high water, 3 January 2014**

Under flood conditions, this drainage bottleneck, together with the sea wall immediately to the south of the reed bed and the higher level of the warth beside Frampton Pill hold the water in a cell against the canal bank.

This scenario has been repeatedly observed.

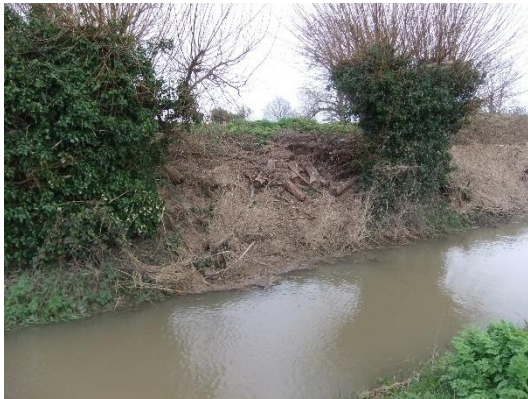
**Fig. 30 – Some sections display a more engineered profile, 14 March 2020**

It is not unreasonable to assume that the original profile of the embankment was consistent and more akin to the one in this photograph (i.e. no short vertical drop or hollows, just a uniform slope to the ditch).

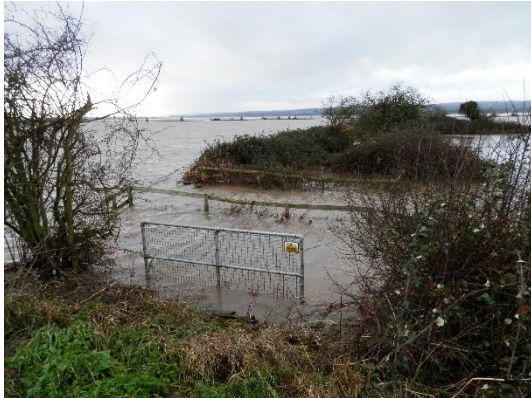
The remark that 'anecdotally water in 2014 [3 January] was up against the embankment for at least 5 hours' is a woeful understatement. The photographs supplied to the EA included this one of the Buckholdt siphon. The water did not quickly disappear after that as the technical note seems to imply.
