# Operation and Maintenance Guideline for Geosynthetic Lined Water Reservoirs

## Fabricated Geomembrane Institute

June 24, 2022

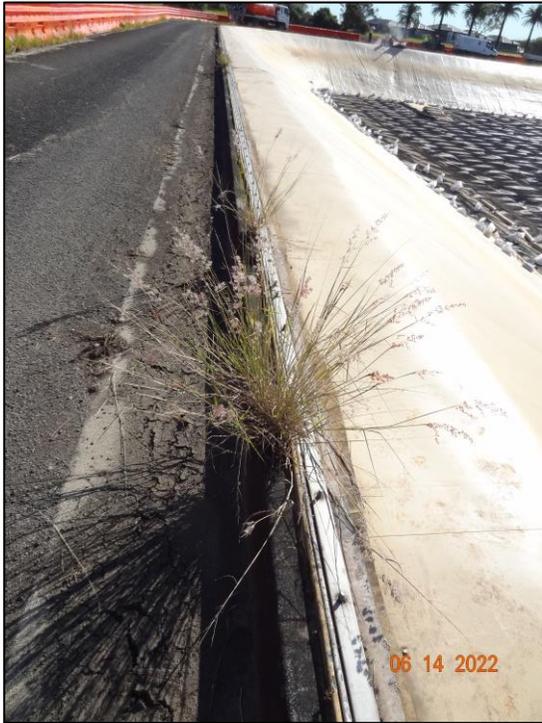
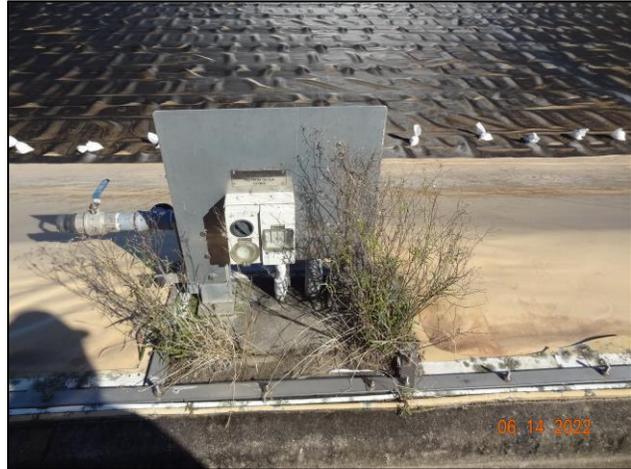
**Figure 1. Vegetation growing: (a) under geomembrane batten strip and (b) around reservoir instrumentation within bottom liner system.**

- The perimeter and exposed portion of the bottom liner system should be inspected for vegetation. Vegetation can grow on or below the geomembrane due to the presence of water. For example, **Figure 1** shows vegetation growing under the geomembrane along the perimeter of the bottom liner system of a potable water reservoir. If present, this vegetation should be removed before it becomes large and creates a void under the geomembrane.

Weekly	Quarterly	Annually	Responsible Entity		
					Department Engineer	Dam Operator	Independent Dam Safety Engineer
External Embankment or Dam Periodic Inspections & Monitoring	Monitor Weather Forecasts	As Needed			✓	✓	
	Presence of vegetation growing on or under geomembrane – (see <b>Figure 1</b> )		✓		✓	✓	✓
	Erosion protection measures – vegetation, mats, and geotextiles		✓		✓	✓	✓
	Routine Inspections – sloughing, cracking, settlement, sinkholes		✓		✓	✓	✓
	Seepage Observations		✓		✓	✓	
	Regular Dam Safety		✓		✓	✓	
	Reservoir Level – (see <b>Figure 2</b> )		✓		✓	✓	
	Formal Dam Safety		✓		✓	✓	✓
	Animal intrusion – deer, rodents		✓	✓	✓	✓	✓
Special Inspections	After Unusual Event	As Needed			✓	✓	✓
	If Unusual Conditions	As Needed			✓	✓	✓
Outlet Works Pipe	Internal Inspection	Every 5 years			✓		✓

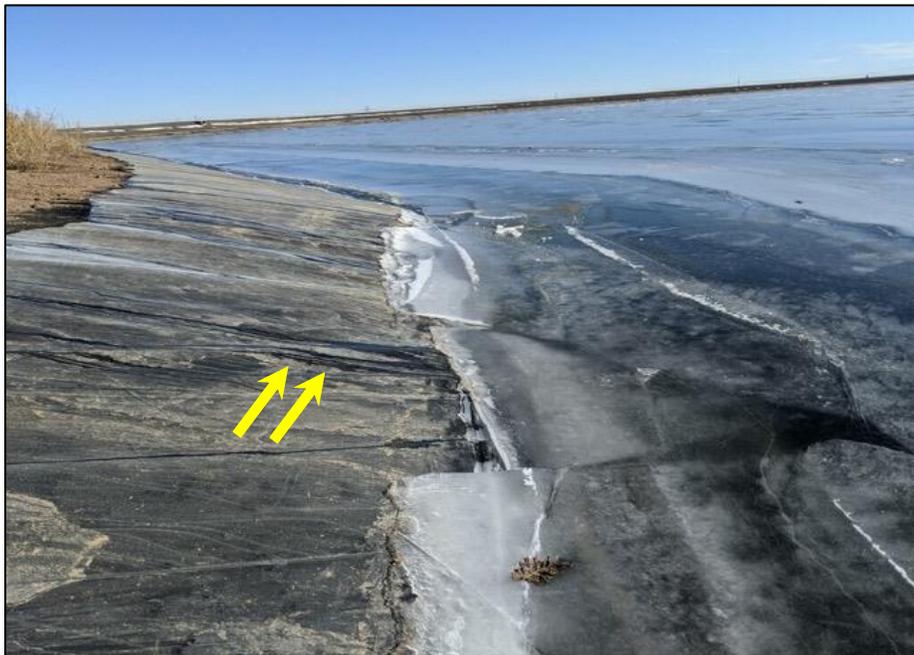
**Figure 2. Geomembrane damage (see arrow) due to floating ice.**

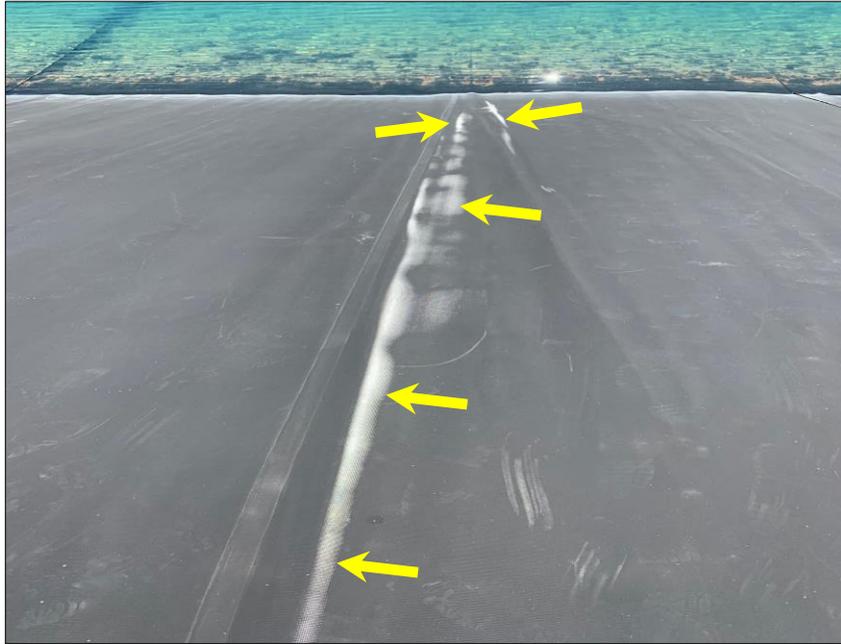
**Figure 3.** UV degradation of parent geomembrane, which should have been observed earlier to prevent further degradation and failure of the geomembrane.

Weekly	Quarterly	Annually	Responsible Entity		
					Department Engineer	Dam Operator	Independent Dam Safety Engineer
Primary Geomembrane (GM) and Geosynthetics Inspection	Observe all GM seams and patches – identify any loose seams or extrusion welds; clean as needed for inspection		✓		✓		✓
	Observe exposed GM – (see <b>Figure 3</b> )		✓		✓		✓
	Observe GM tightness, which can cause cracking at batten strips, pipe boots, other attachments, etc.		✓		✓		✓
	Check all attachments and seals (see <b>Figures 4 and 5</b> )		✓		✓		✓
	Anchor trenches (see <b>Figure 6</b> )		✓		✓		✓
	Inlet and outlet diversion ditches		✓		✓		✓
	Damage to protective materials and/or GM-(see <b>Figure 7</b> )		✓		✓		✓
	GM cracking or delamination (see <b>Figures 8, 9, and 10</b> )		✓		✓		✓
	GM decolorization – oxidation (see <b>Figure 3</b> )		✓		✓		✓
	GM oxidation – color on hand wipe or chalky		✓		✓		✓
	GM wrinkles and folds		✓		✓		✓

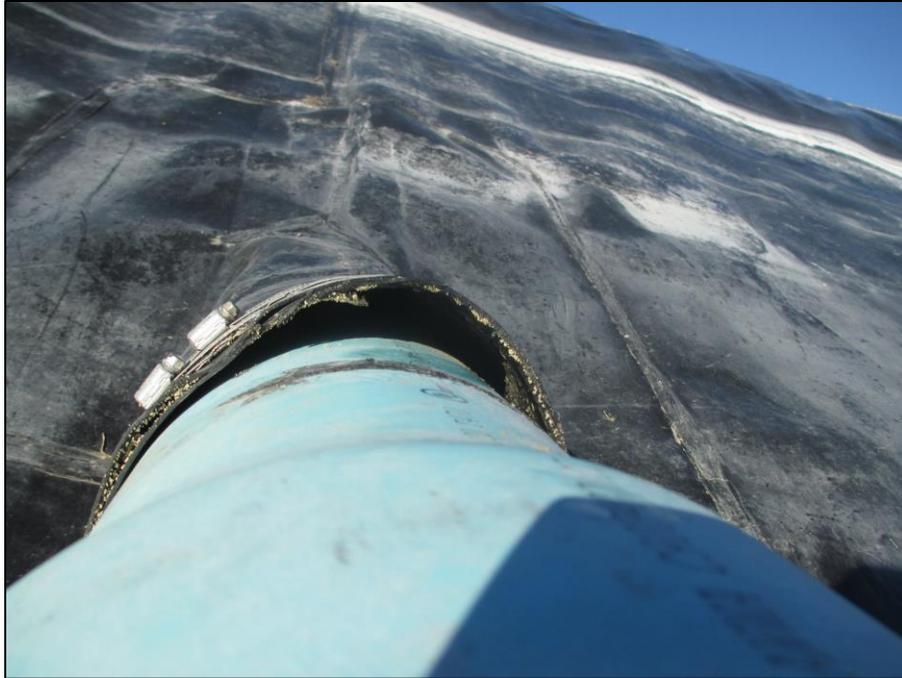
**Figure 4.** Pipe clamp loosened over time and now the clamp and butyl should be replaced and the clamp retightened and caulk applied to seal the geomembrane to the pipe.

Material separation – cracking, exposed scrim, etc. (see <b>Figures 4, 7, and 8</b> )		✓		✓		✓
	Check slopes and reservoir for subgrade softening and failures - (see <b>Figure 11</b> (tire ruts) and <b>Figure 12</b> (settlement))		✓		✓		✓
	Check slopes and reservoir for subgrade settlement and improper remedial measures - (see <b>Figure 13</b> )		✓		✓		✓

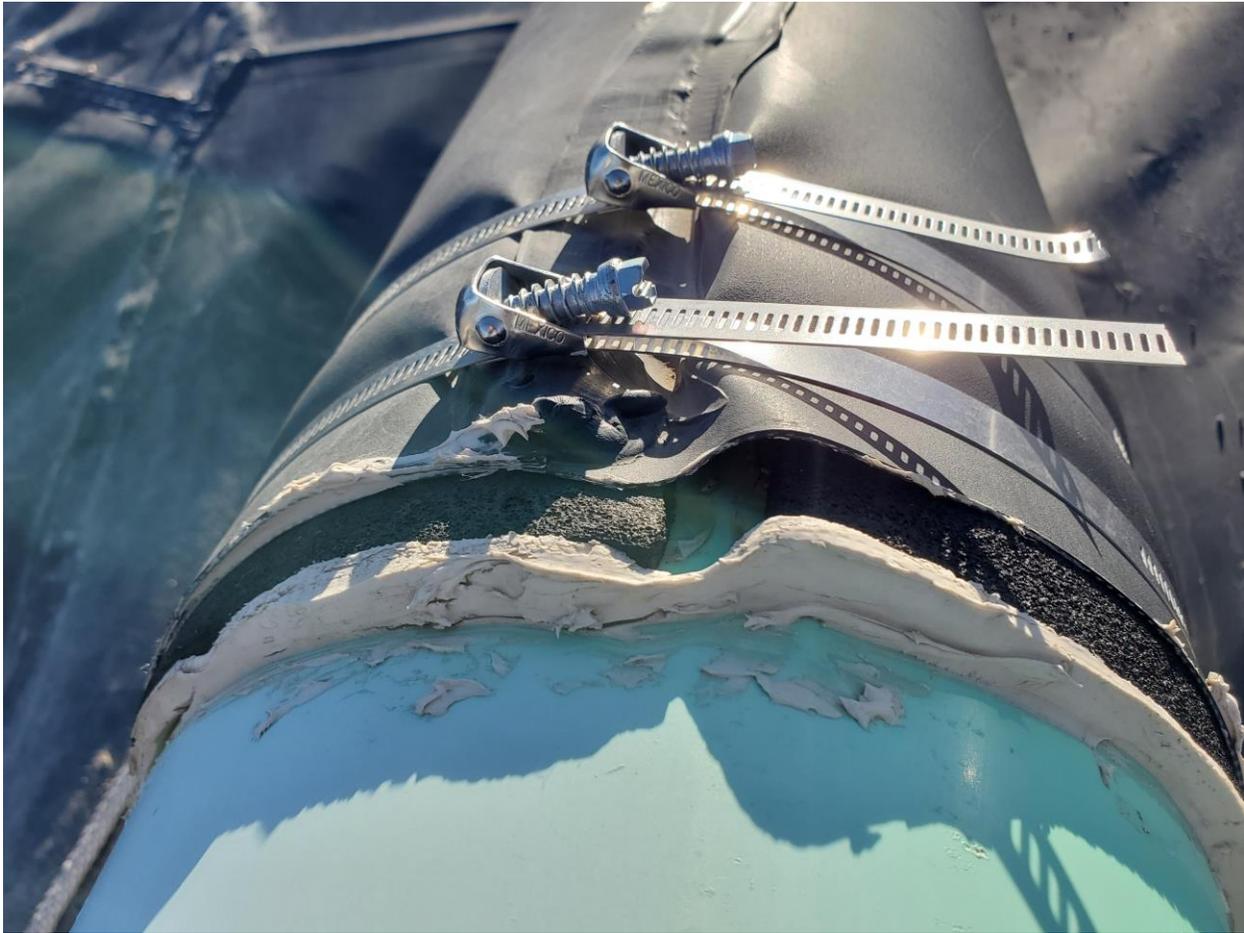
**Figure 5.** Detached caulk over time and now the butyl and caulk should be replaced and the clamp retightened. Also recommended but not shown in this photo is a sacrificial piece of geomembrane underneath the clamps to help prevent damage to the geomembrane

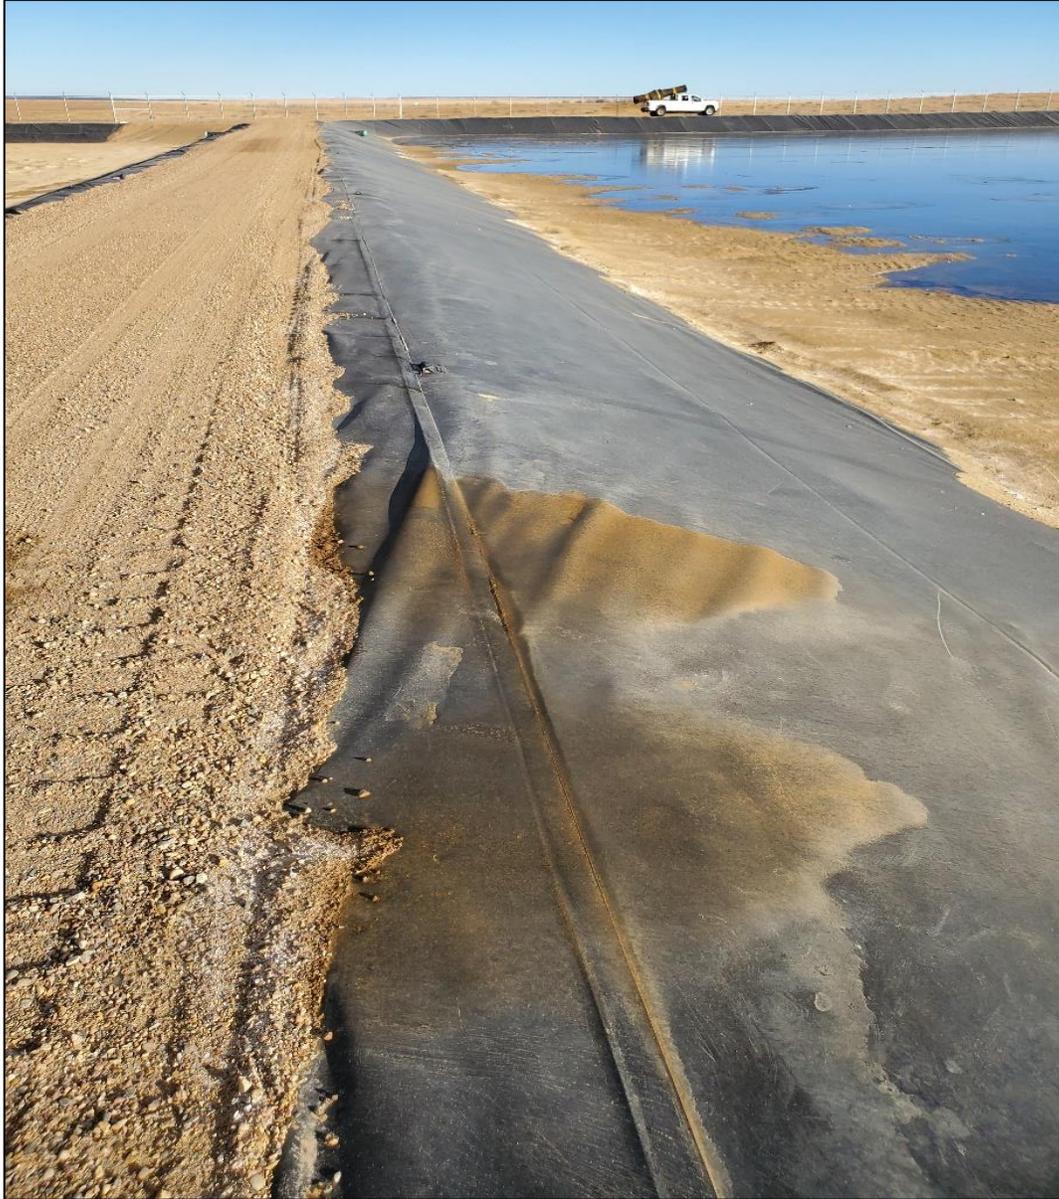
**Figure 6.** Photograph showing: (1) hydrocarbon spills on geosynthetics and driving too close to the geosynthetics, (2) horizontal seam along the crest of the slope, which is not recommended due to applied tensile stresses and should be addressed during the design phase, and (3) geomembrane on top of pickup truck may damage the material and is not safe.

- Do not use any sharp hooks, probes, or knives to check the integrity of the geomembrane seams.
- Do not park vehicles or place equipment, e.g., a pump or hose with hose clamps, directly on or immediately adjacent to geomembrane and geosynthetics so hydrocarbon spills do not occur as shown in **Figure 6** below. Place a sacrificial geomembrane under the equipment or ATV so no leakage on the reservoir geosynthetics occur.

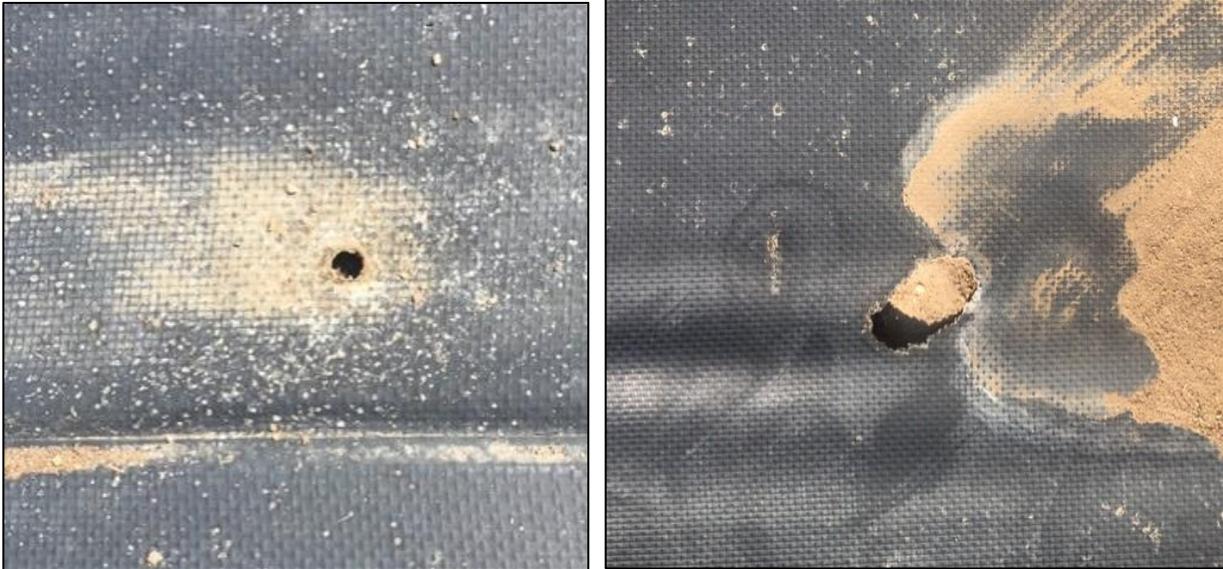
**Figure 7. Hole in geomembrane due to rodent(s) identified via visual inspection.**

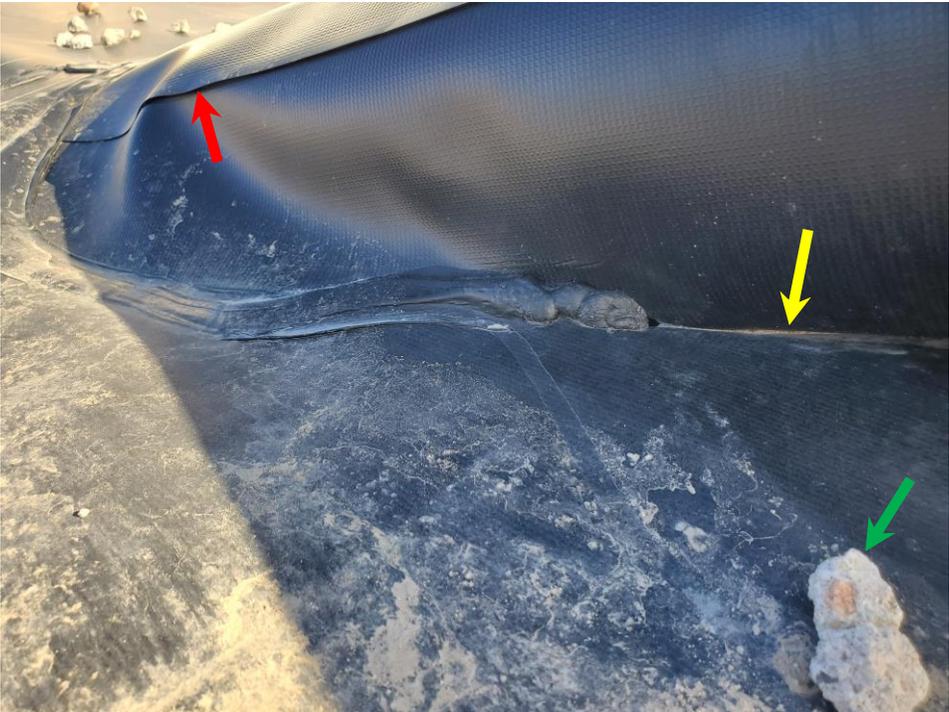
**Figure 8. Photograph showing: (1) leakage around extrusion weld (see exposed subgrade at yellow arrow), (2) large glob of extrudate at the seam end, (3) rock on geomembrane that should be removed (see green arrow), and (4) edge of seam flap exposed (see red arrow).**

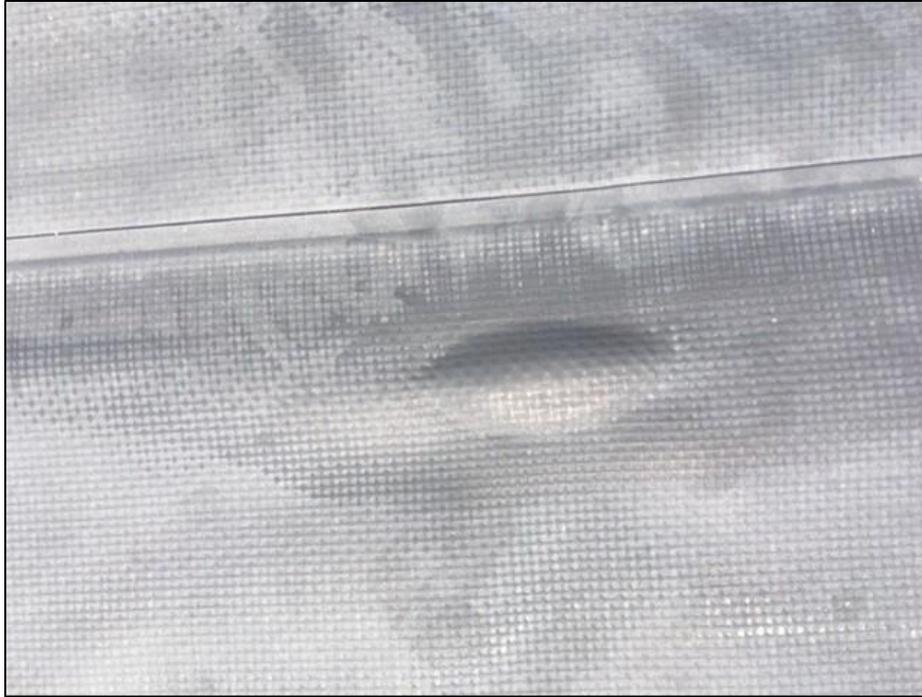
**Figure 9. Delamination of top layer of reinforced geomembrane and creation of a blister.**

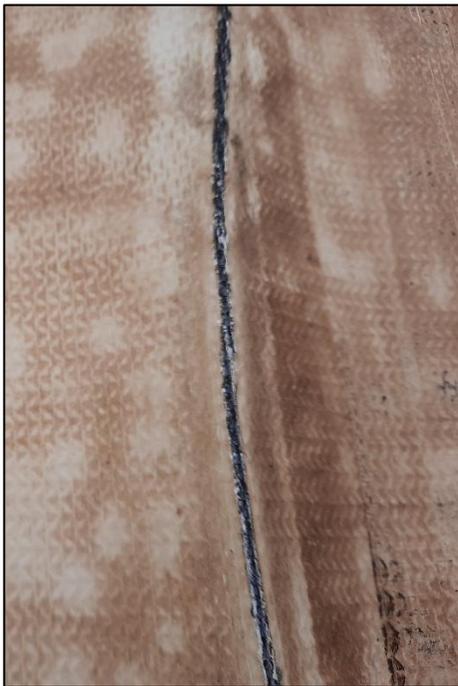
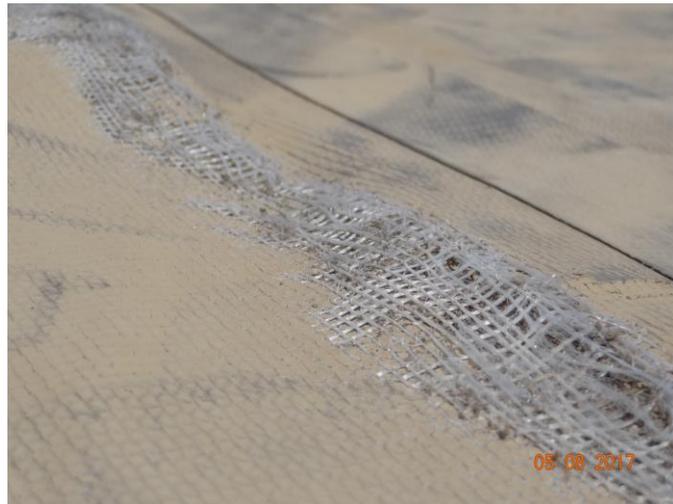
**Figure 10. Geomembrane experiencing: (a) cracking and (b) delamination.**

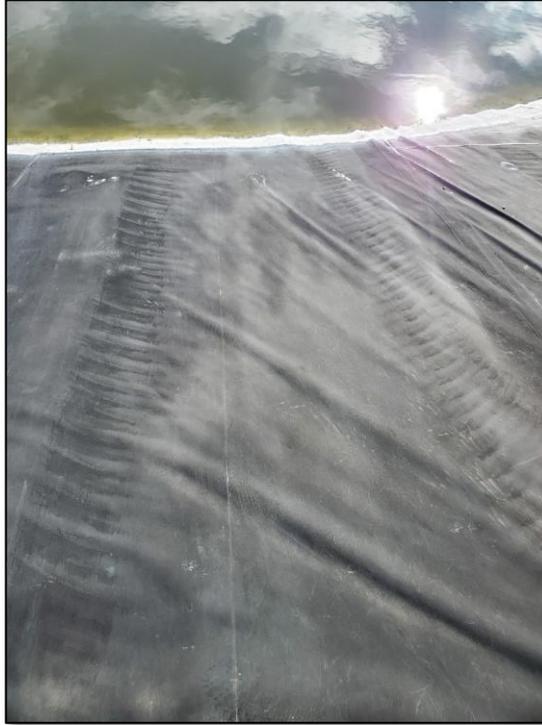
**Figure 11.** Tire imprints in geomembrane indicating equipment was driven directly on top of the geomembrane. Equipment should never be driven on geosynthetics to repair geosynthetics or remove debris and sediment unless it has low ground-pressure (approved by design engineer) and on a suitable access ramp.

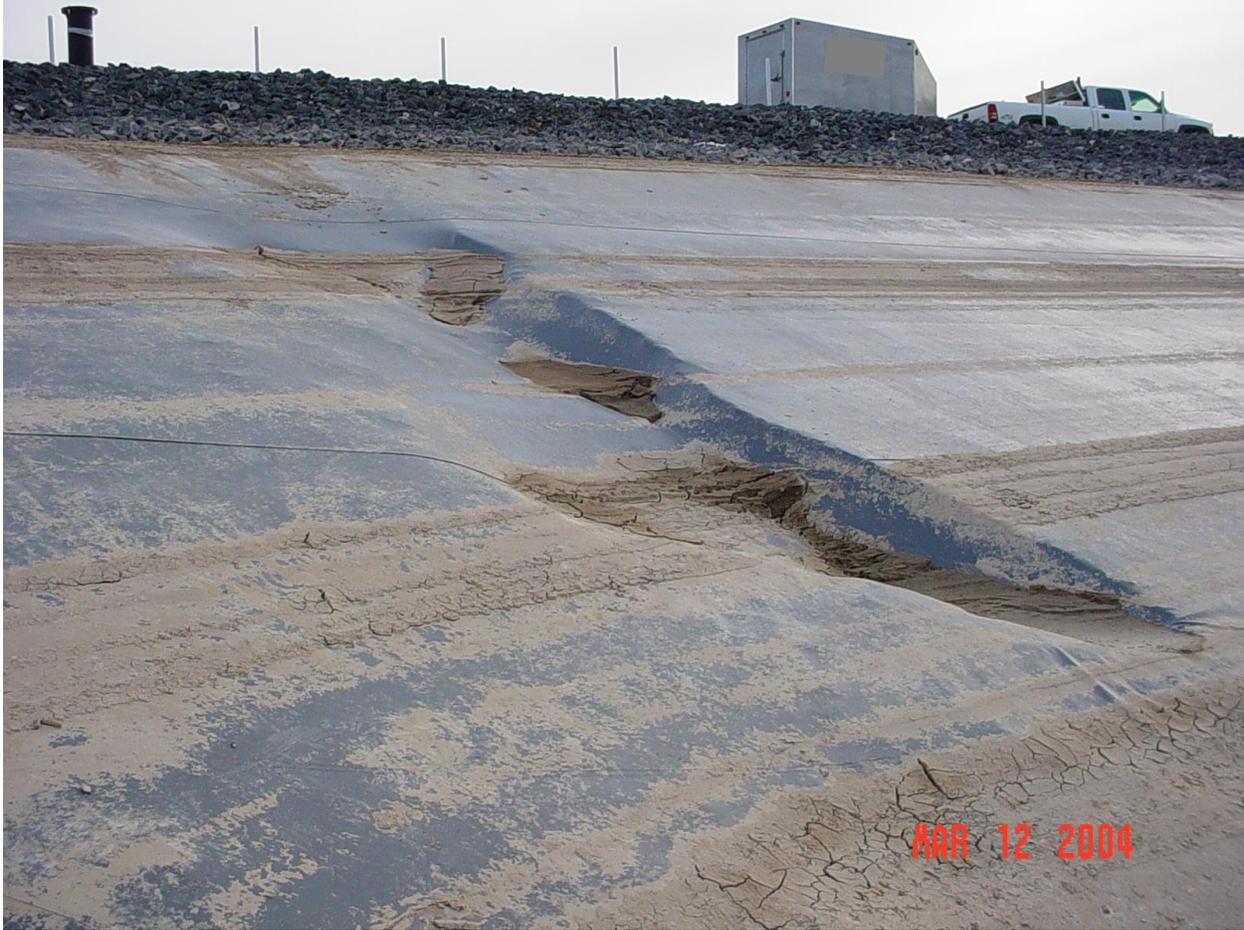
**Figure 12. Subgrade failure and sloughing under the geomembrane.**

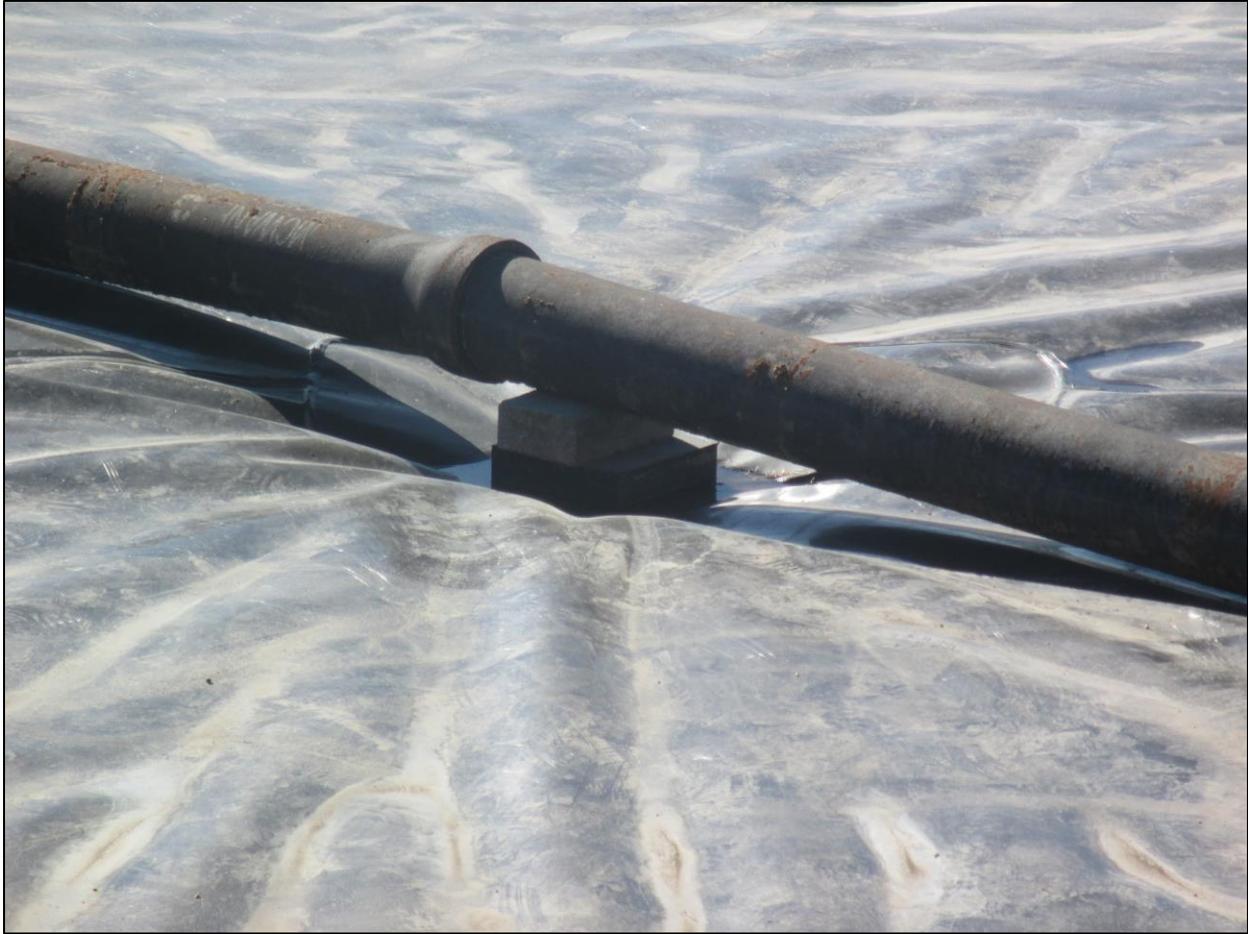
**Figure 13.** Subgrade settlement and blocks being used to support pipe, which may damage the underlying geomembrane as well as pipe union if the block were not present. If a block or pipe union has to be placed on a geomembrane, a rubsheet or other sacrificial material should be placed underneath it.

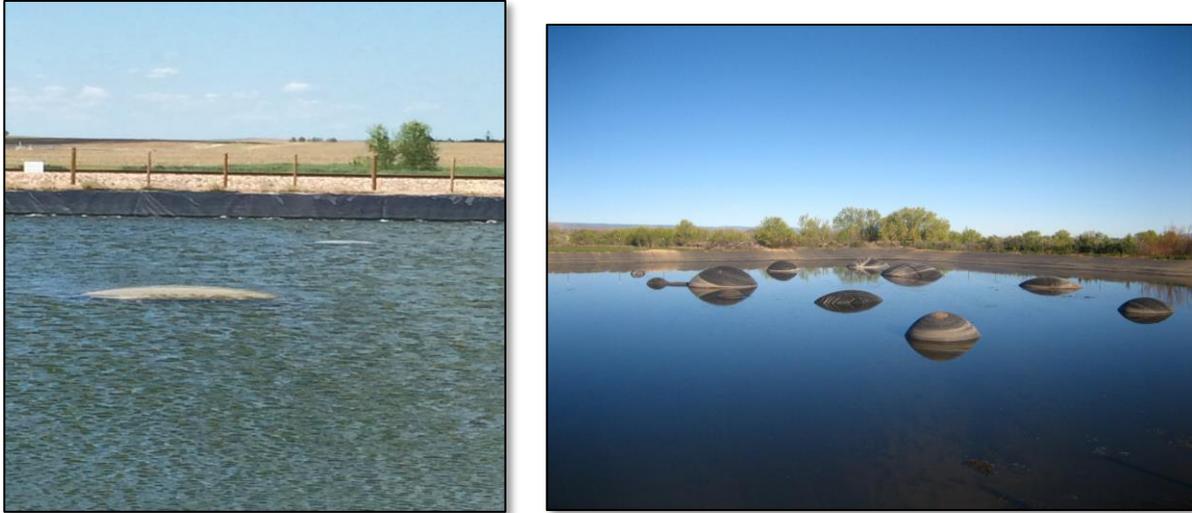
**Figure 14. Geomembrane whales due to gas buildup below geomembrane.**

Check slopes & reservoir for geomembrane whales or bubbles – (see <b>Figure 14</b> )		✓		✓		✓
		Weekly	Quarterly	Annually	Responsible Entity		
					Department Engineer	Dam Operator	Independent Dam Safety Engineer
Embankment/Dam Instrumentation  Electric Leak Location (ELL)	<p>Check all instrumentation: piezometers in embankment, liquid level in pipes, sump indicators, surface monuments, flow meters (inflow and outflow)</p> <p>If GM damage is observed, ELL may be needed</p> <p>Conduct ELL every five years regardless of inspections to reduce water loss - tests 100% of lining area</p>	As Needed or as required by dam safety			✓		✓
