**Locality:** STRATFORD  
**Place address:** 17 HOBSON STREET  
**Citation date** 2016  
**Place type (when built):** Mechanics Institute and Free Library  
**Recommended heritage protection:** Local government level  
Local Planning Scheme: Yes  
Vic Heritage Register: No  
Heritage Inventory (Archaeological): No

**Place name:** Mechanics Institute and Boer Memorial Plaque

**Architectural Style:** Federation Free Classical  
**Designer / Architect:** Edgar J. Henderson  
**Construction Date:** 1890

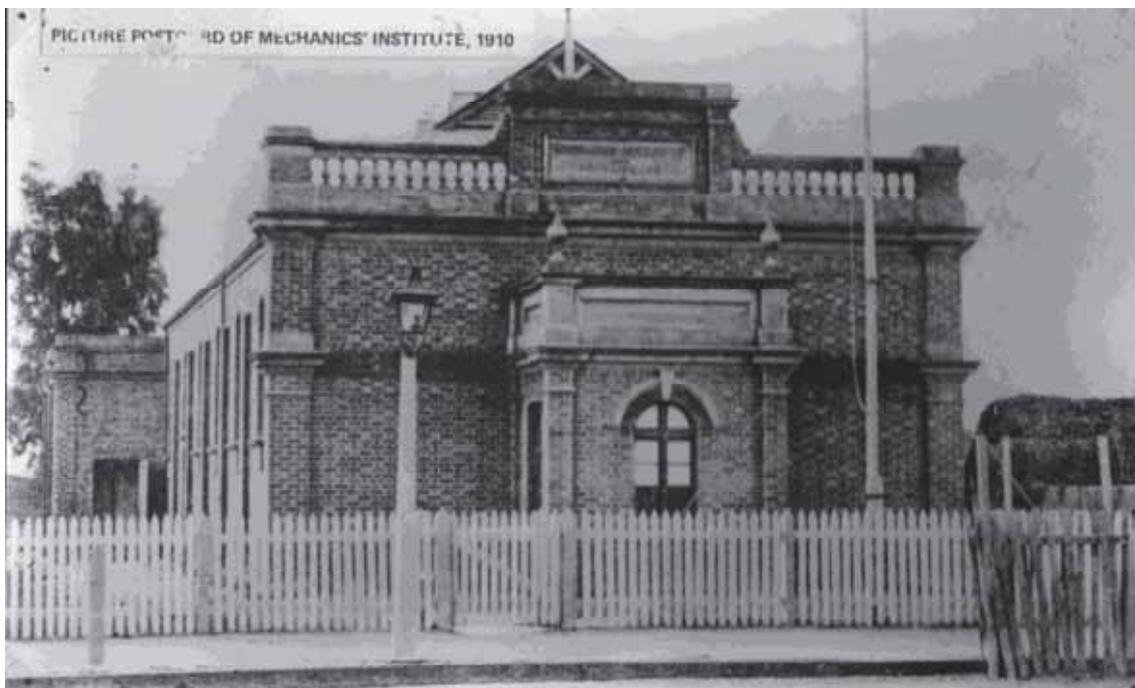
Figure H1. The hall in 1910. At the peak of the roof the gablette, flying gable end, finial and timber vents were evident, as well as the triangular vents to the roof (since removed). A flagpole stood to the right of the facade, while a timber picket fence and pedestrian gate ran along the front boundary (SDHS).

6.1. The decorative rendered window sills, cornices, capitals, stringcourses, etc have been painted, however, these architectural features were not designed to be painted (see Figures H1 & H2). They were a light-coloured unpainted render. It is recommended that the paint be chemically removed, which will restore the original finish and save on 10 yearly repainting costs.

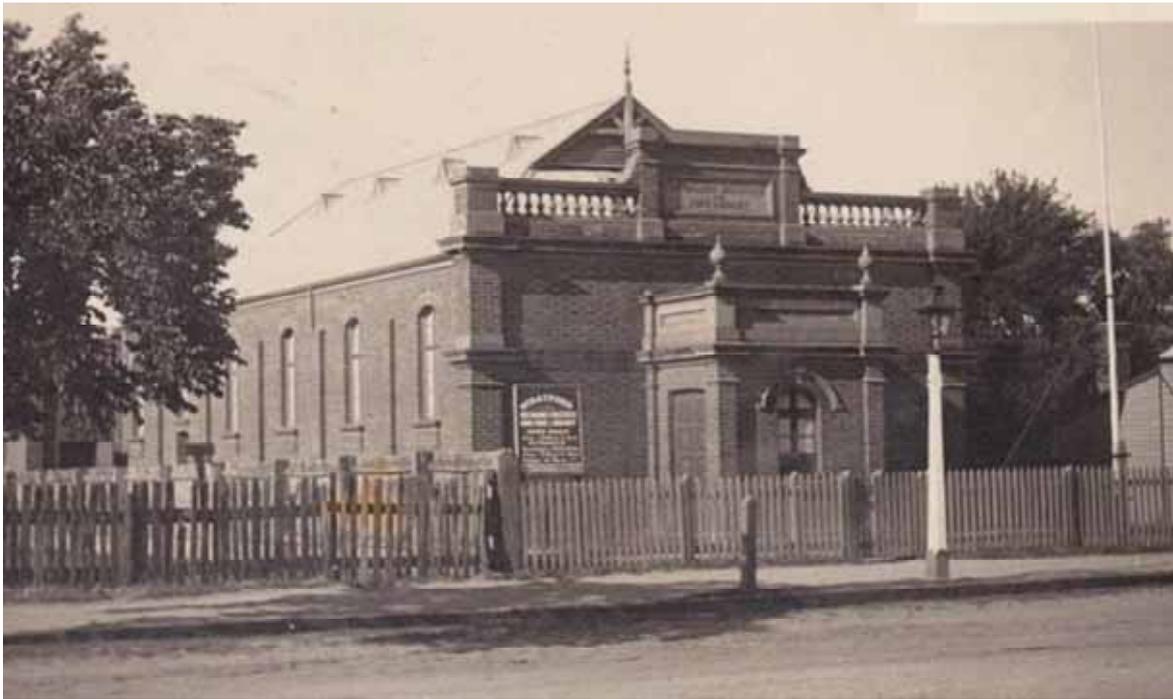
Figure H2. The hall at an unknown early date (similar to 1910 photo). At this date the roof had four triangular roof vents and the west side of the porch had a panelled entrance door (all since removed) (SDHS).

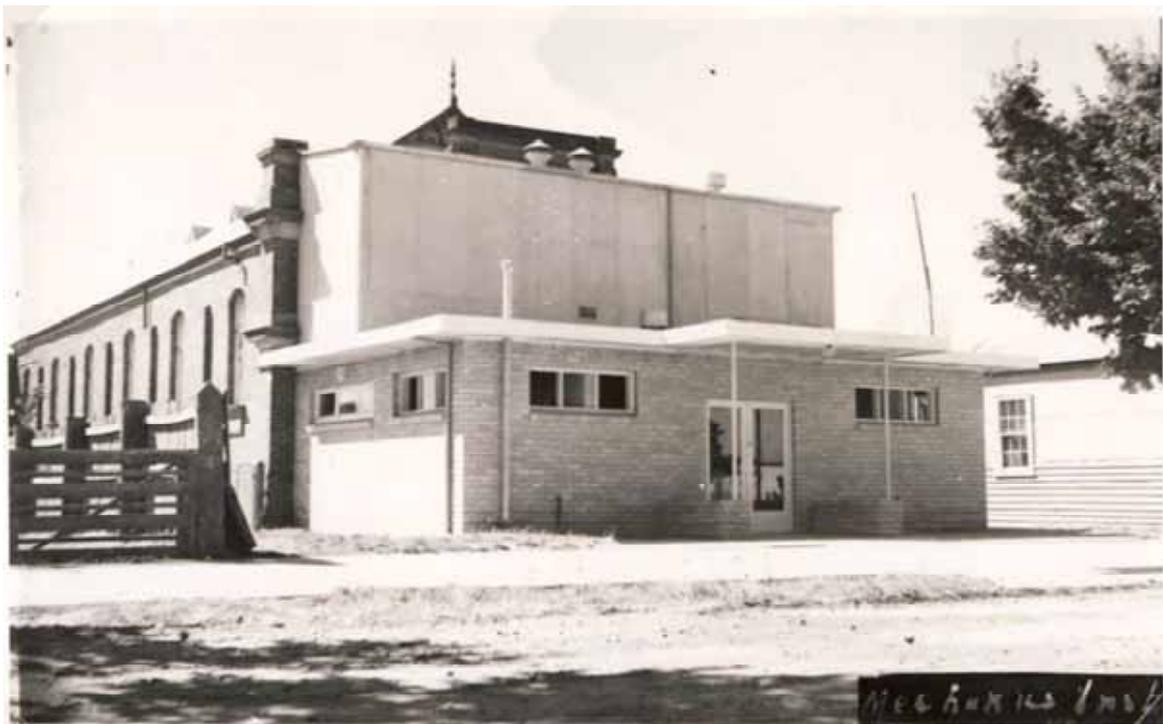
Figure H3. The hall in 1958. The front elevation had been replaced with an intrusive cream brick addition and section above, which covered the entire facade of the hall, all since removed (SDHS).

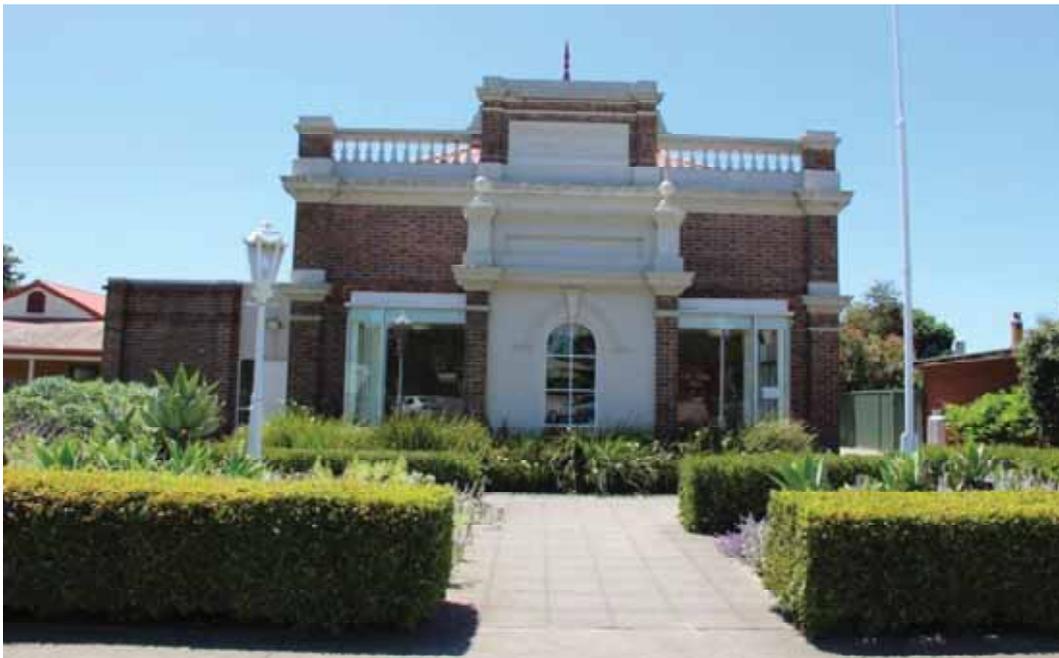
**Figure D1.** The hall setback behind a modern landscaped area with a flagpole. The 1950s cream-brick addition was removed from the facade in 2004 and glass additions were constructed either side of the entrance, and a large brick extension built down the west side of the building. The original bold Classical facade is now visible with its balustraded parapet and entrance porch with its bold parapet. The central arched window is a representation of the original entry doorway.

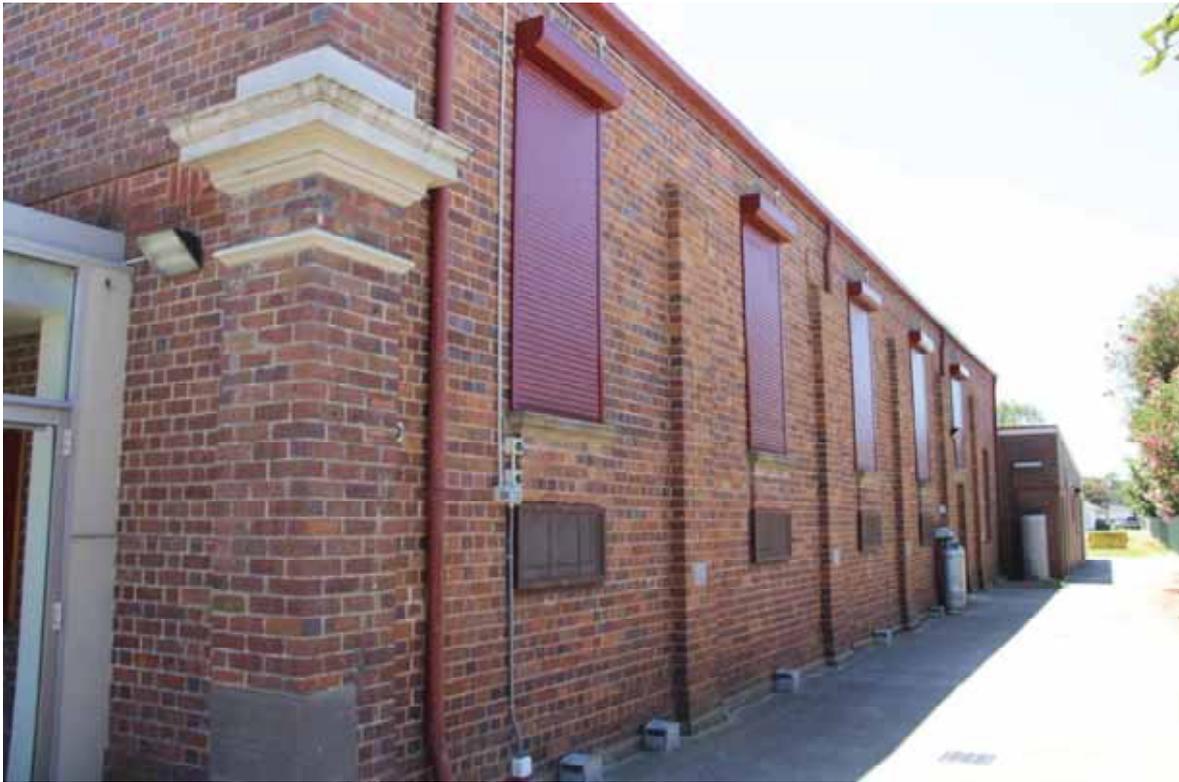
Figure D2. The east elevation with windows (behind modern roller shutters) with rendered sills and a brick apron, above a modern vent. Simple engaged buttresses are located between each window. The large modern addition to the rear extends beyond the side elevations.

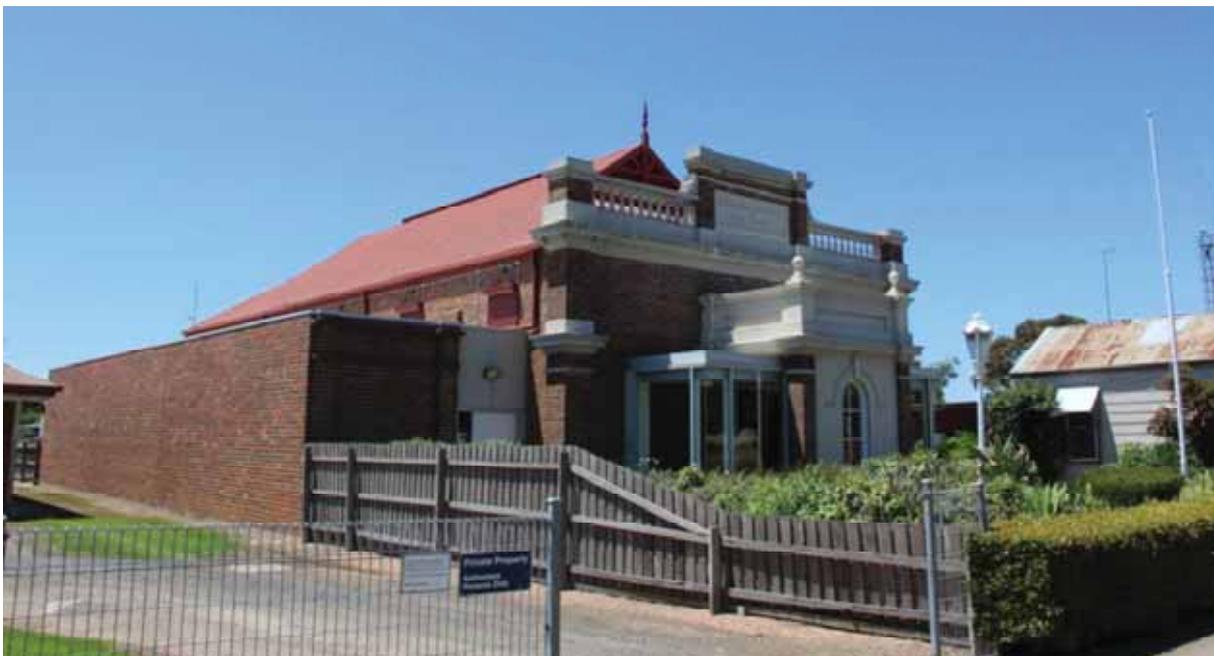
Figure D3. The west elevation of the hall is partly visible behind the modern addition. The gablette to the roof is visible, with its timber detail and finial.

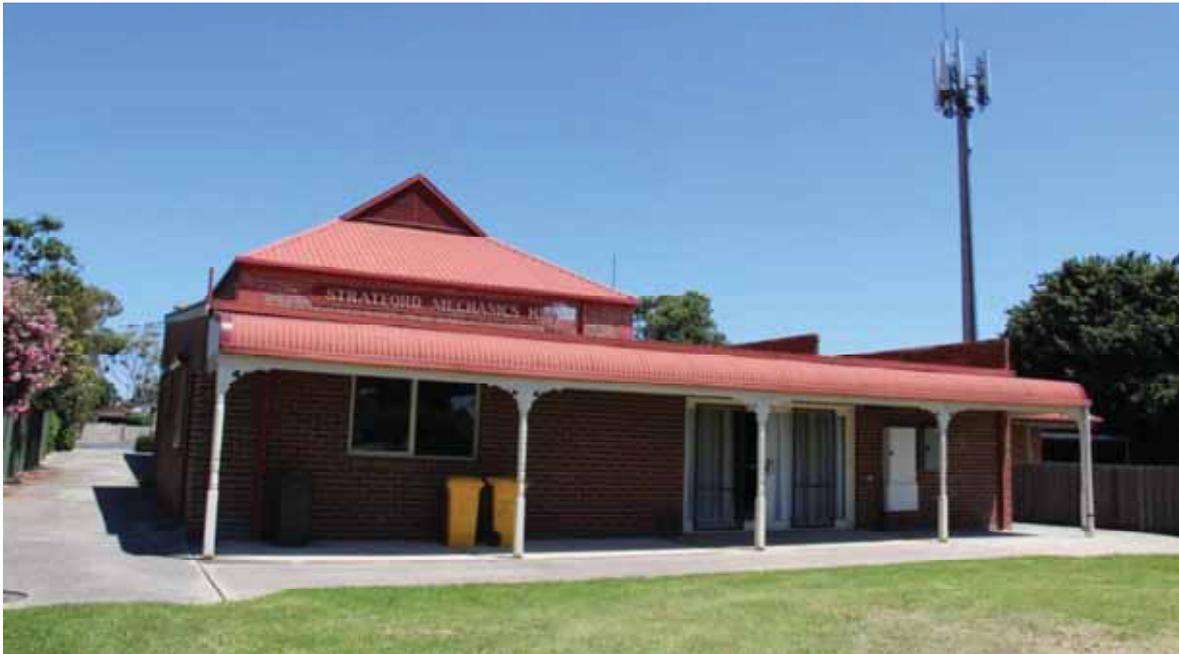
Figure D4. The rear (north) elevation with the gablette to the original section of the building, which is clad in modern metal red decking, and the lower roof-form of the modern addition, with its heritage style verandah, clad in modern red Colorbond.

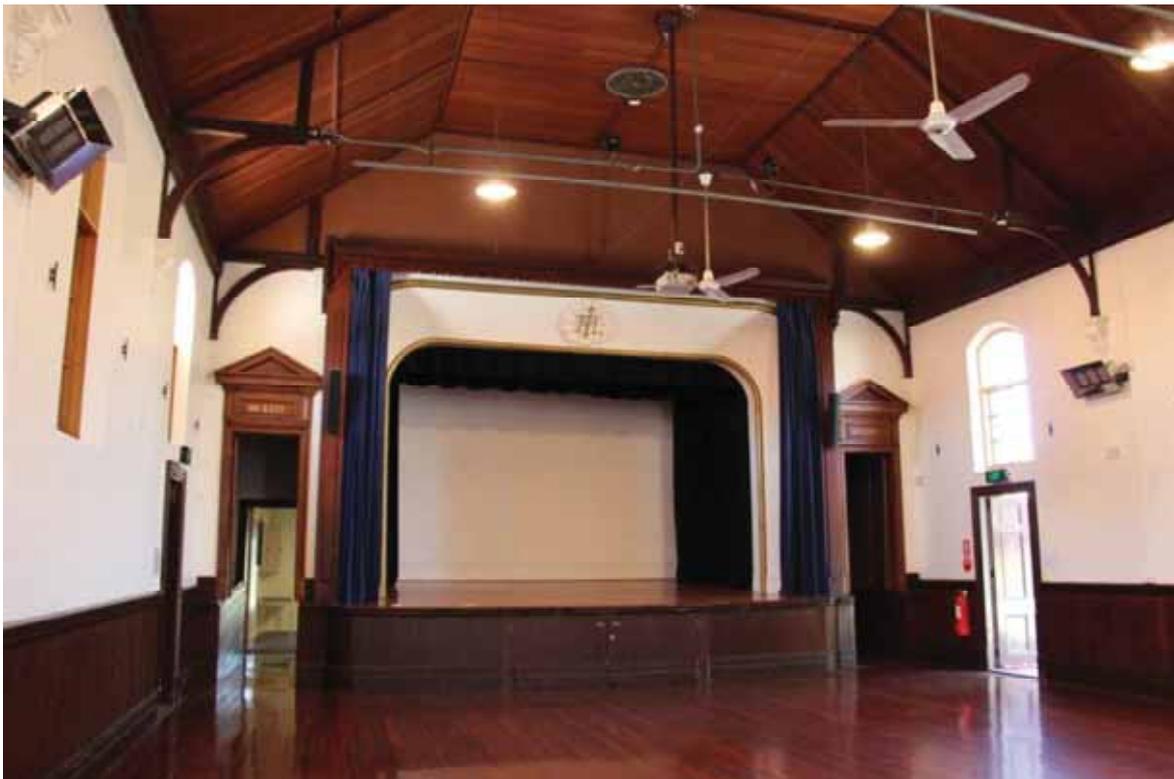
Figure D5. The interior of the hall with its original timber stage, proscenium with wreath, timber lined ceiling with cast iron ceiling rose vents, hammer beams, dado to the walls and aedicules to the original doors at the side of the stage.

**Figure D5.** The interior of the hall retains its original timber details including the stage, timber lined ceiling, hammerbeams, dado, doors and aedicules to the doorways either side of the stage (the floor was replaced c1995). The openings and stage height were altered either side to allow access to the rear extension.

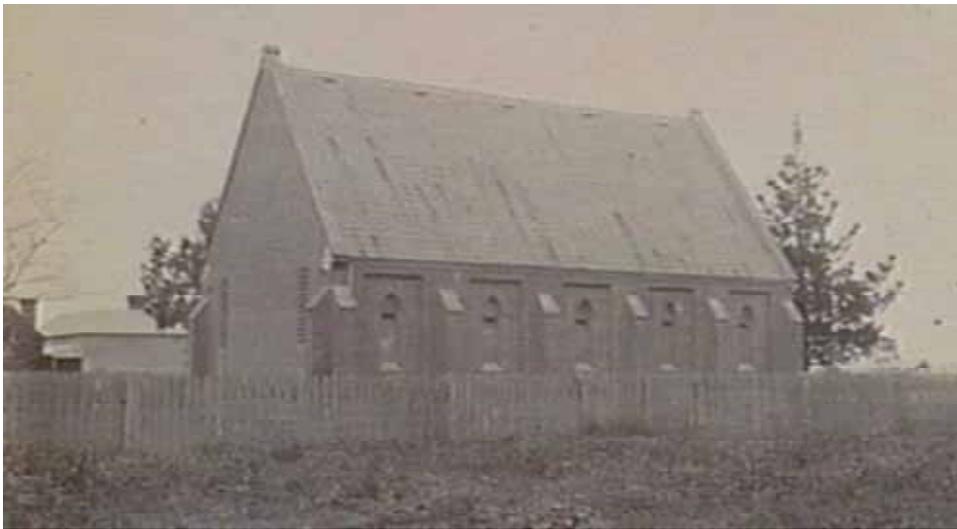
Figure H1. A photo dating between c1894 and c1907 that showed the brick church with slate roof, from the north-east, before the chancel was constructed (in 1907). To the south of the church there was a hipped-roof house which may have been the first rectory. (SLV).

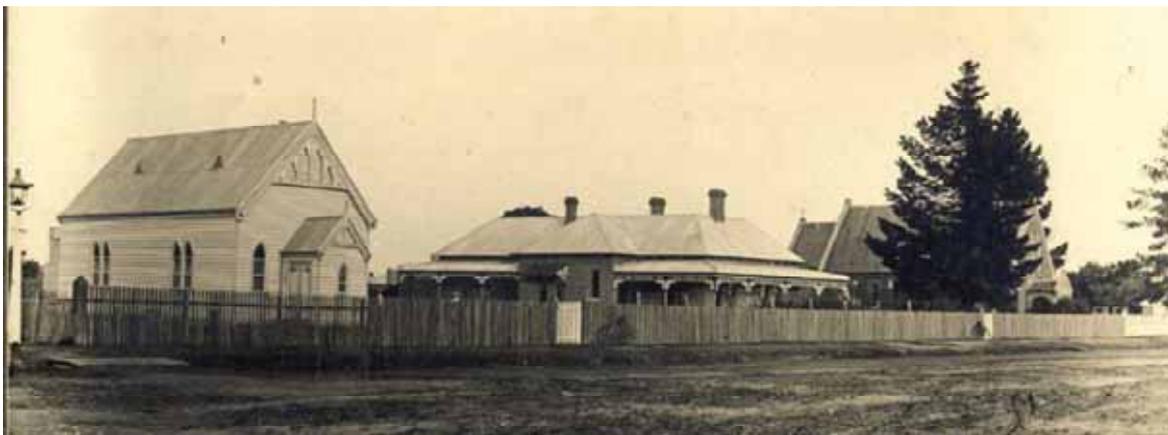
Figure H2. A photo dating post-1910 showed the complex from the north. At the north end was the timber hall with lapped corrugated iron and roof vents, and finial, in its original location, the brick rectory with lapped corrugated iron roof cladding, was central and the church was at the south end, behind a pine tree. Note the long picket fence. (SDHS).

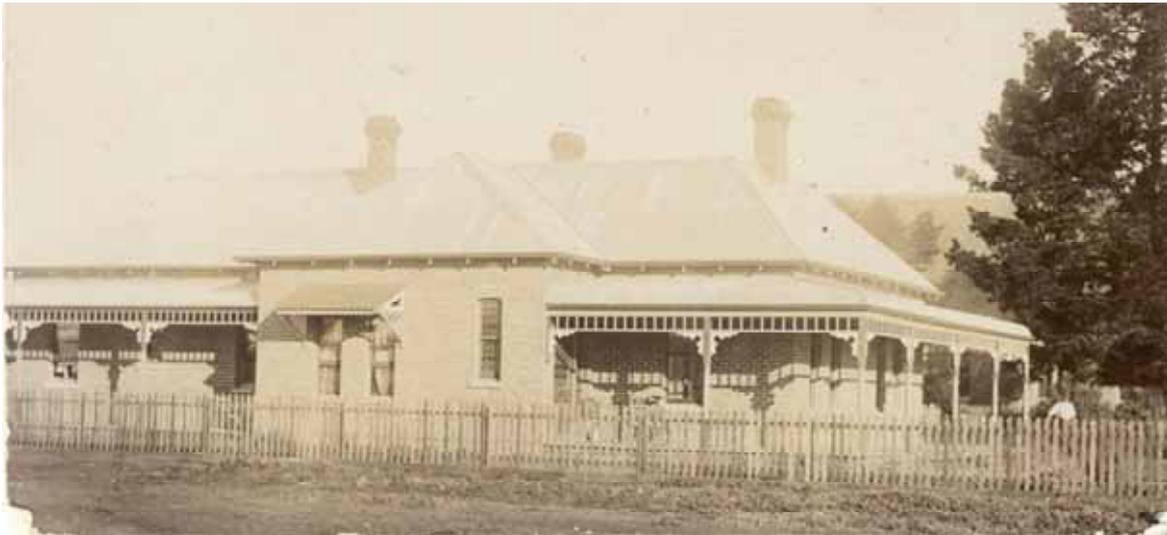
Figure H3. An early photo (post-1910; when the rectory was built) showed the north elevation of the rectory in more detail and the long picket fence. (SDHS).

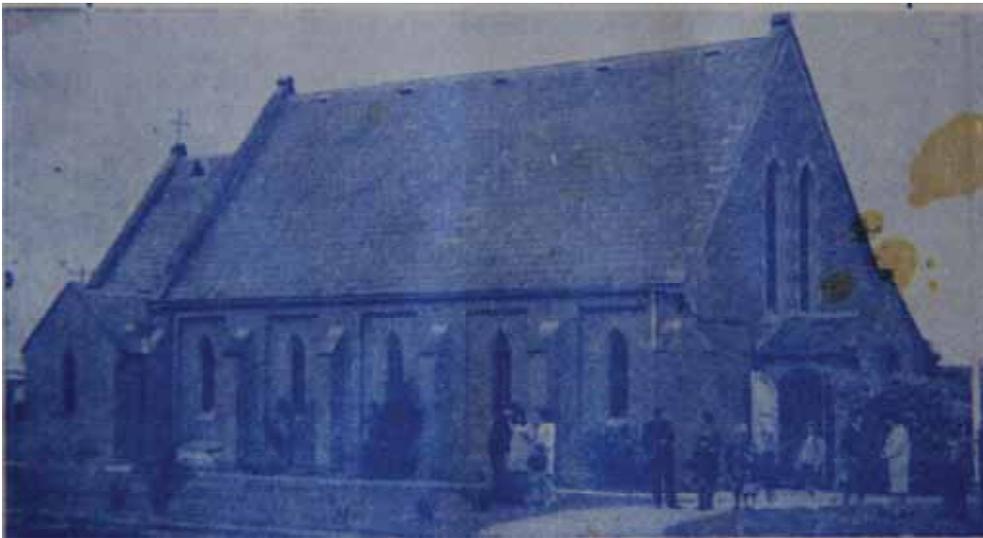
Figure H4. A photo from a pamphlet of the 1968 centenary service of Thanksgiving, held on 15 September 1968. The entrance porch led to the nave of the church with its five bays separated by buttresses, with the chancel to the rear and the small room projecting north (SDHS).

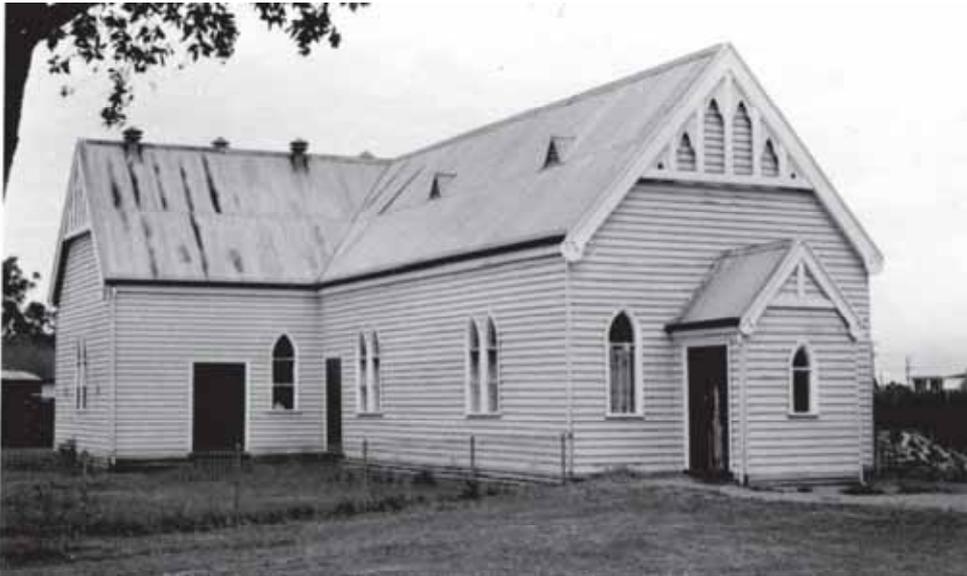
Figure H5. A photo dating to 1980 that showed the timber hall in its original location to the north of the rectory. At this date the hall comprised the entrance porch, the original gabled-roof section clad in galvanised corrugated iron, and the large transverse-gable section at the rear, projecting to the north (SLV).

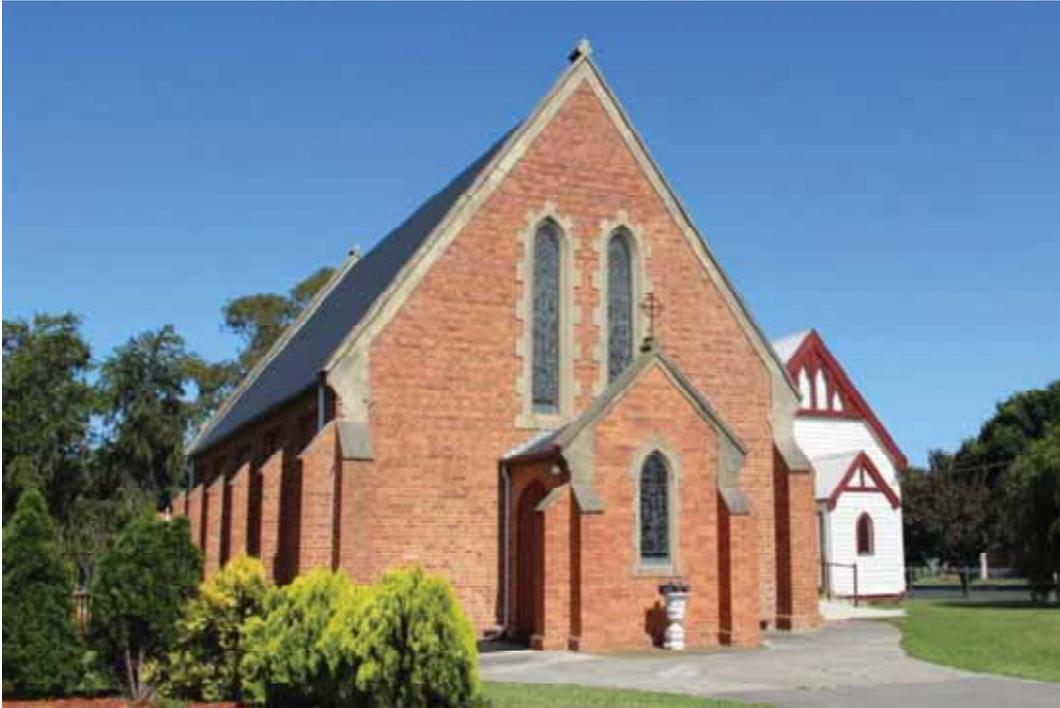
Figure D1. The church is constructed of handmade red brick in an English bond, with a small brick plinth and steeply-pitched gabled roof clad in slate. To the facade, rendered dressings (not painted) are applied to the parapeted gables, buttresses, and to the window surrounds with a quoining pattern to the sides.

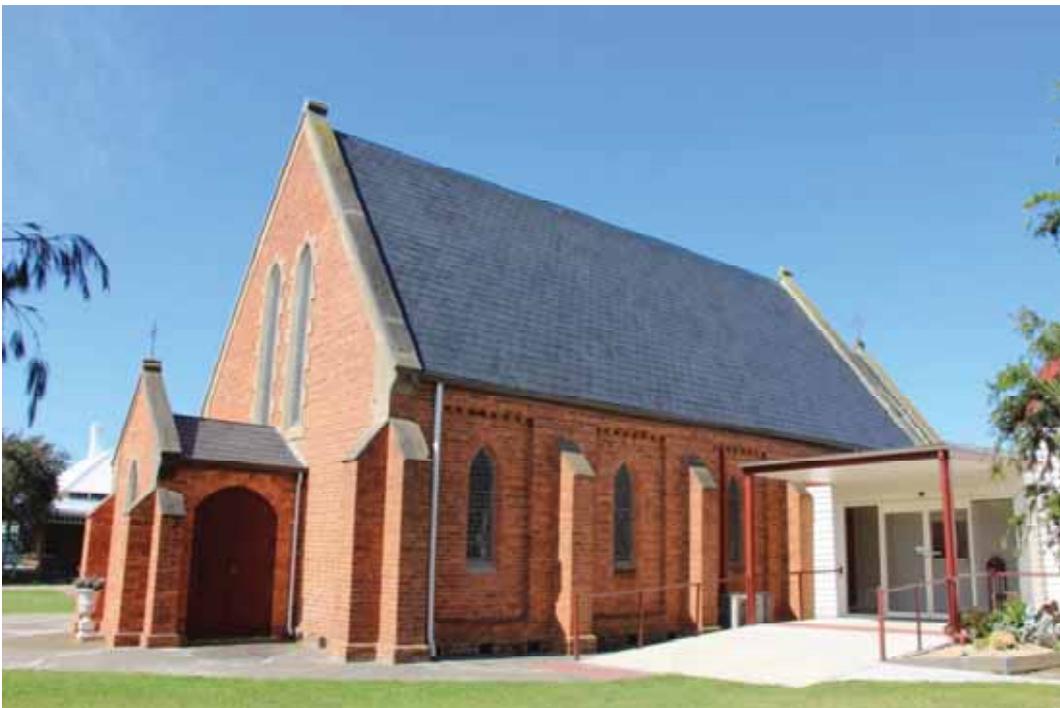
Figure D2. The south elevation. The side elevations comprise five bays, created by buttresses. Each bay has a slightly recessed panel with a row of corbelled bricks at the top. Each bay has a pointed-arch window with radiating voussoirs above and pictorial leadlight. A modern building connects part of the south elevation of the church (enveloping the two rear bays) and weatherboard hall to the south.

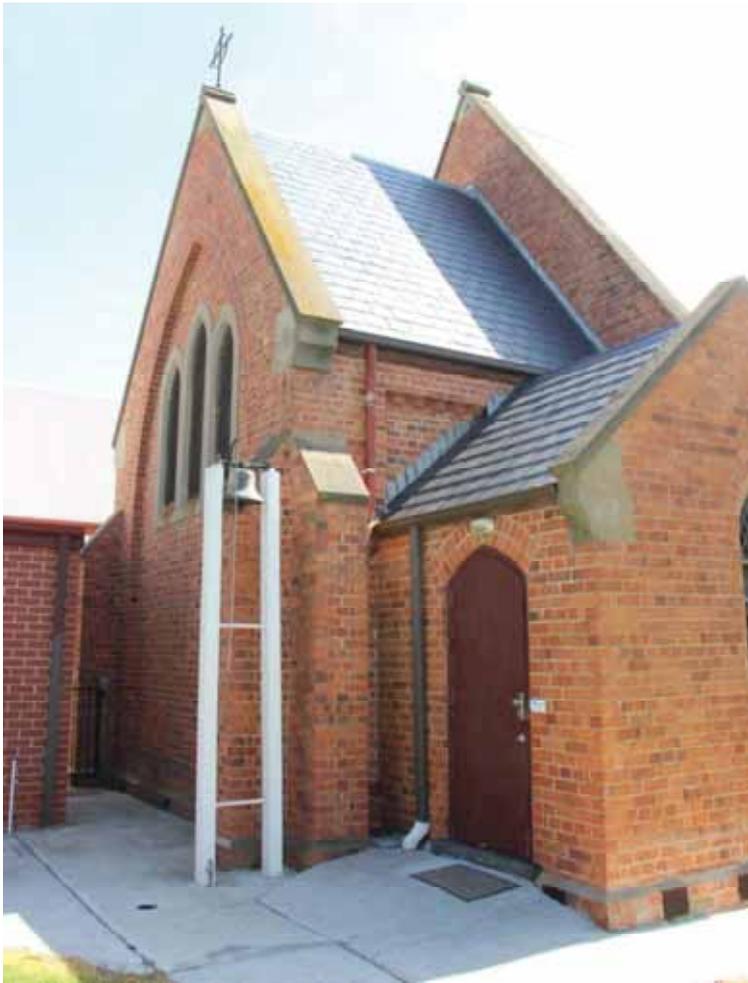
Figure D3. At the rear (east) end of the church is a large chancel (1907) with a group of three pointed-arch windows with rendered surrounds and pictorial leadlight. Projecting off the north side of the chancel is a small vestry (1907) with the same architectural details as the nave and chancel. Concrete has been built up to floor level at the doorway. A small timber bell tower stands at the rear (east end) of the church.

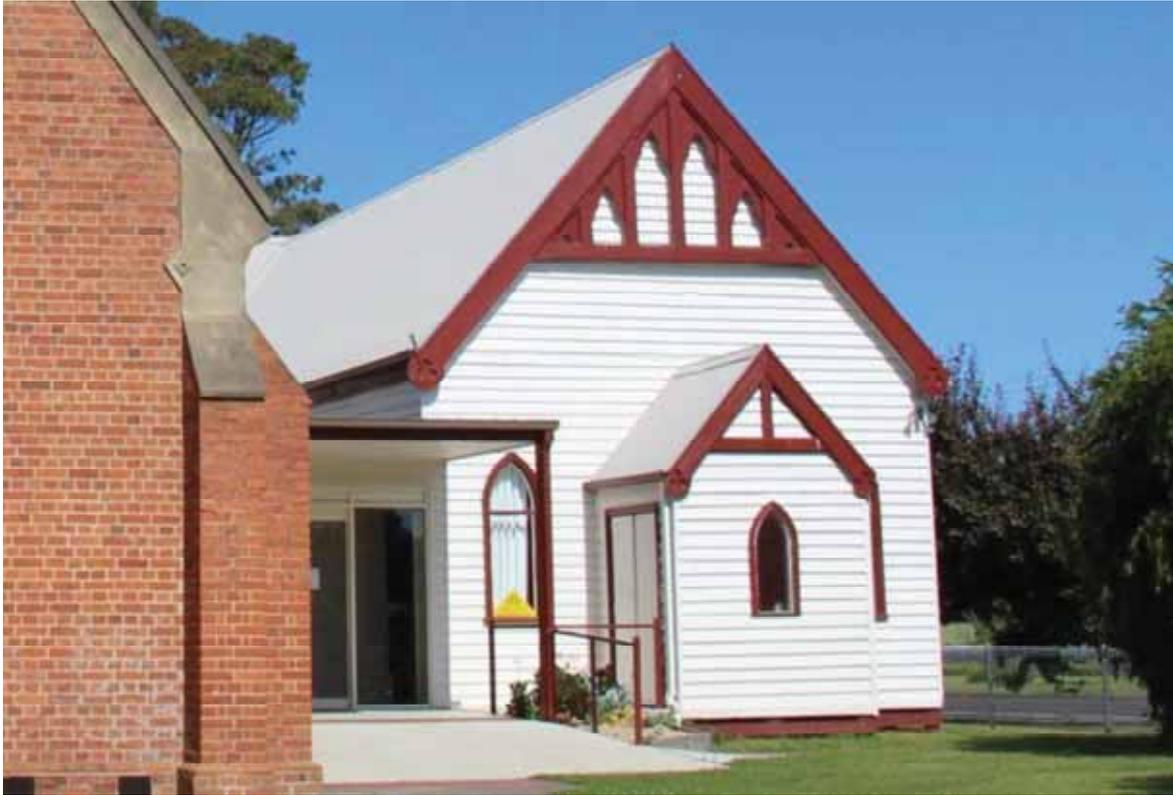
Figure D4. The 1901 weatherboard hall to the south of the church has a steeply-pitched gabled roof clad with (recent) corrugated iron, with a decorative timber valance to the gabled end of the facade. The wide bargeboards finish at the ends with lobes with a trefoil motif. A central entrance porch imitates the details of the elevation behind.

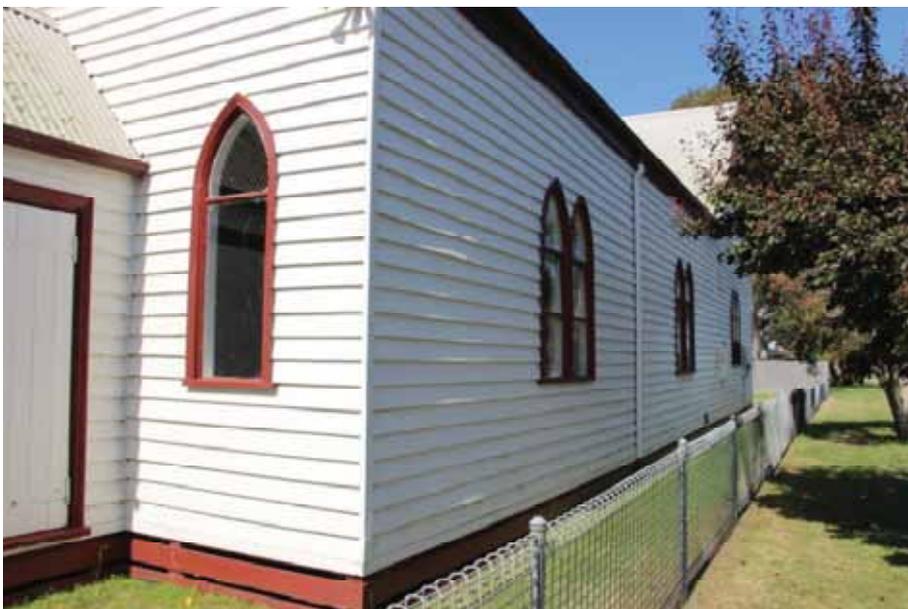
Figure D5. The south elevation of the hall has three pairs of pointed-arch windows (with clear glass) with central hoppers. There is excellent underfloor ventilation between the gaps in the base boards.

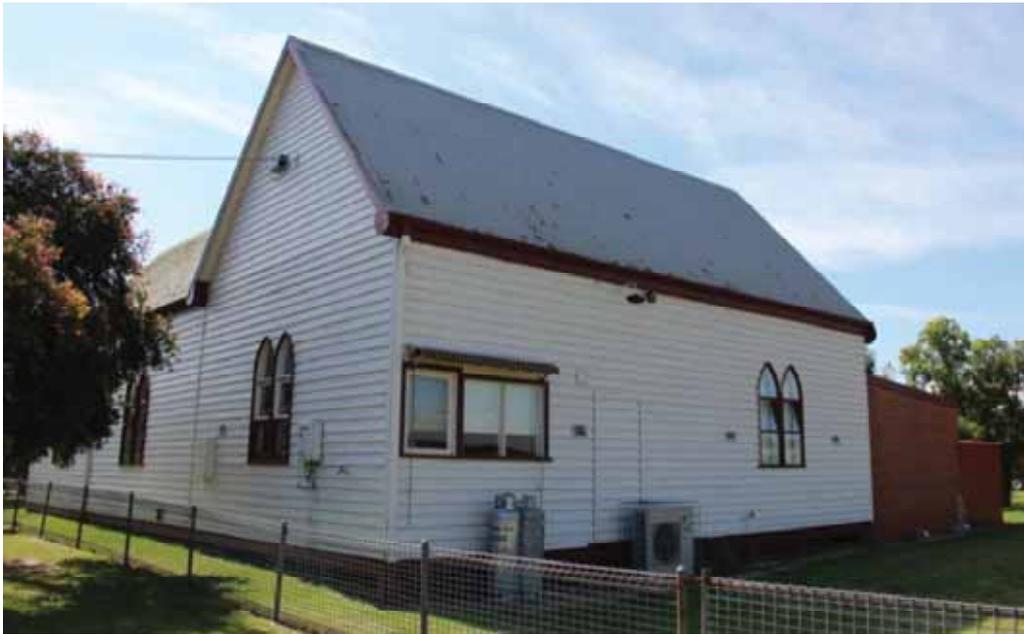
Figure D6. The east (rear) section of the hall is a weatherboard building with a transverse gable. The section contains pairs of pointed-arch windows in the same style as the 1901 building, but also has later square-headed timber-framed windows to the rear elevation.

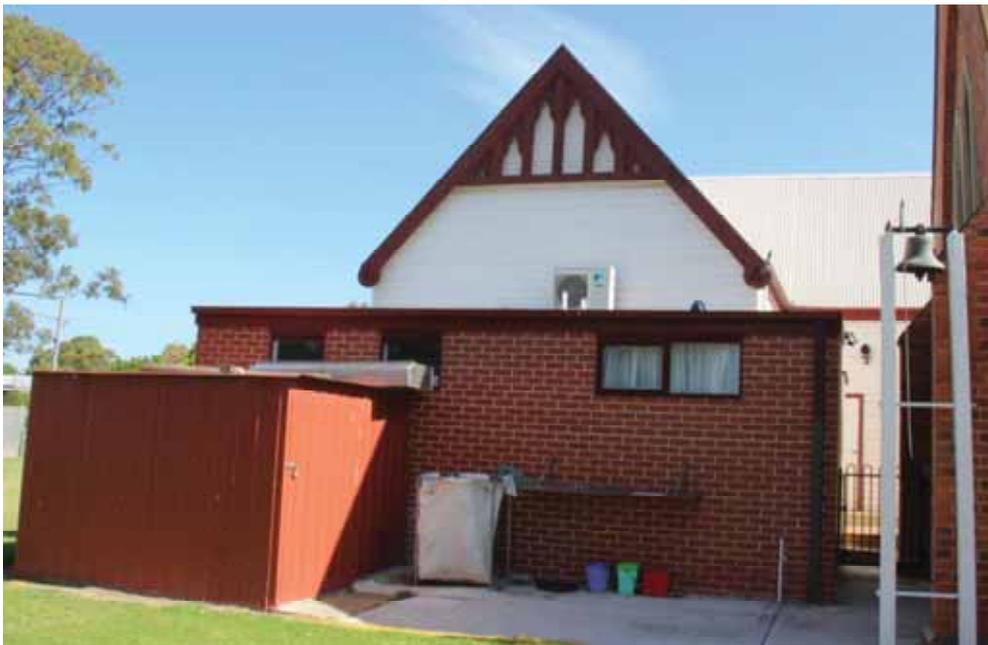
Figure D7. The gabled-end of the north elevation of the rear section of the hall retains the bargeboards and timber valance that imitate those of the facade of the 1901 hall. A modern brick addition is attached to rear of the hall.

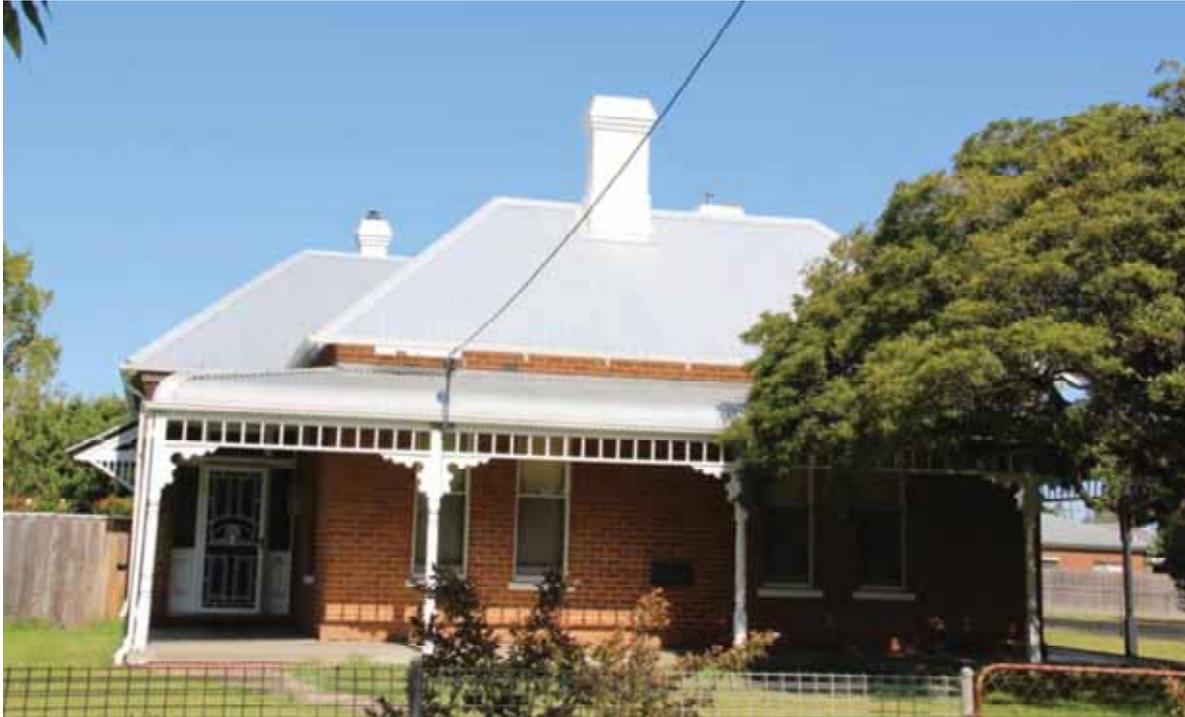
Figure D8. The 1910 rectory is a substantial brick residence with a large M-hip roof clad in (recent) corrugated iron, retaining three (overpainted) corbelled brick chimneys. A verandah with a bull-nosed profile and a concrete floor, returns on the north and south elevations, stopping at projecting hipped-roof bays.

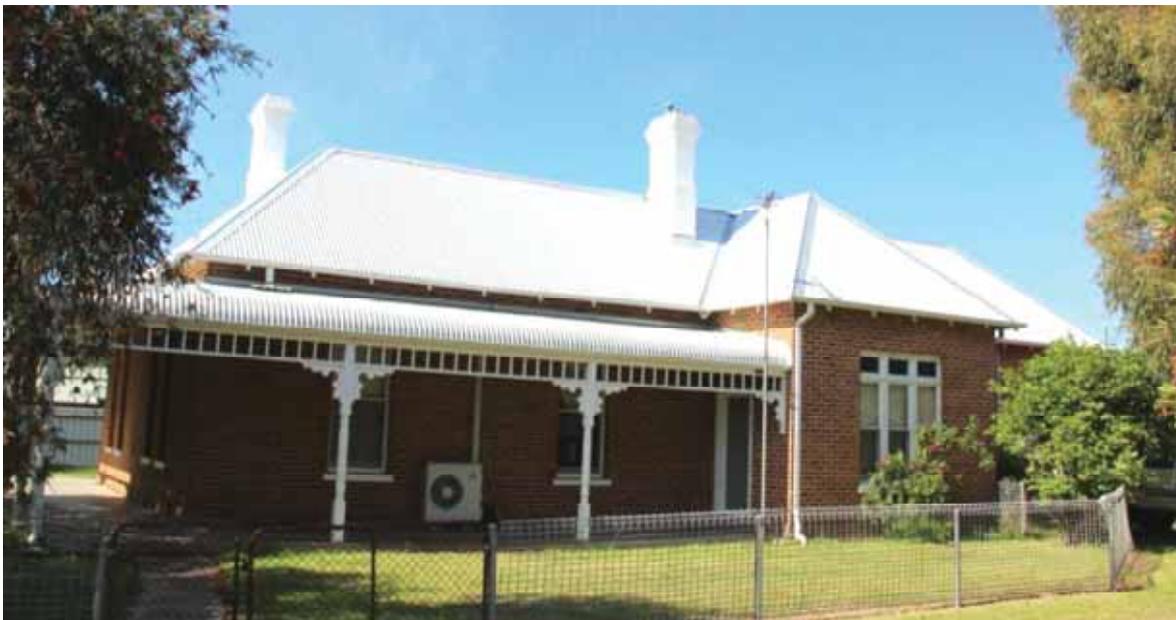
Figure D9. Windows underneath the verandah are tall narrow one-over-one sash windows, while the projecting bay on the south elevation has a large group of windows comprising three narrow one-over-one sash windows with coloured highlights. All windows have (overpainted) rendered (or stone) sills.

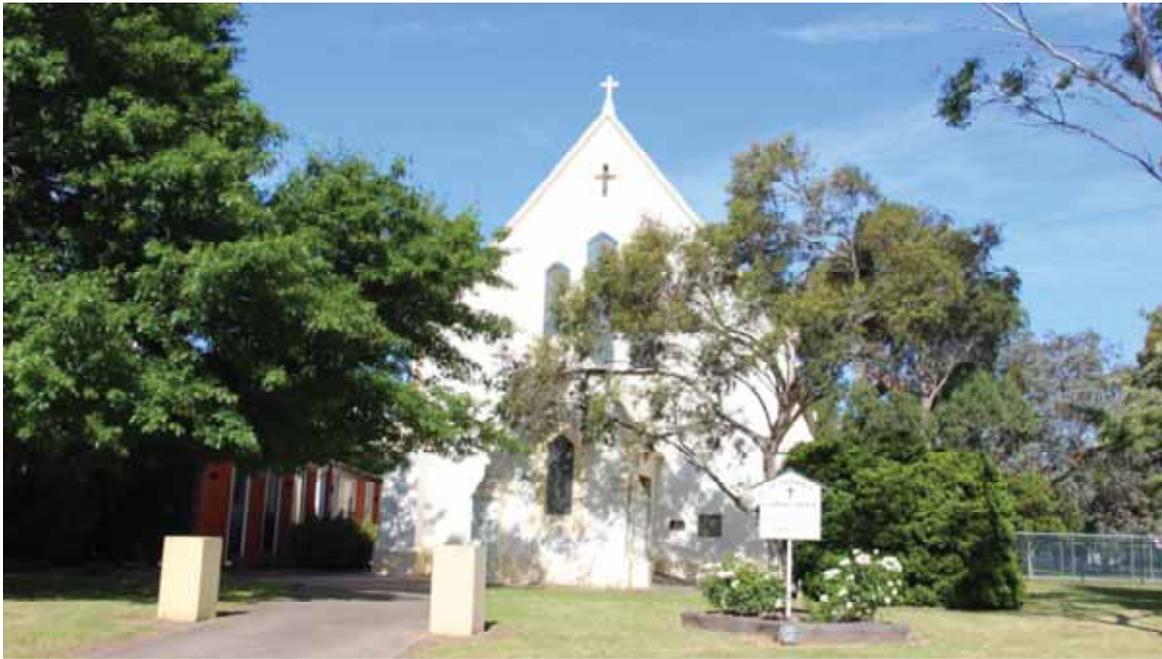
Figure D1. The church is a substantial brick structure, sitting on a large rendered plinth, with decorative render (overpainted) to the entire exterior. The steeply-pitched gabled roof is clad with (recent) metal decking with a rendered parapeted gable.

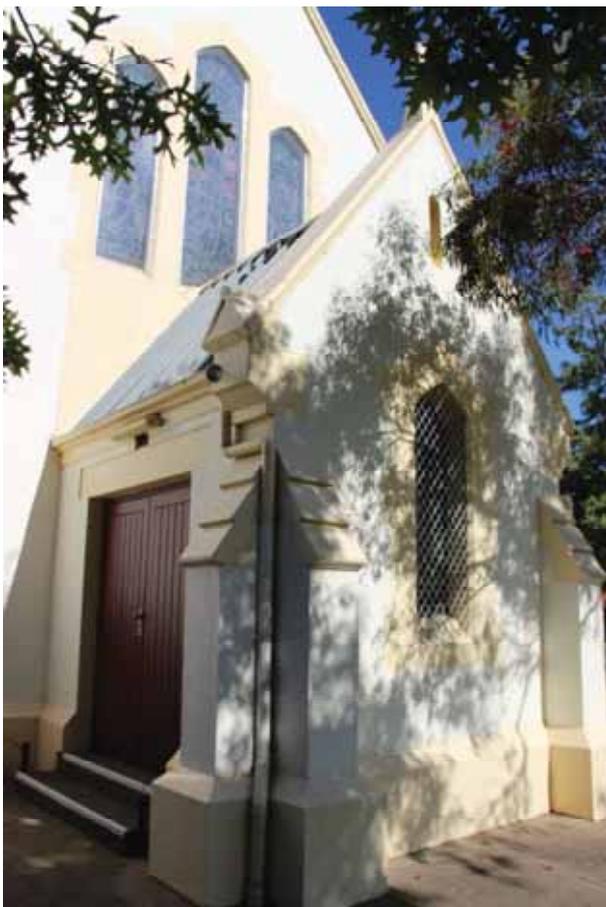
Figure D2. At the centre of the facade is the entrance porch, which imitates the details of the nave behind. The front of the porch has a pointed-arch window (covered with a modern security grill), while the sides have double timber ledged and framed doors (in a square opening) with their original handles and plates, incised with a cross.

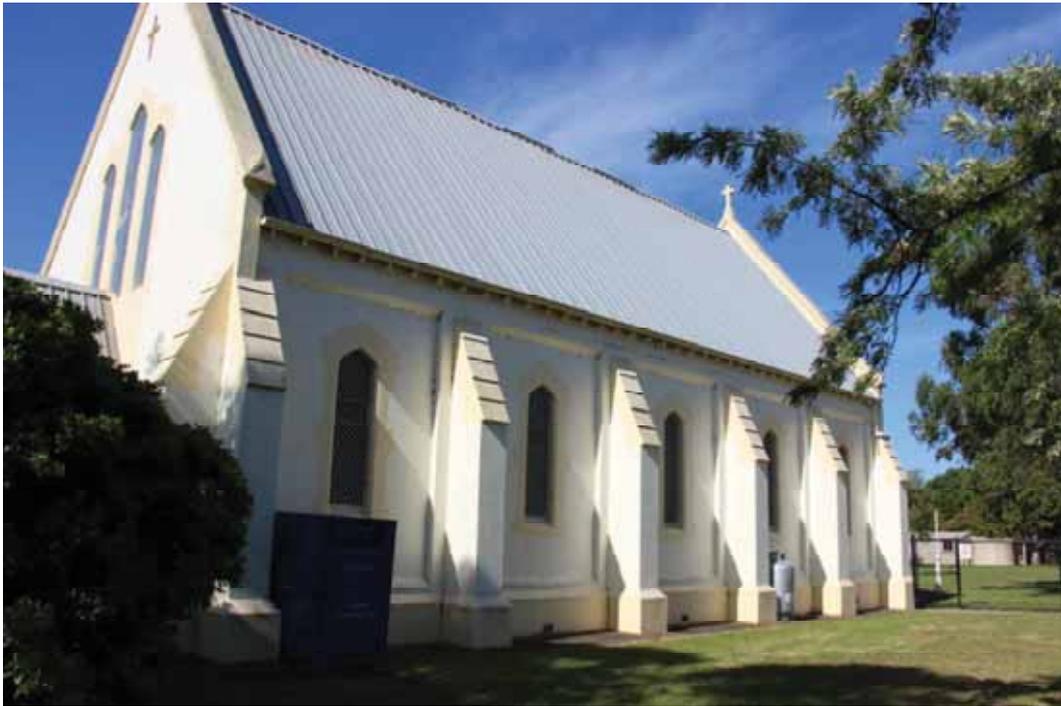
Figure D3. The south elevation. The side elevations are divided into five bays by solid buttresses. Each bay has a single window in a large recessed square panel. The windows, like those of the facade, have a pointed-arch, rendered trimmings (overpainted in a cream tone) and leadlight in pictorial and diaper-patterns, covered in modern security grill.

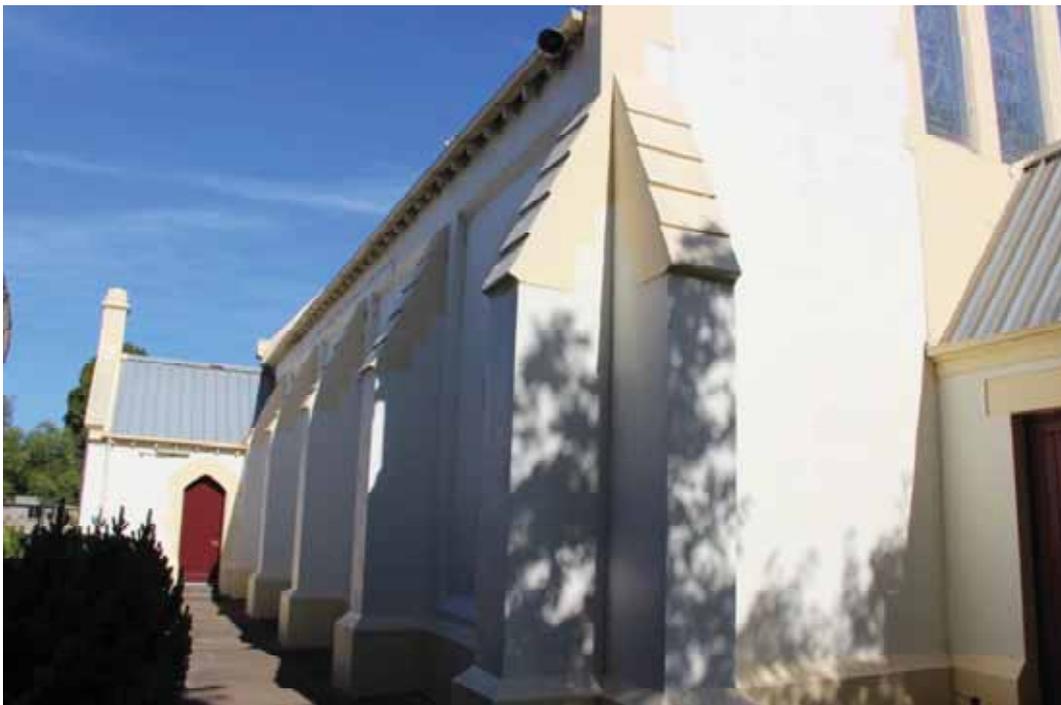
Figure D4. The north elevation has a gabled-roof vestry projecting off the chancel end, with timber ledged door (with a pointed arch opening) facing west. It has a large parapeted gable which appears to extend to form a bellcote.

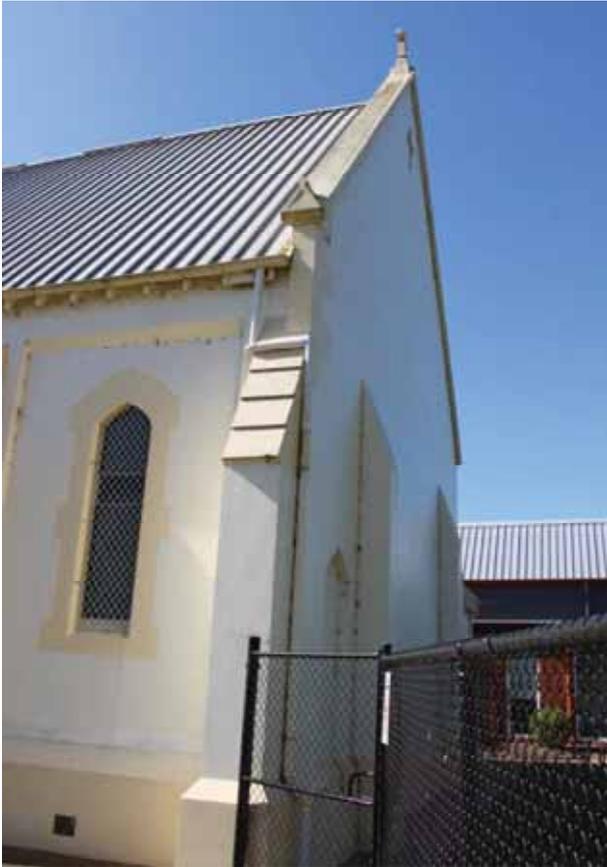
Figure D5. The rear (east) elevation has a simple treatment. It has a niche in the shape of a cross at the top of the gabled-end, like the facade, and two simple buttresses.

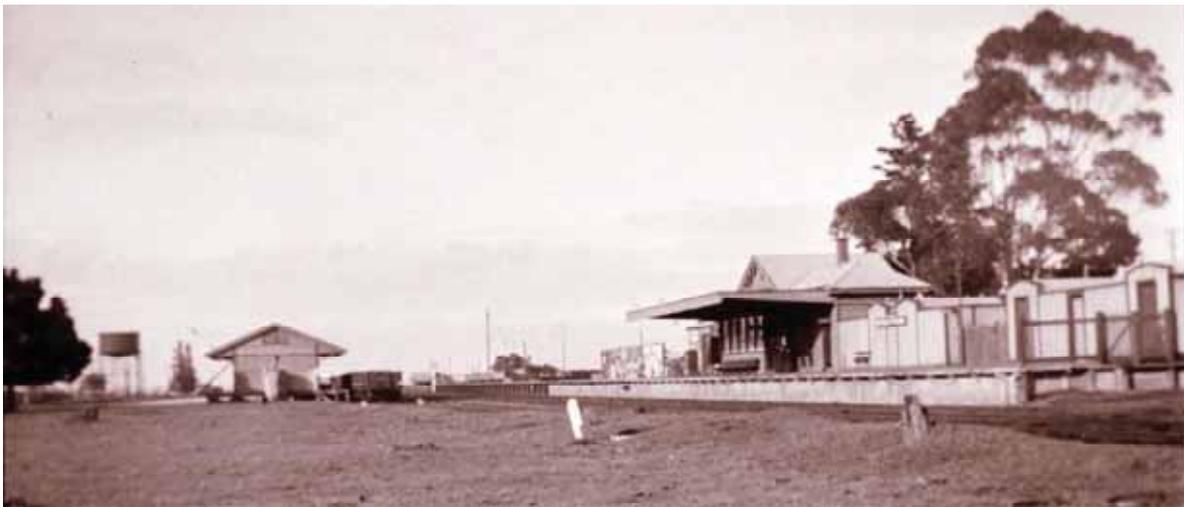
Figure H1A. An early photo (may date to c1930s-50s) of the station from the north, with the passenger platform on the right with a number of outbuildings lining the platform. On the left is a goods platform and corrugated iron goods shed, and the crane and water tower at a southern location (SDHS).

A large timber crane remains at a distance to the south of the station building, within the railway reserve. It is not known if this is an early or original element (probably evident in the c1930s-50s photograph) of the station. A small modern shed is located to the north of the station building.
