**Locality:** STRATFORD  
**Place address:** 17 HOBSON STREET  
**Citation date** 2016  
**Place type (when built):** Mechanics Institute and Free Library  
**Recommended heritage protection:** Local government level  
Local Planning Scheme: Yes  
Vic Heritage Register: No  
Heritage Inventory (Archaeological): No

**Place name:** Mechanics Institute and Boer Memorial Plaque

**Architectural Style:** Federation Free Classical  
**Designer / Architect:** Edgar J. Henderson  
**Construction Date:** 1890

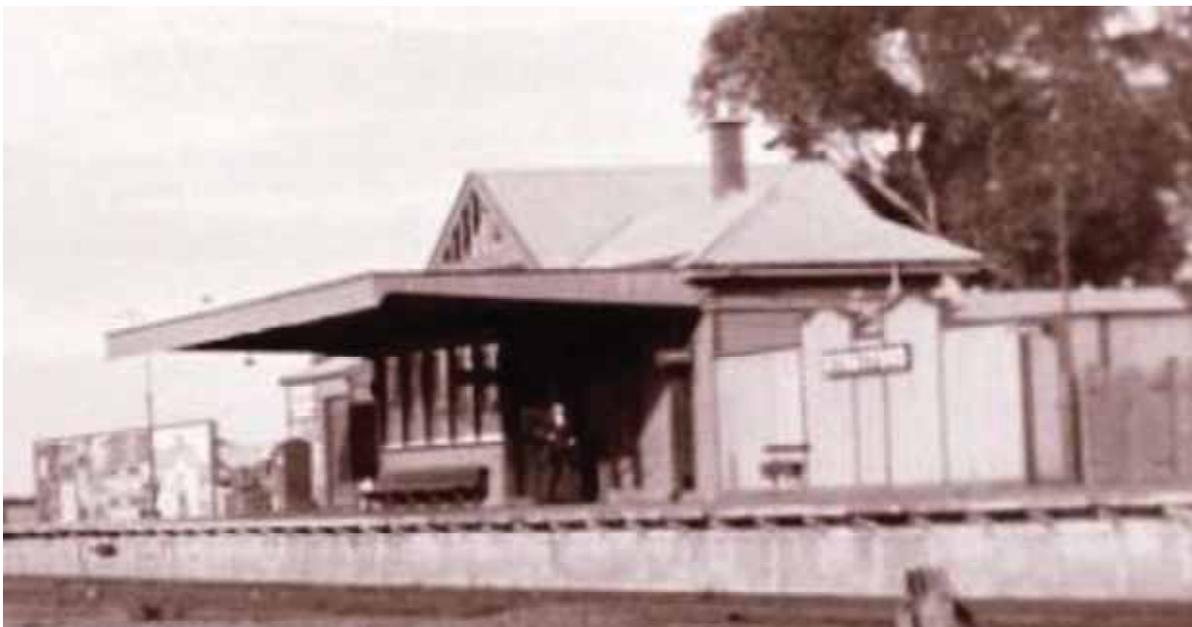
Figure H1B. A detail of the public platform and station in Figure H1A.

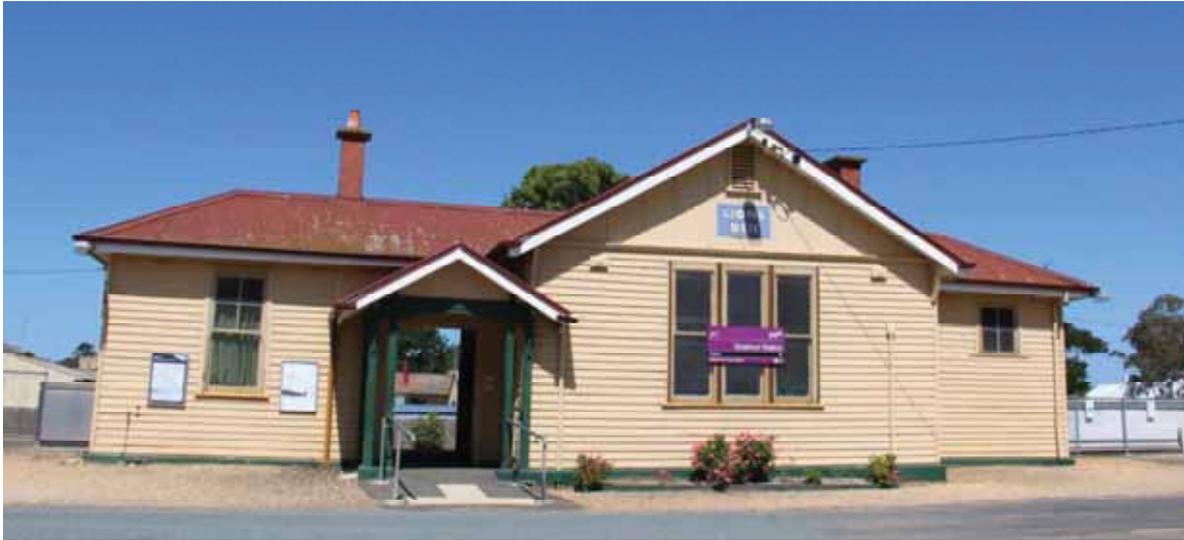
**Figure D1.** The west elevation with the large projecting gabled-bay and entrance porch to the left.

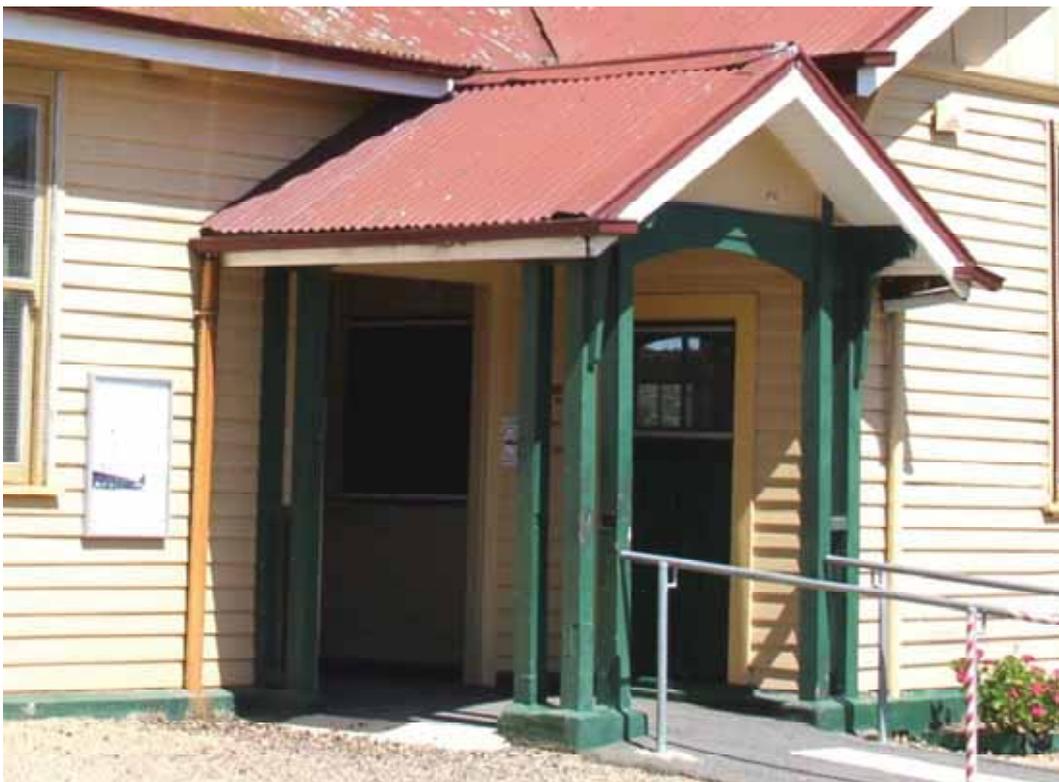
**Figure D2.** The gabled-roof entrance porch supported by pairs and triples of timber posts, with timber brackets and arch.

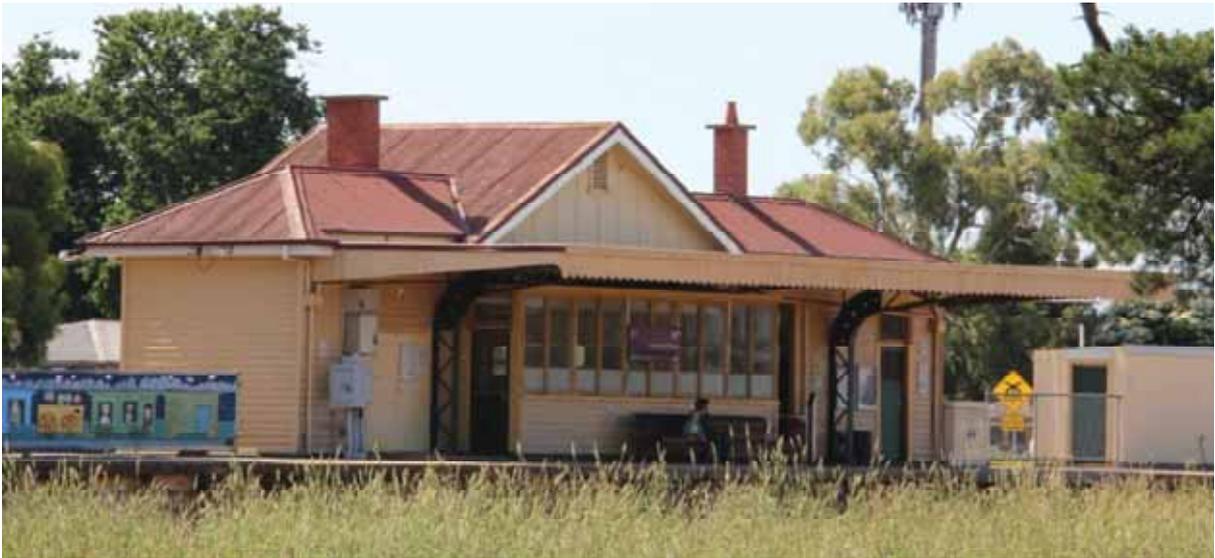
Figure D3. The platform (east elevation) of the station with its large metal trusses supporting the cantilevered awning with fluted and scalloped metal valances.

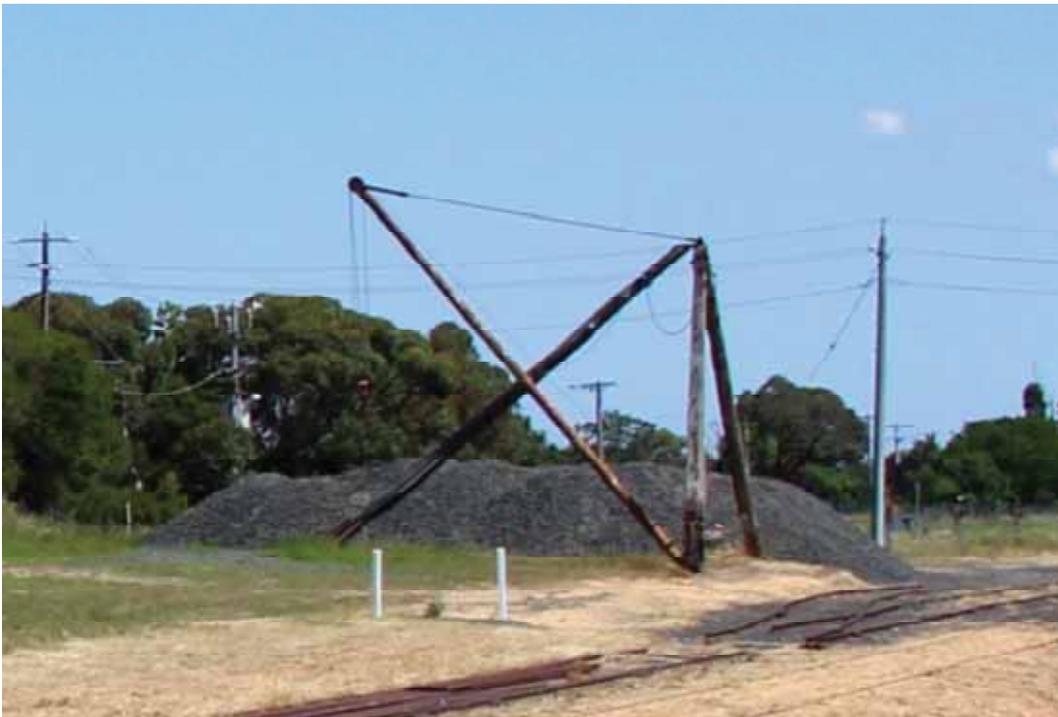
Figure D4. The early goods crane, located to the south of the station in the railway reserve.

**Figure D4.** To the south of the railway station on the eastern side of the tracks, within the railway reserve, is a large timber goods crane. It appears to be early in date (confirmation required if this is original to the 1888 or 1920-21 railway station).

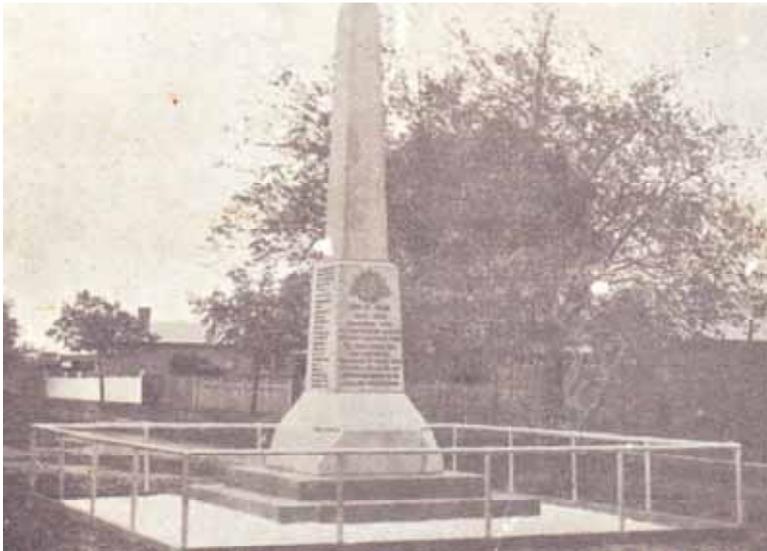
Figure H2. Early photo dating to the unveiling on 2 Nov 1924, of the Stratford Fallen Soldiers Memorial. Note the fence without a gate for access to lay wreaths. Also note the level of the ground (crushed white gravel?) hides the foundation concrete, which was incorrectly exposed in recent works (SDHS, ID No. 04003-28VSFH).

The Stratford Citizen's Committee appealed for funds for the erection of a soldiers' memorial from 1923 (*Gippsland Times*, 18 Jun 1923:5). In November 1923, the Fallen Soldiers Memorial was unveiled by Brigadier-General Forsyth (*Gippsland Times*, 6 Nov 1924:3) at its original location on Dixon Street (Figure H2). It was dedicated to the Shire's servicemen who served in World War I, including the three Mitchell Brothers. Later plaques were late added to in memory of those who served in, World War II, followed by the Korean and Vietnam Wars. The memorial was probably relocated to its current location with the opening of the Memorial Park in 1953. The granite obelisk is almost identical in design to the central (WW1) obelisk at the Briagolong Memorial (SDHS).

**Figure D3.** The concrete foundations were meant to be concealed below ground level, (Fig H2) now show salts leaching out from the base. There are two levels of bluestone steps above the concrete, some with (lime) mortar missing from the joints, the granite faceted base with names (e.g. GALLIPOLI) incised by hand into the stone and painted black, and a modern brass painted plaque attached to the vertical face. On the square granite pedestal there are the names of soldiers hand cut in lead and painted black. The dark patches seen in the granite stone are natural impurities. The back of the monument has names of soldiers from WW2.

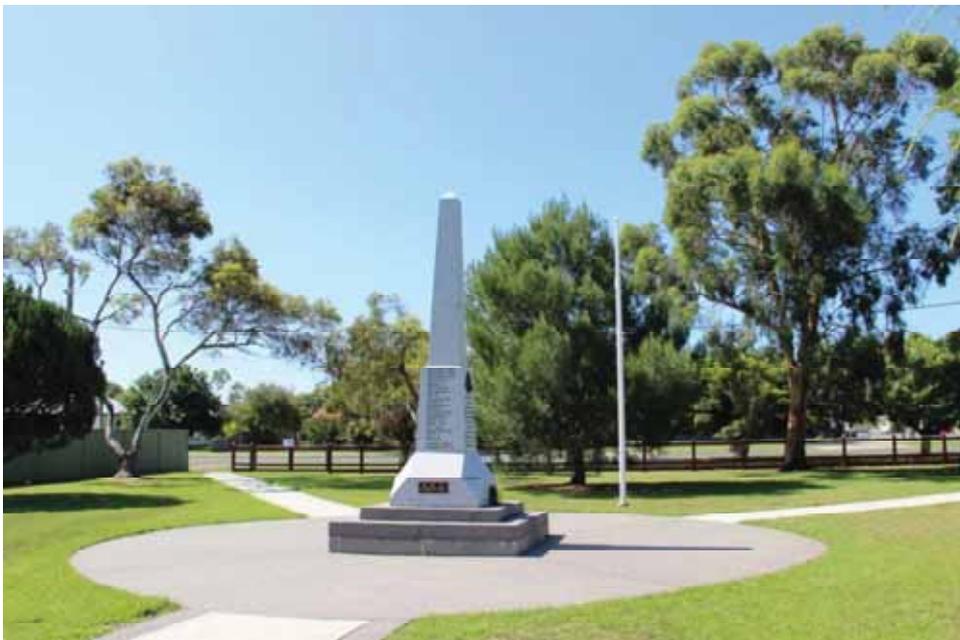
**Figure D1.** The granite obelisk in its existing (recently constructed) setting.

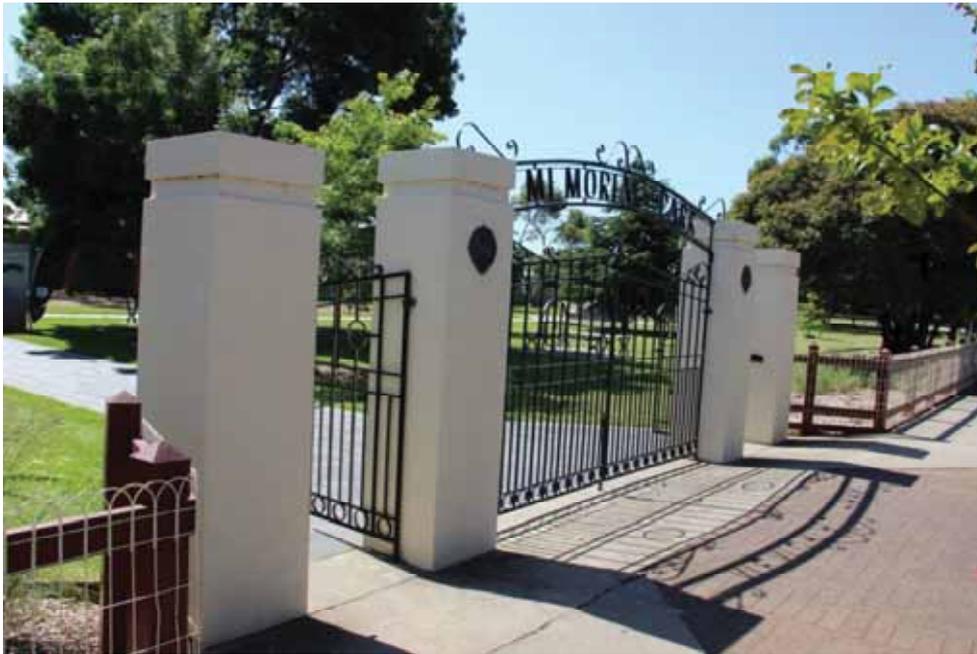
Figure D2. 1953 Memorial Gateway (altered 20140 facing Tyers St.

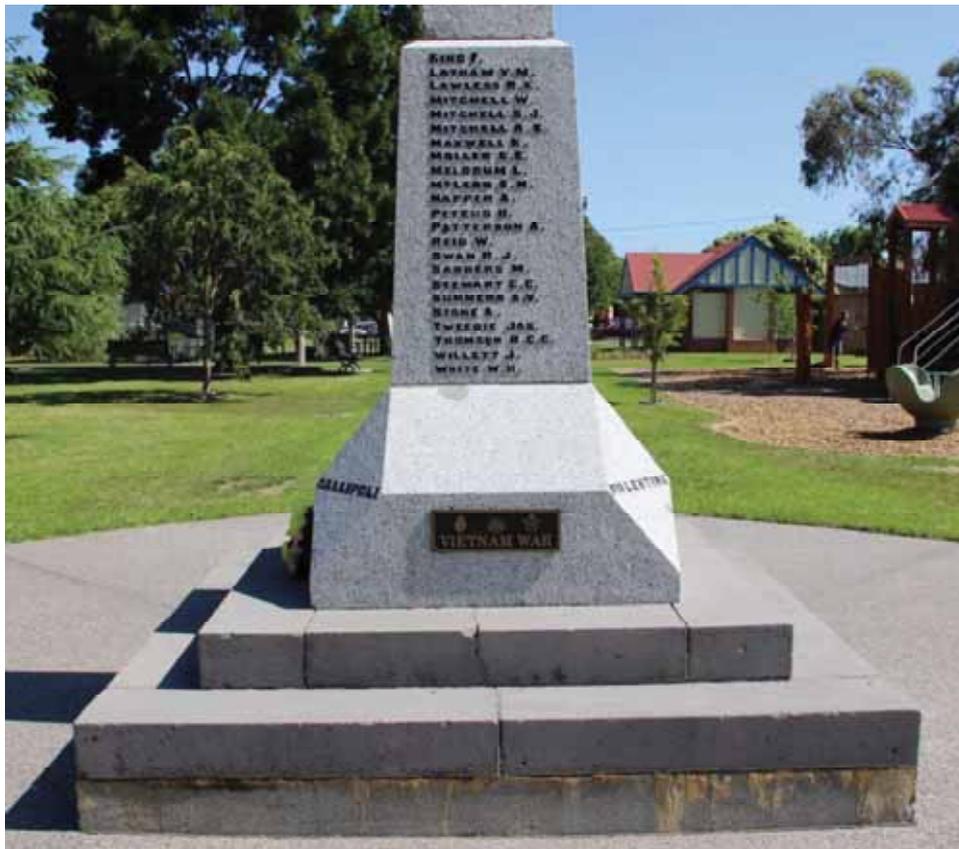
Figure D3. Detail of the concrete foundations, bluestone steps, names (eg GALLIPOLI) incised into the granite, and names on soldiers in lead. Modern bronze and painted plaque.

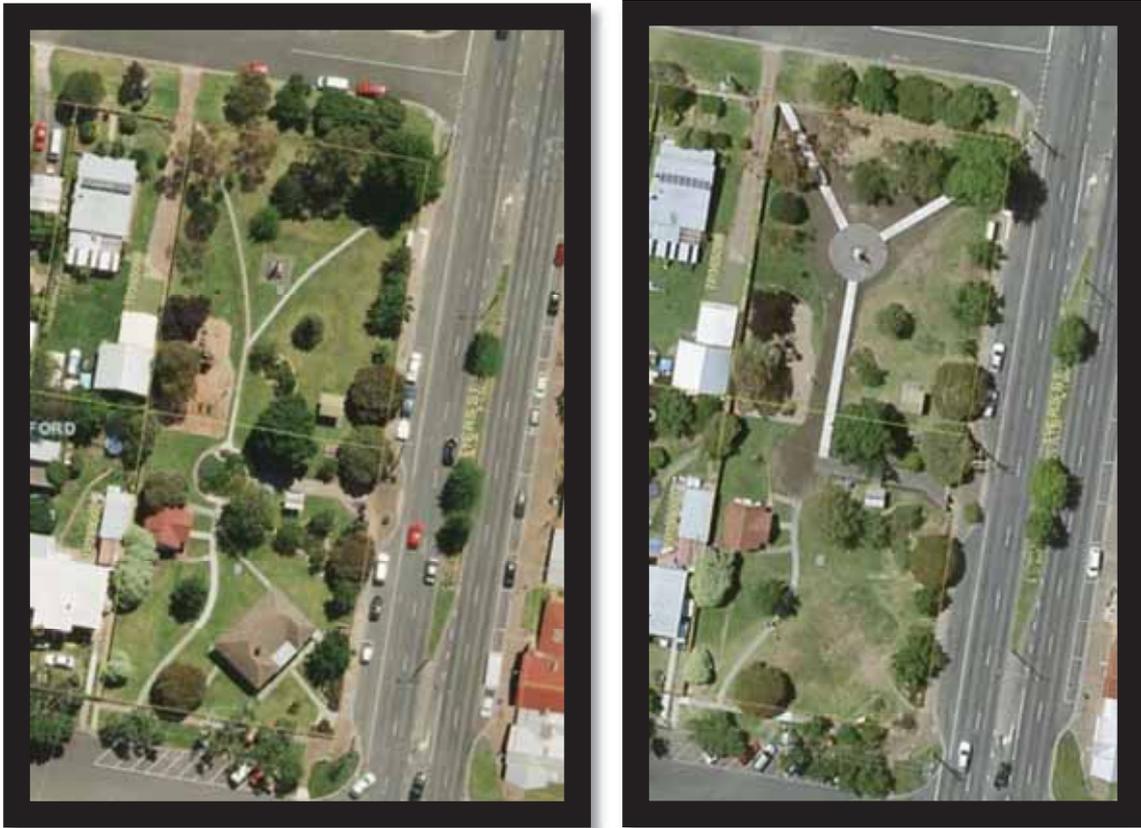
Figure D4. Aerial views in 2012 (left) and 2014 (right). Note concrete paths added in 2014.

**Figure D4.** An aerial view in 2012 shows the 1953 gates half way along the Tyers St boundary, and the path directly from them to a circular feature. The 1923 obelisk memorial was set in a square sacred space with two informal paths split from one, to go to the two north corners of the park along Tyers St. The 2014 Aerial shows the recent renovation of the park with the concrete paths and circular concrete apron around the memorial.

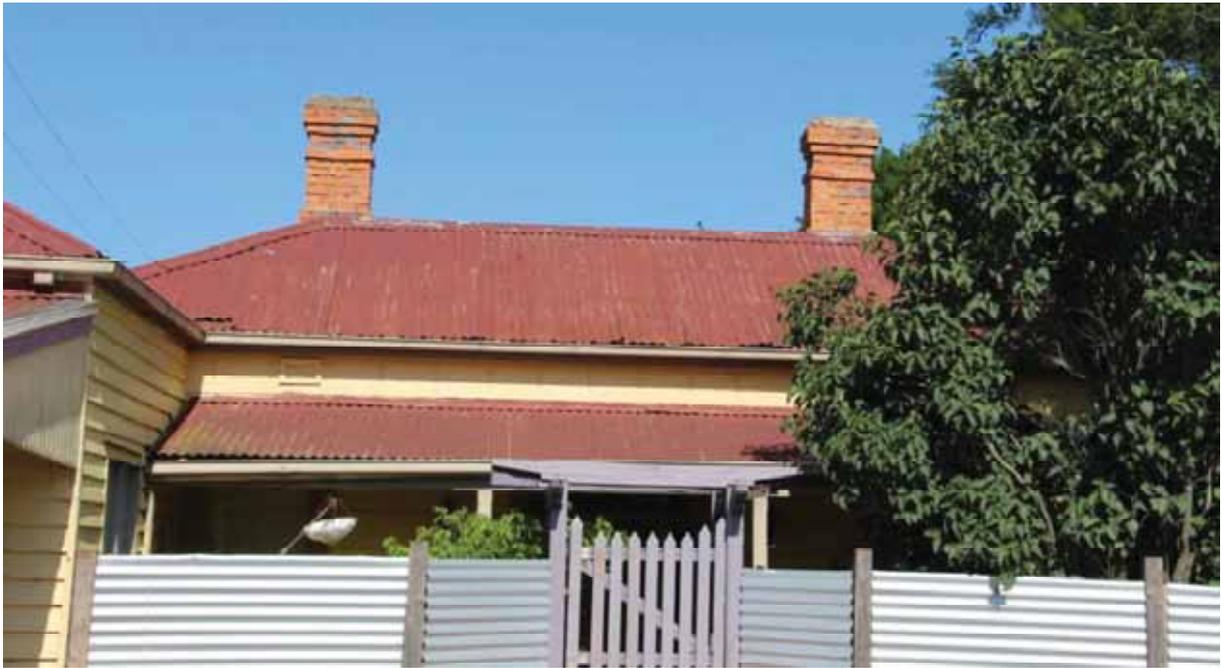
Figure D1. The house has an M-hip roof, clad with corrugated iron, and a verandah to the facade which returns on the south elevation. The house retains two corbelled brick (unpainted) chimneys that are constructed of handmade red bricks. A skillion-roof verandah is clad with corrugated iron (painted), supported by stop-chamfered timber posts.

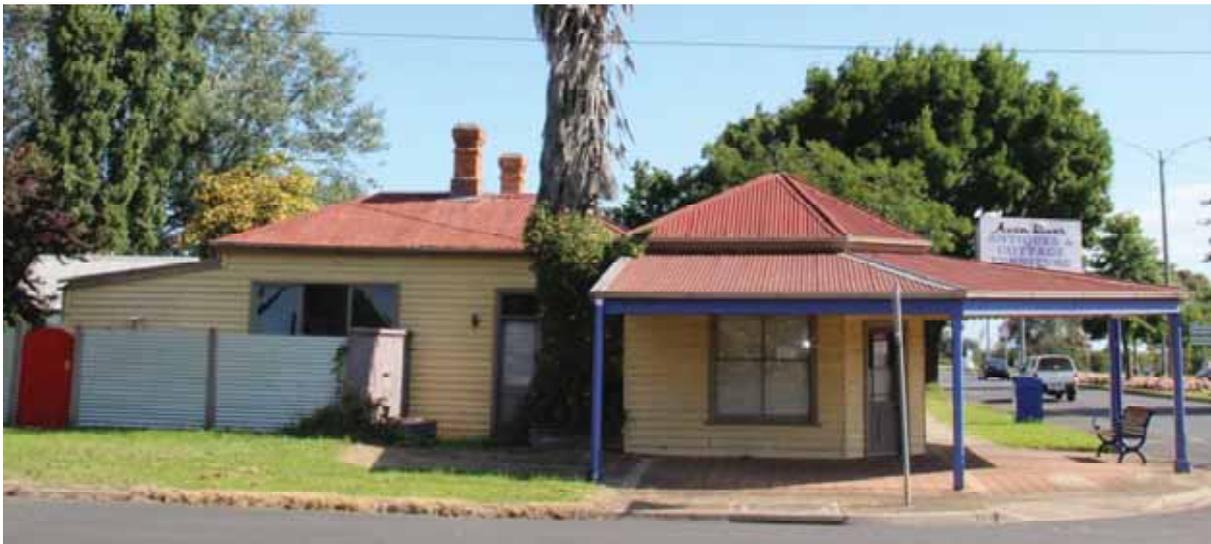
Figure D2. The north elevation has weatherboard cladding and modern timber doors and windows. The weatherboards continue to create a skillion-roof section at the rear (east) of the house.

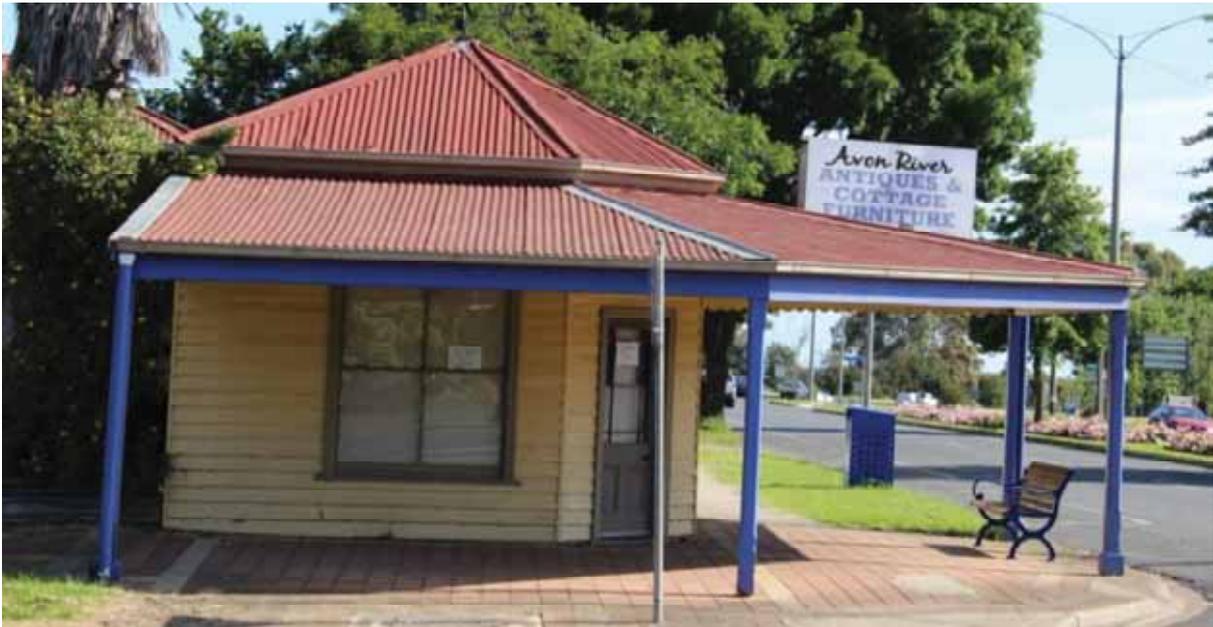
Figure D3. The small weatherboard corner shop has a faceted hipped roof clad in galvanized corrugated iron (painted). The original wide verandah extends over the pedestrian footpath, is clad with galvanized corrugated iron, has round-edged palings to the sides, and is supported by shop-chamfered timber posts, some with a timber base.

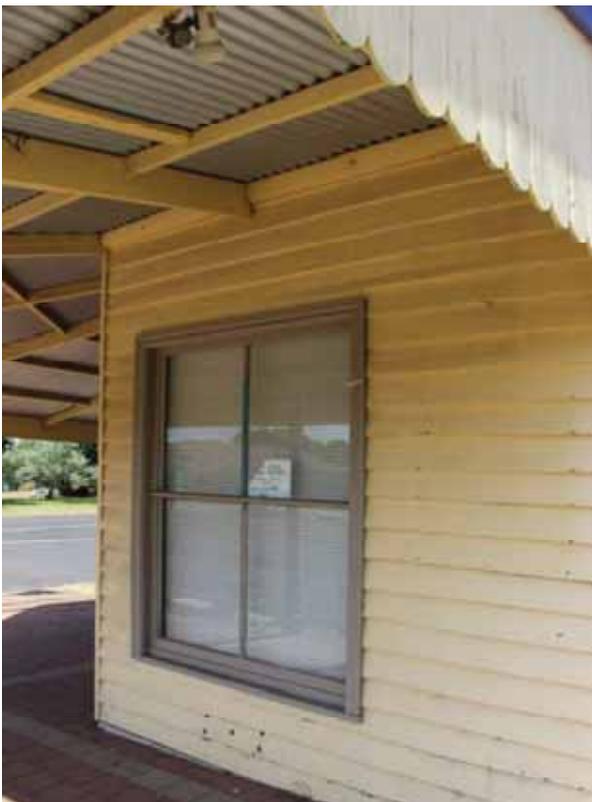
Figure D4. The two main elevations of the shopfront have large timber windows.

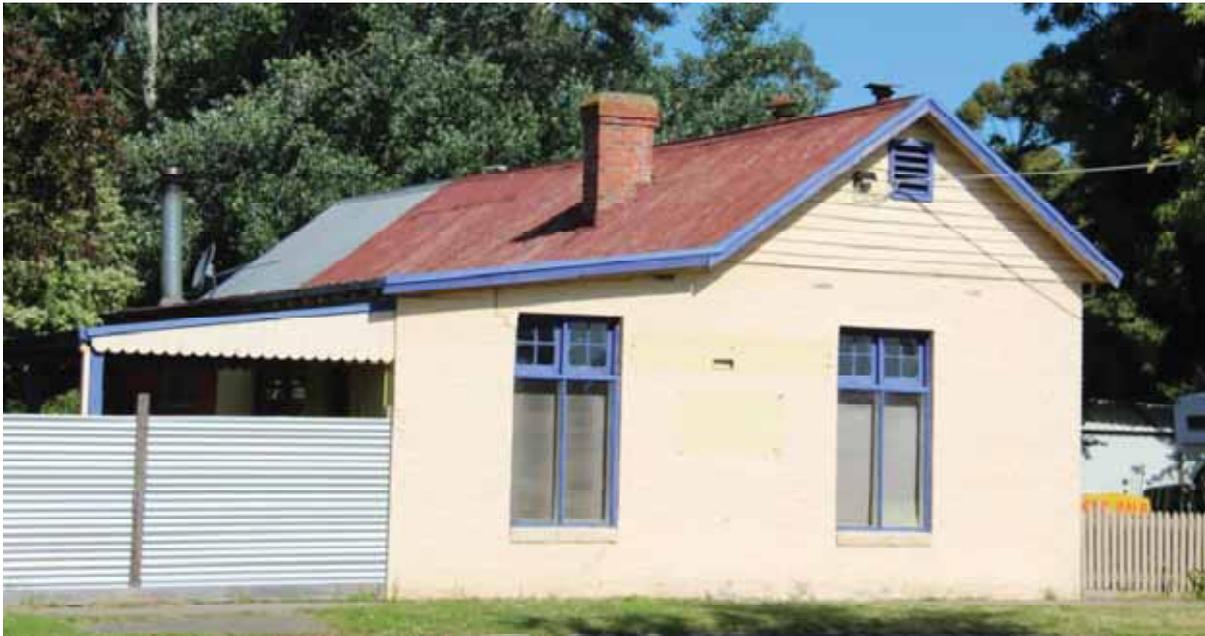
Figure D5. The north elevation of the bakery, and the east elevation fronting Tyers Street. The large brick (overpainted) bakery has a gabled roof clad in galvanized corrugated iron (painted) with round vents (c1900) to the roof, a corbelled brick chimney (unpainted) and exposed rafter ends to the eaves. The gabled end to Tyers Street is clad with weatherboards, with a rectangular vent. The lower skillion with the scalloped boarding is recent. The windows may date from c1900, but may be second hand windows inserted into this wall when the building ceased being used as a bakery.

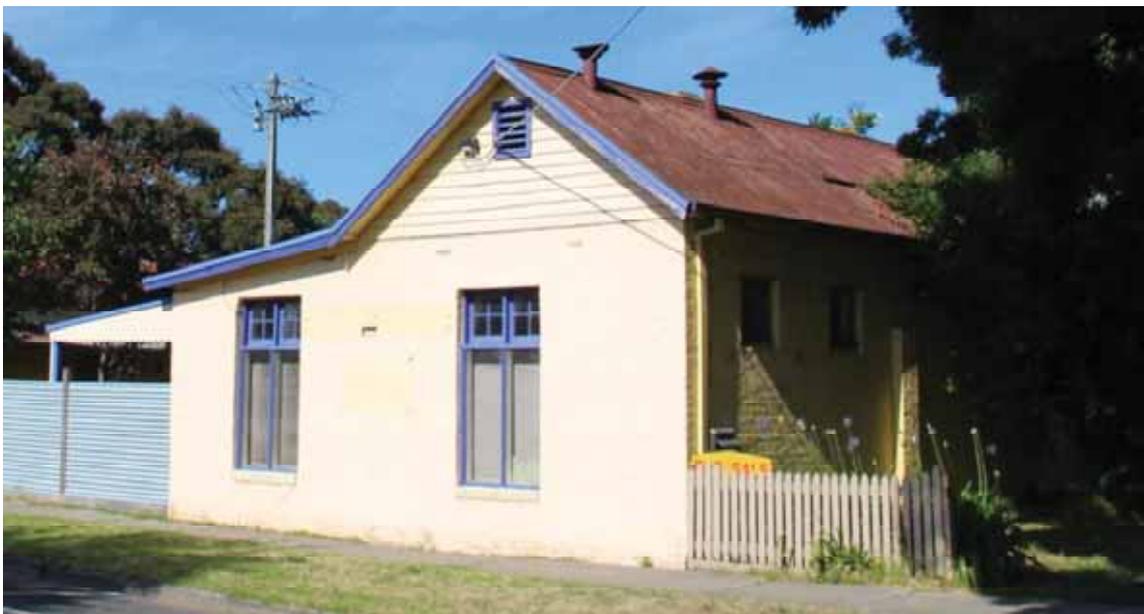
Figure D6. The east end of the bakery and to the right is the south elevation. The east elevation has two pairs of tall timber windows with a four-paned window to the top quarter, with brick sills and rendered (overpainted) lintels. These windows may date from c1900, but it is unlikely that they were located on this wall whilst the building was being used as a bakery. They may be second hand windows inserted into this wall when the building ceased being used as a bakery. The south elevation has small windows (one retains a four-paned window), also with brick sills and rendered lintels.

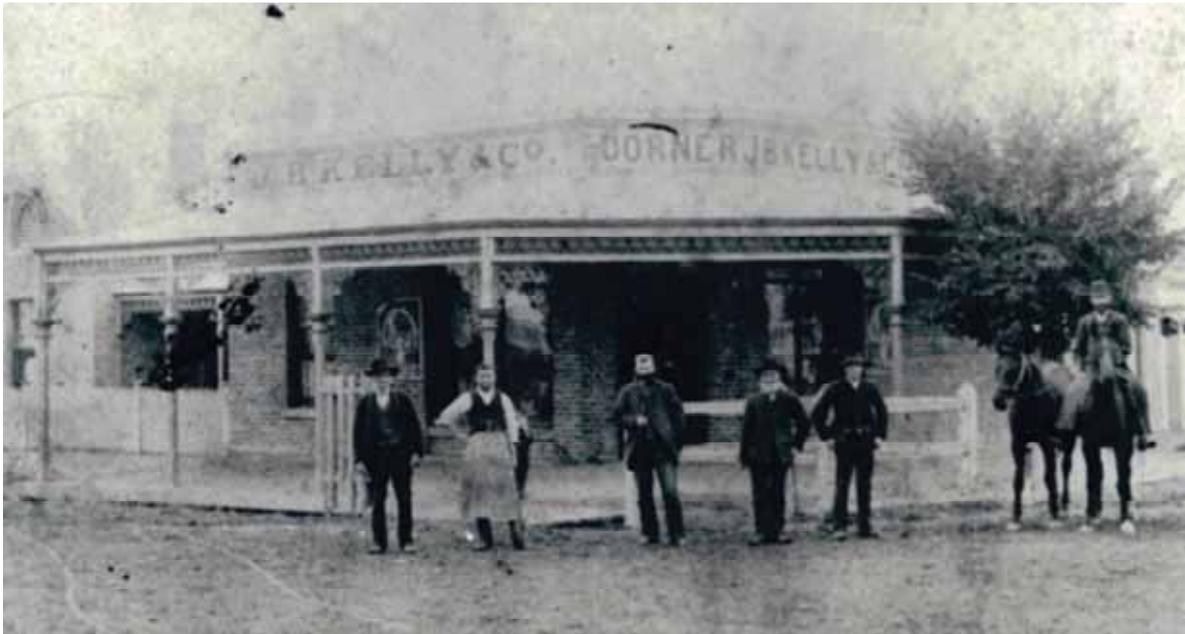
Figure H1. An early photo that shows J. B. Kelly's corner shop with the attached residence, both with decorative Victorian verandahs, behind a row of men posing in front of the shop, including Kelly (SDHS).

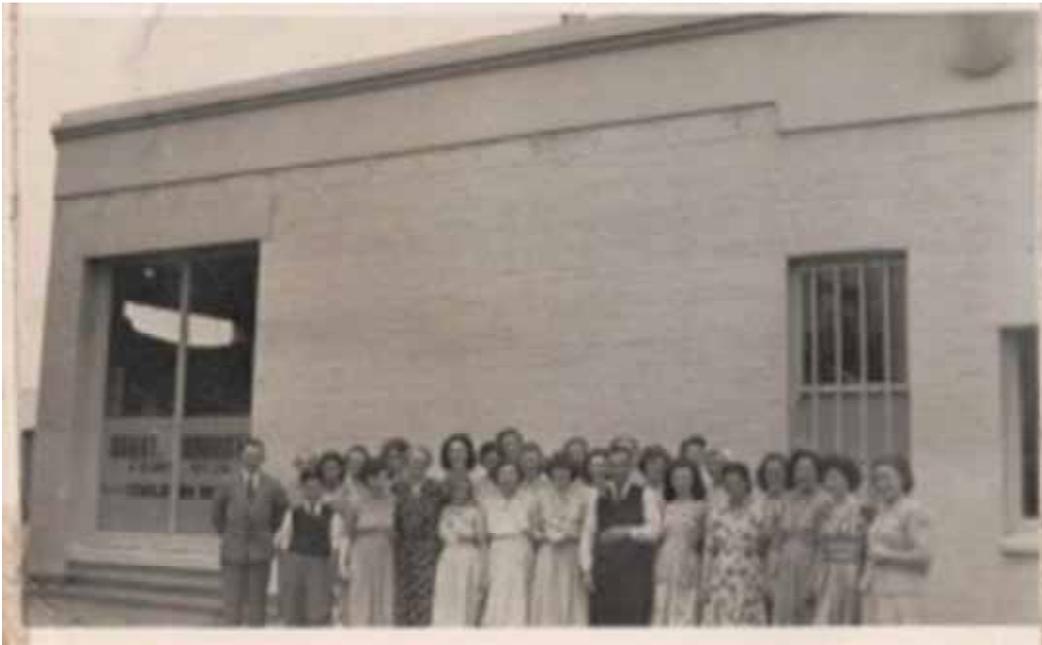
Figure H3. Workers standing in front of the north elevation of the corner shop, at the Christmas breakup at Grant Barnett Umbrella Factory. The verandah had been removed, the building painted, and security bars added to the rear window (SDHS).

4.6.2. Reconstruct the missing cast iron brackets, valance, on both verandahs as shown in Fig H3.

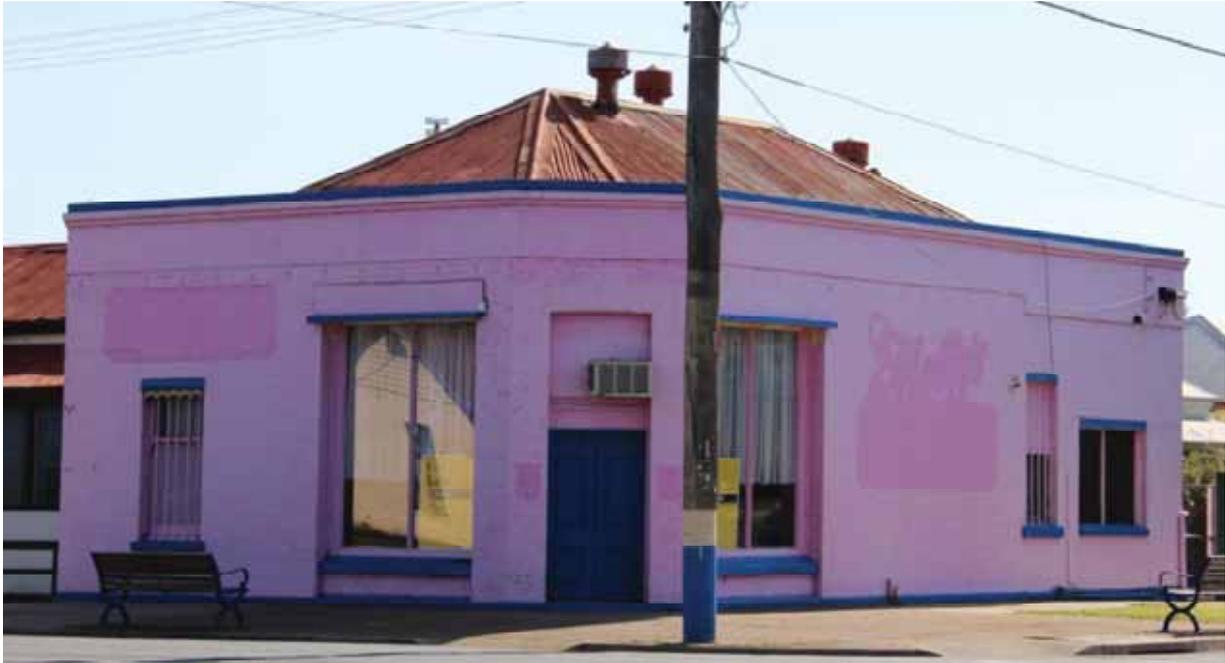
Figure D1. The large shop has a hipped roof clad with galvanized corrugated iron (overpainted) and a number of recent round metal vents to the roof. The shop is constructed of handmade red-brick (all overpainted) with a small brick plinth. The main elevations of the brick shop front Tyers and Blackburn Street, with a chamfered corner entrance and rendered parapet.

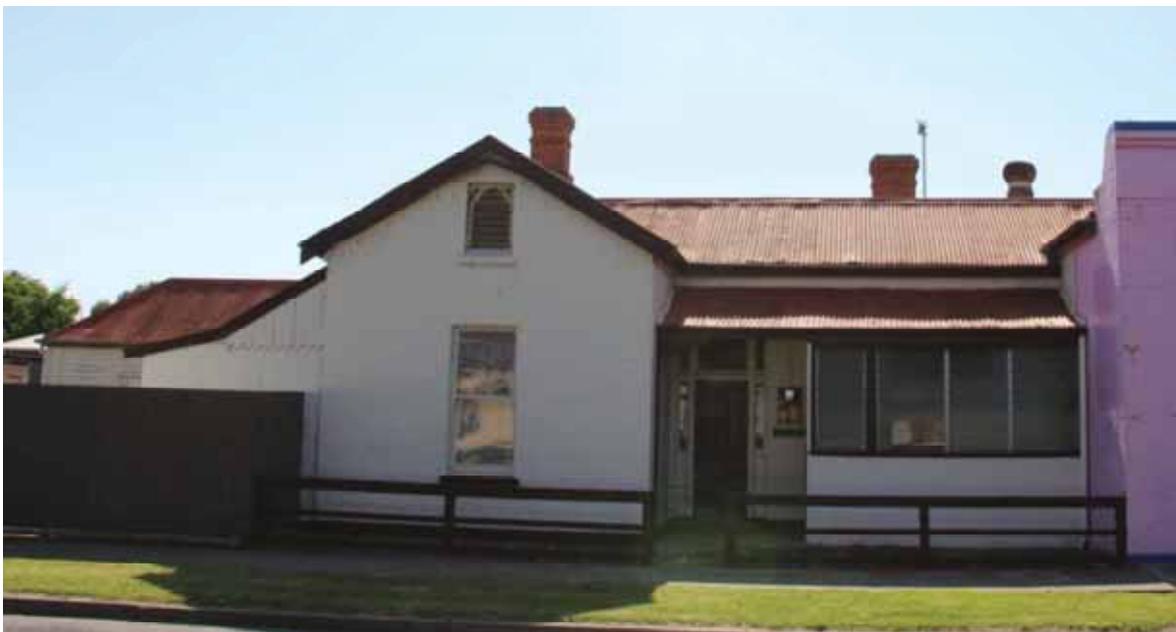
Figure D2. The residence is attached to the south of the shop, fronting Tyers Street. The brick (overpainted) residence has an M-hip roof, and a projecting gabled-bay to the facade, all clad in galvanized corrugated iron (overpainted). The facade has a projecting gabled-bay to the left and a slightly-concave verandah fills the recessed portion of the facade to the right.

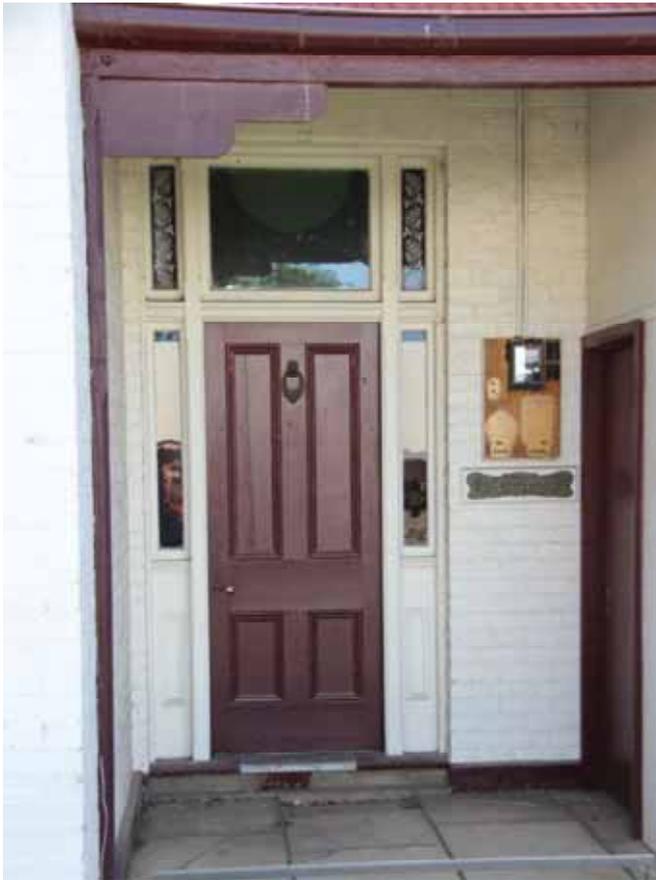
Figure D3. The Victorian entrance has a timber panelled door with sidelights above timber panels, and highlights with stained glass; above are radiating brick voussoirs. The bricks have been painted.

**Figure D3.** The Victorian entrance has a timber panelled door with sidelights above timber panels, and highlights with stained glass; above are radiating brick voussoirs (overpainted). An Art Nouveau styled nameplate near the entrance door reads 'Matoppo' (dating to the Carter's occupation). See Figure H1 for the original detail to the verandah of the residence.

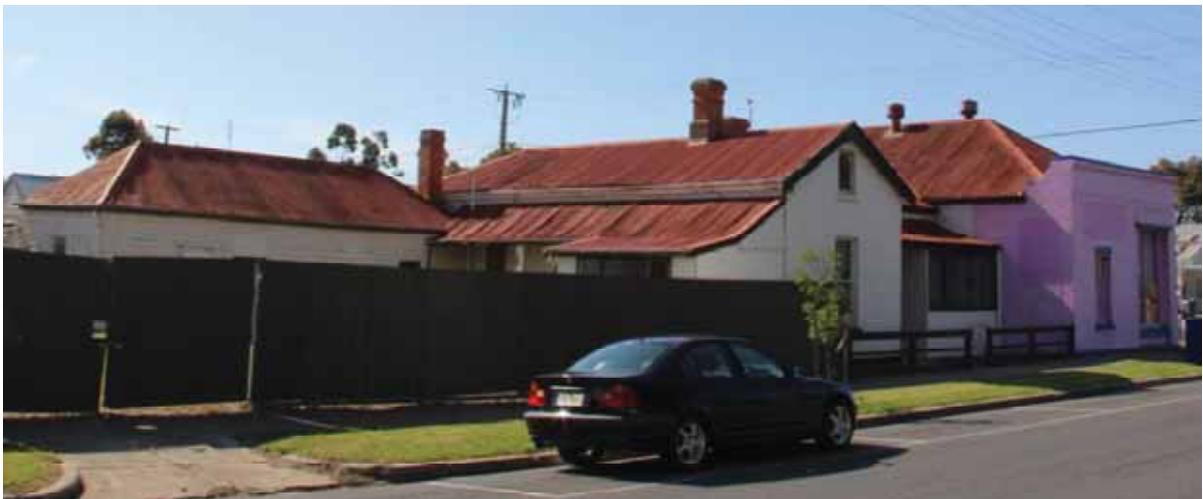
Figure D4. View showing the significant shop, residence and early large hipped-roof outbuilding. Off the south elevation of the house is a skillion-roof verandah clad in galvanised corrugated iron.

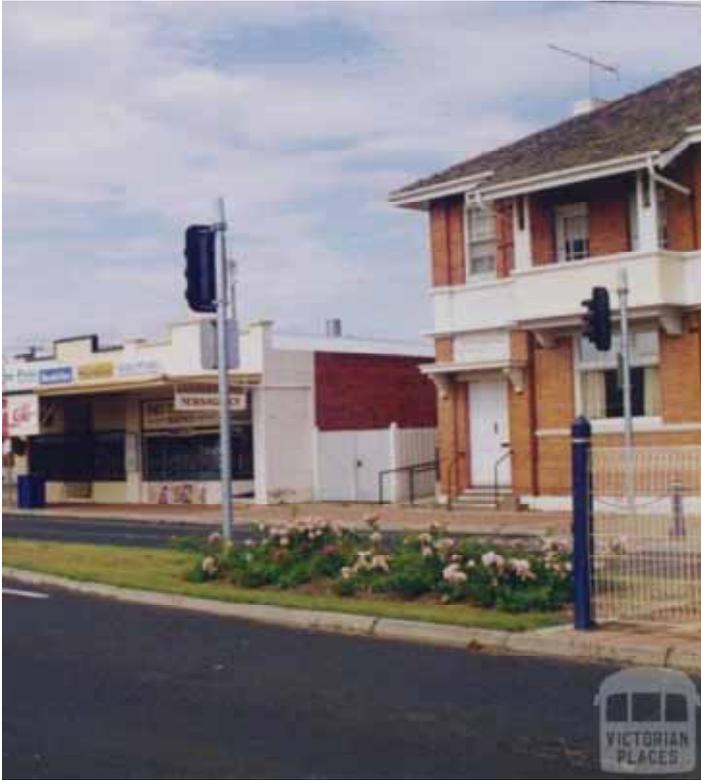
Figure H3. The bank in 1998 (Victorian Places).

In 1994, the Commissioners of the State Savings Bank of Victoria sold the building into private ownership. The property may have already been leased by private owners at this date (LV:V2352/F393). A photo dating to 1998 (Victorian Places) showed that the pair of timber panelled entrance doors (evident in the 1958 photo) remained at this date (Figure H3).

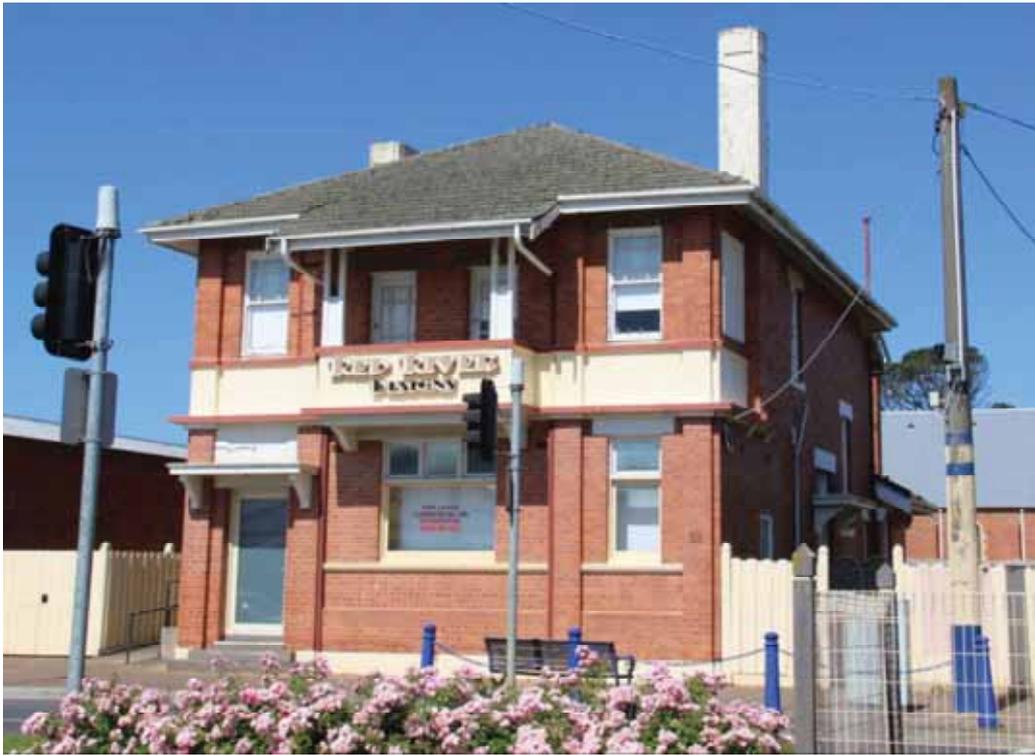
Figure D1. The facade (east elevation) with its low-pitched hipped roof, continuing over the projecting balcony to the first floor.

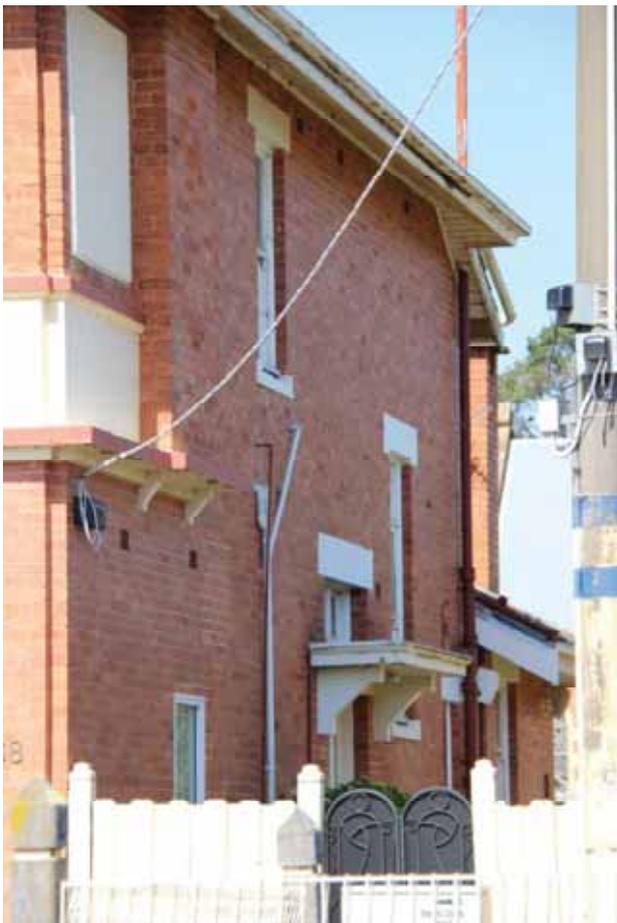
Figure D2. The south elevation with a second entrance with a porch and highlight. Note that the fence is the same as that in Figure H2.

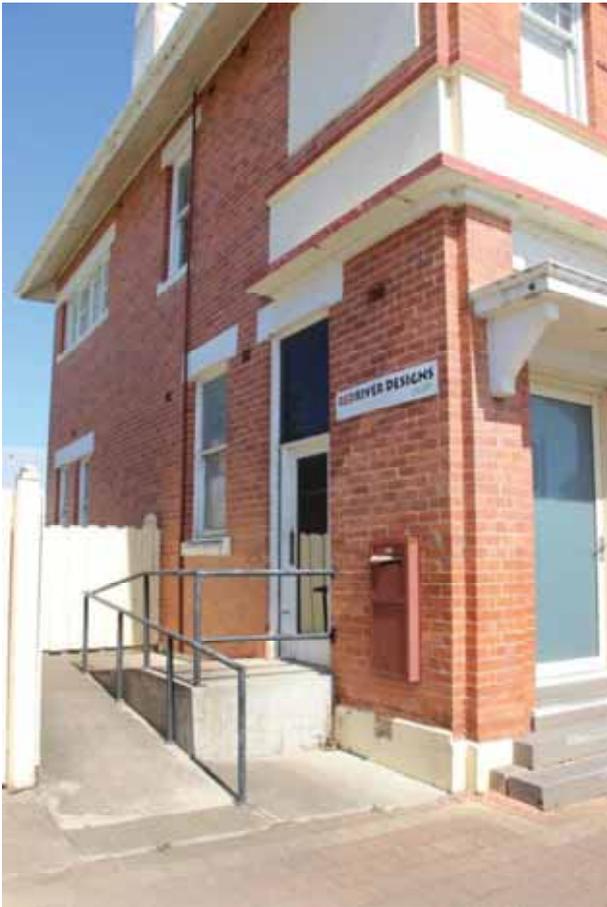
Figure D3. The north elevation with the altered entrance door, original bluestone steps, and single and grouped windows with rendered lintels and sills.

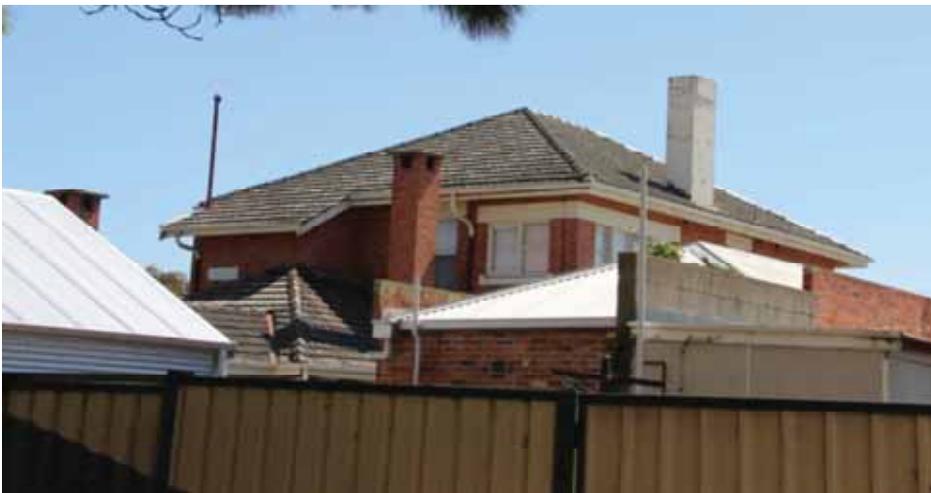
Figure D4. The rear (east) elevation

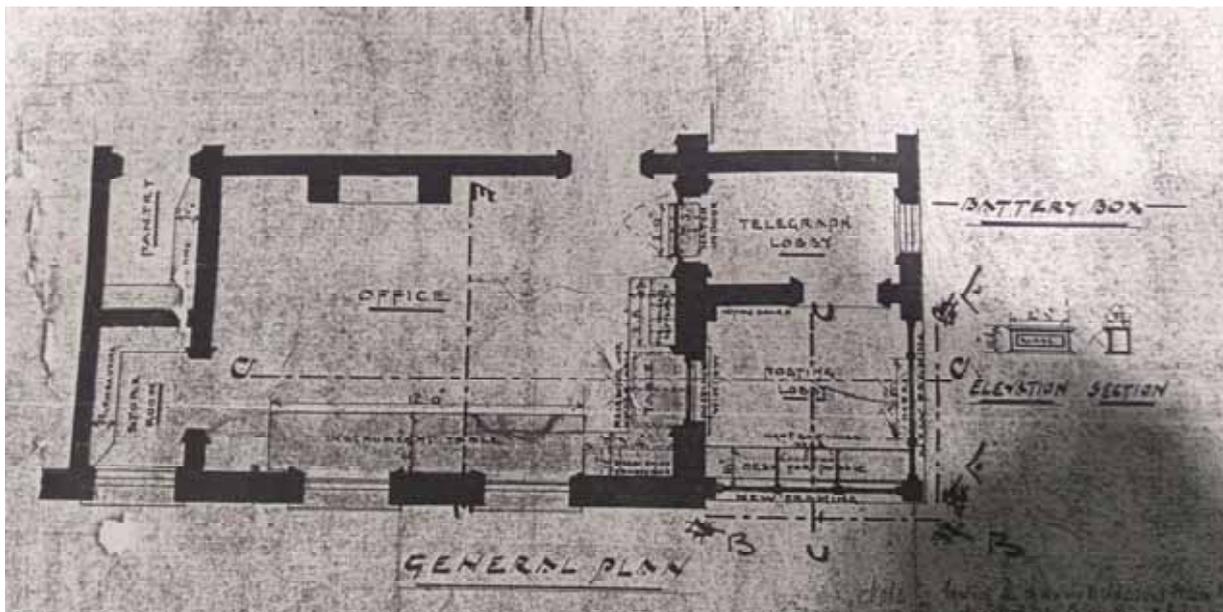
Figure H1. Floorplan dating to 1885 that showed that the original extent of the post office building, which excluded the verandah and the two projecting bays to the main elevations (built 1900) (Saleta 2016).

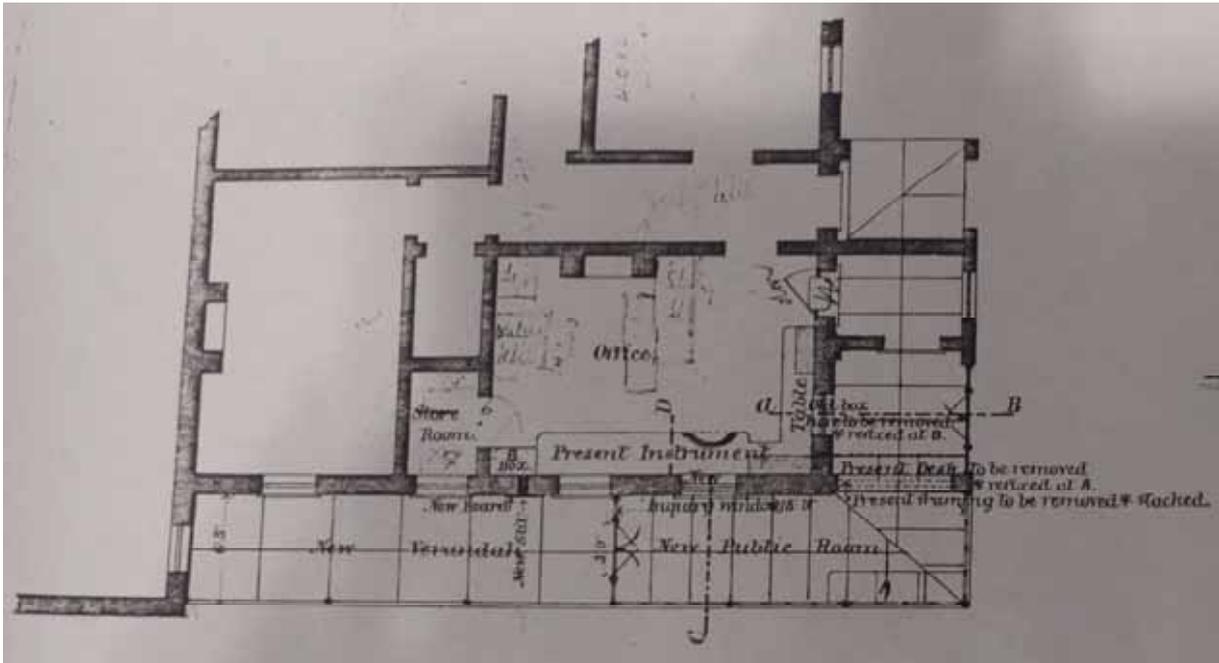
Figure H2. Plan dating to 1887 that showed a new verandah was proposed, along with a 'New Public Room' under the same roofline, along the Tyers Street facade (Saleta 2016).

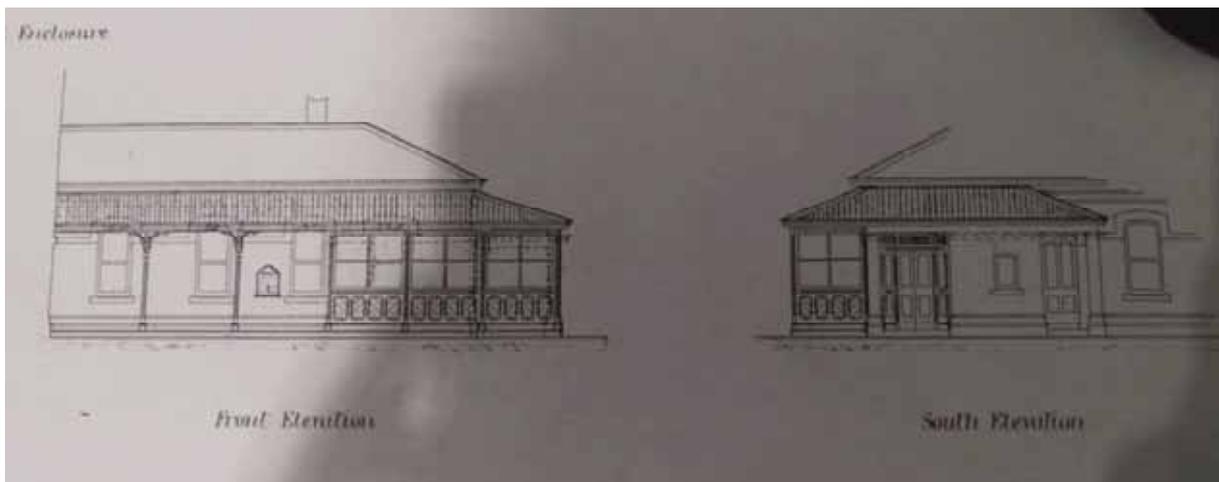
Figure H3. 1887 drawings of the facade (left) and south elevation fronting Hobson Street (right), showing the proposed new verandah construction and new 'public room' to the corner, to be built under the same roofline (Saleta 2016).
