**Locality:** STRATFORD  
**Place address:** 17 HOBSON STREET  
**Citation date** 2016  
**Place type (when built):** Mechanics Institute and Free Library  
**Recommended heritage protection:** Local government level  
Local Planning Scheme: Yes  
Vic Heritage Register: No  
Heritage Inventory (Archaeological): No

**Place name:** Mechanics Institute and Boer Memorial Plaque

**Architectural Style:** Federation Free Classical  
**Designer / Architect:** Edgar J. Henderson  
**Construction Date:** 1890

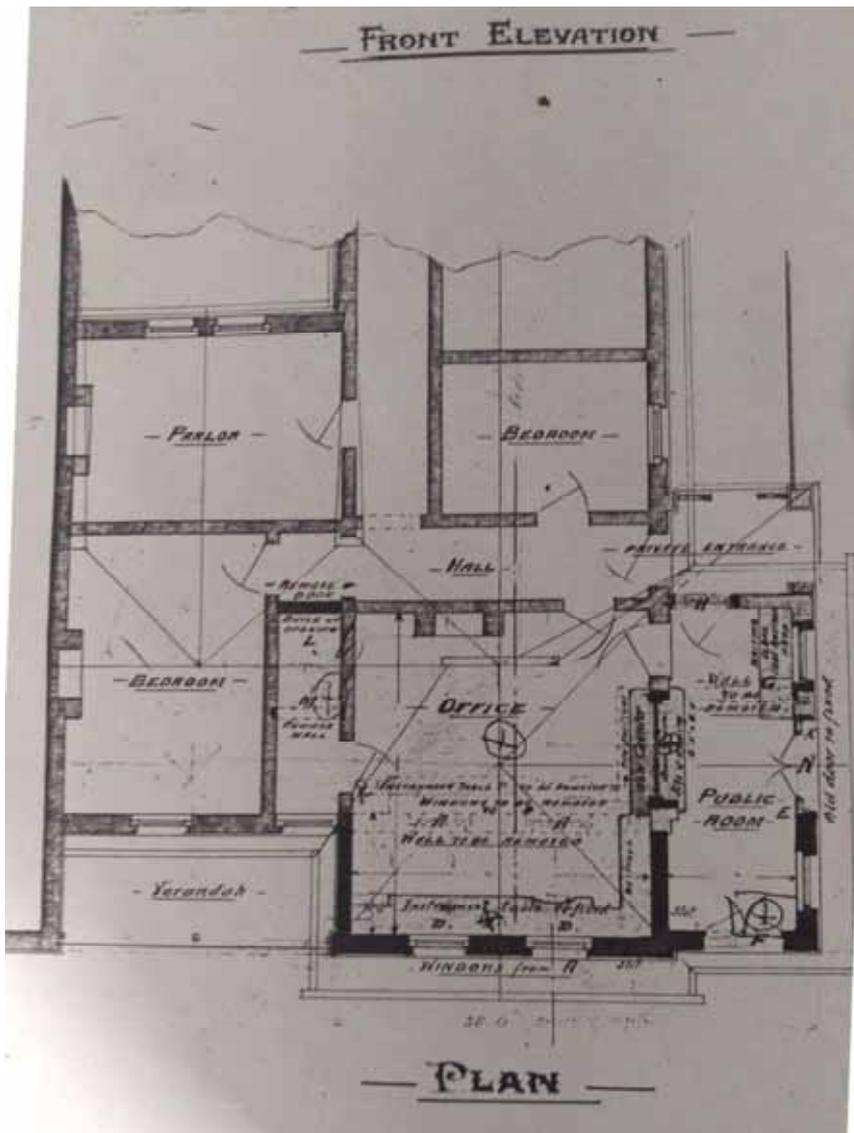
Figure H5. Plan dating to 1899, showing the proposed extension to the office space and public room, to form the two gabled-bays (Saleta 2016).

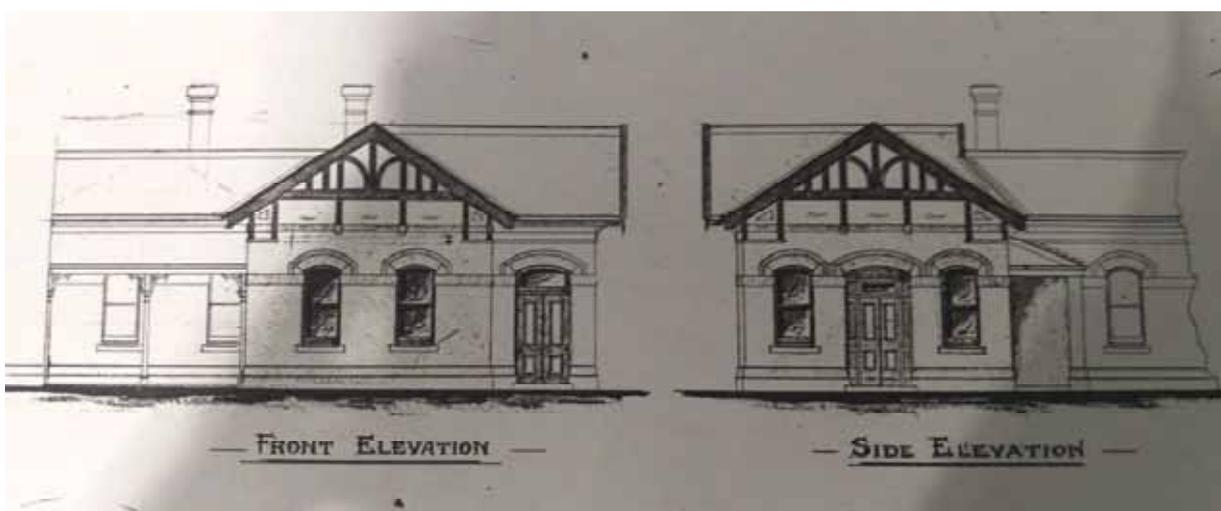
Figure H6. 1899 drawings of the proposed new gabled-bays to Tyers and Hobson streets, with their taller roof forms (Saleta 2016).

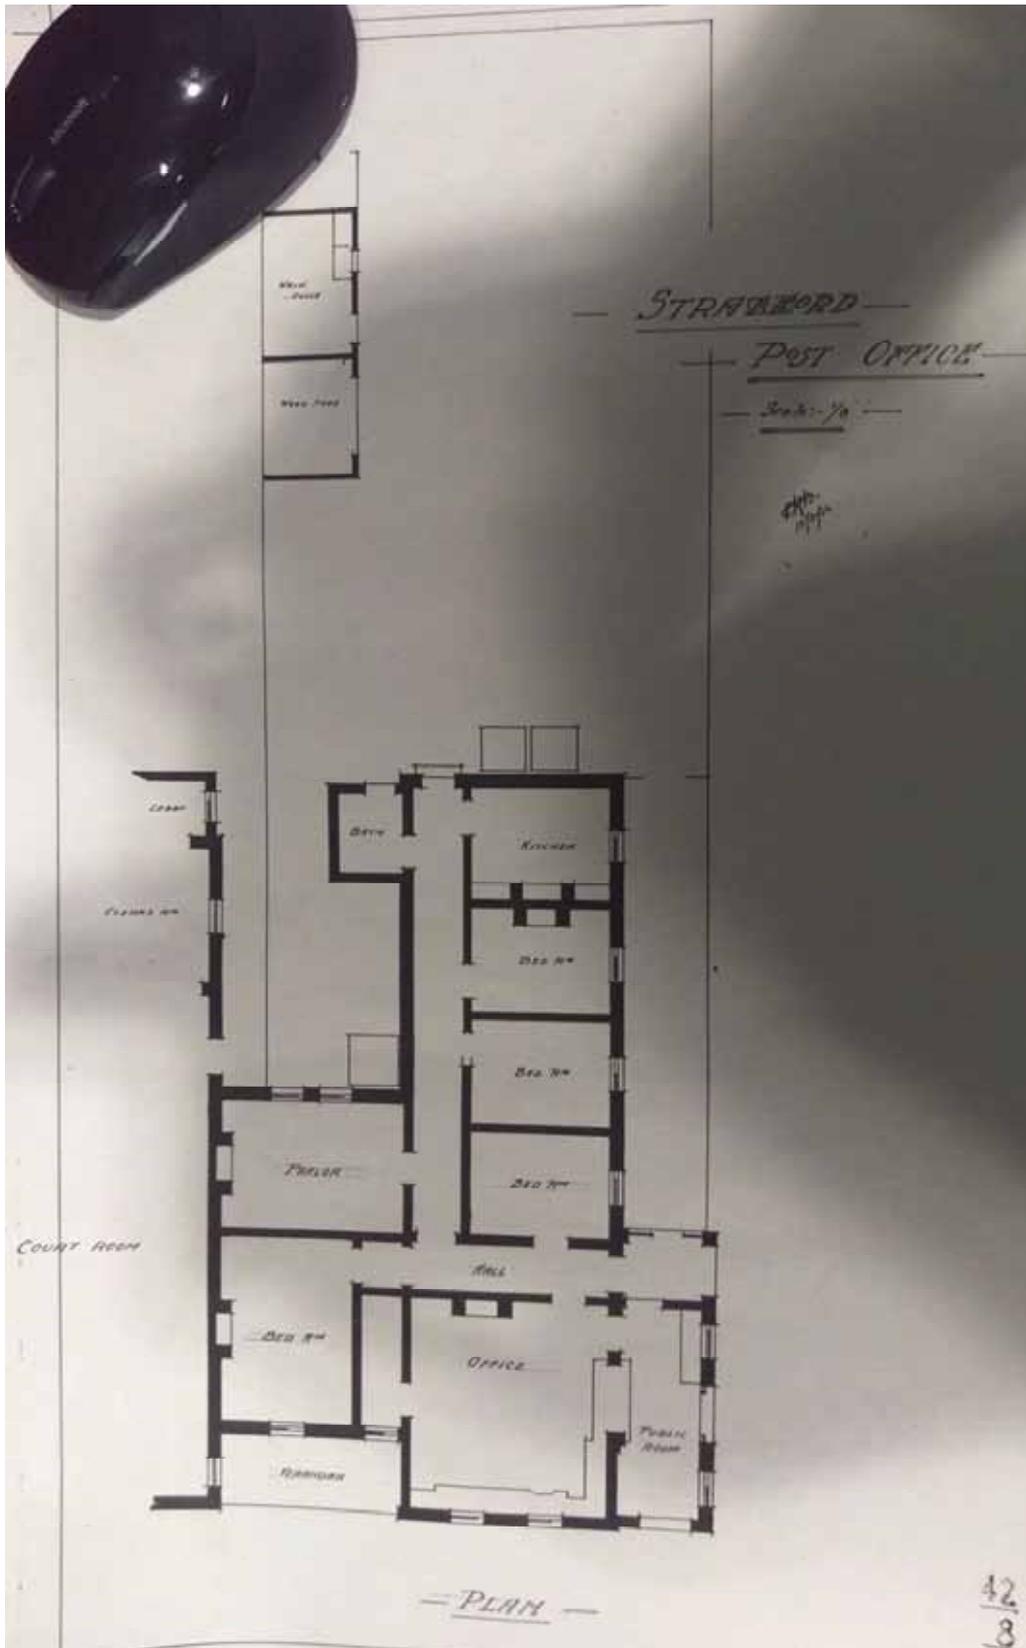
Figure H7. Plans dating to 1916 that showed the plan of the post office after the c1900 additions to the office and public room (Saleta 2016).

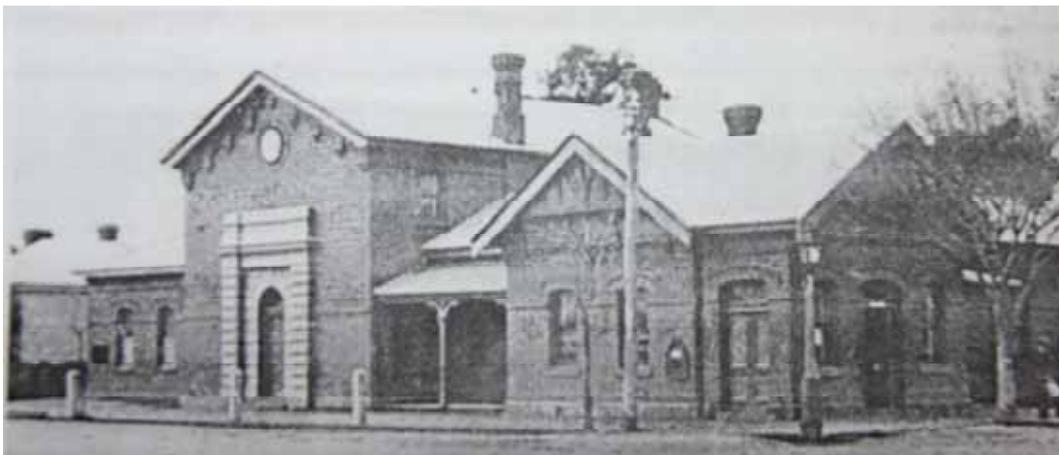
Figure H9. Photo dating to 1906, showing the facade of the post office, court house and Council chambers and picturesque skyline. Note all the roofs are unpainted galvanised corrugated iron, and the verandah and projecting gabled bays of the post office (SDHS).

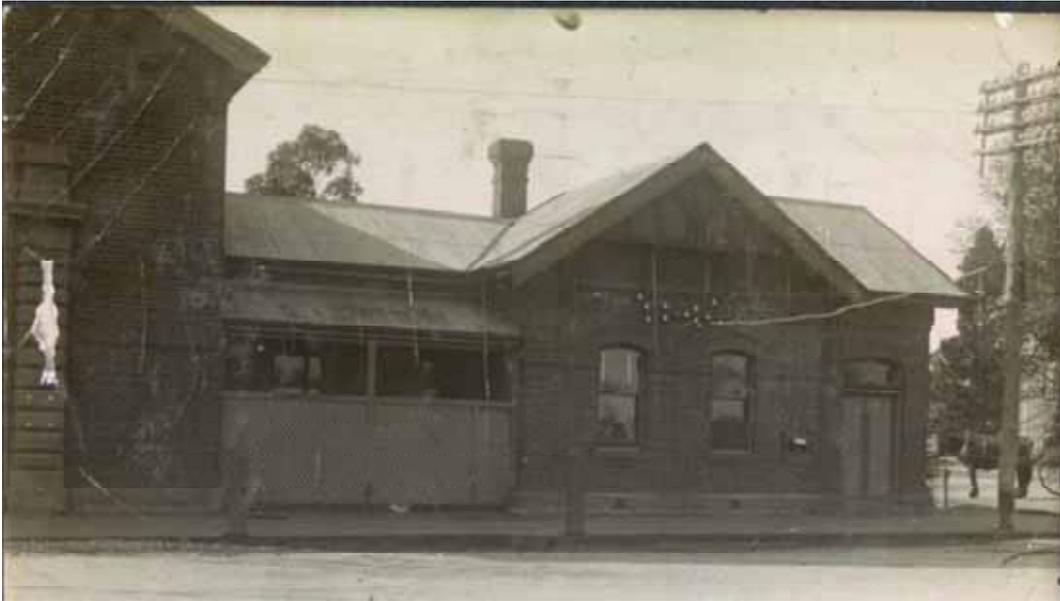
Figure H11. Photo dating to 1917. The timber brackets had been removed from the verandah between the post office and court house, and the space partially enclosed by a trellis (SLV).

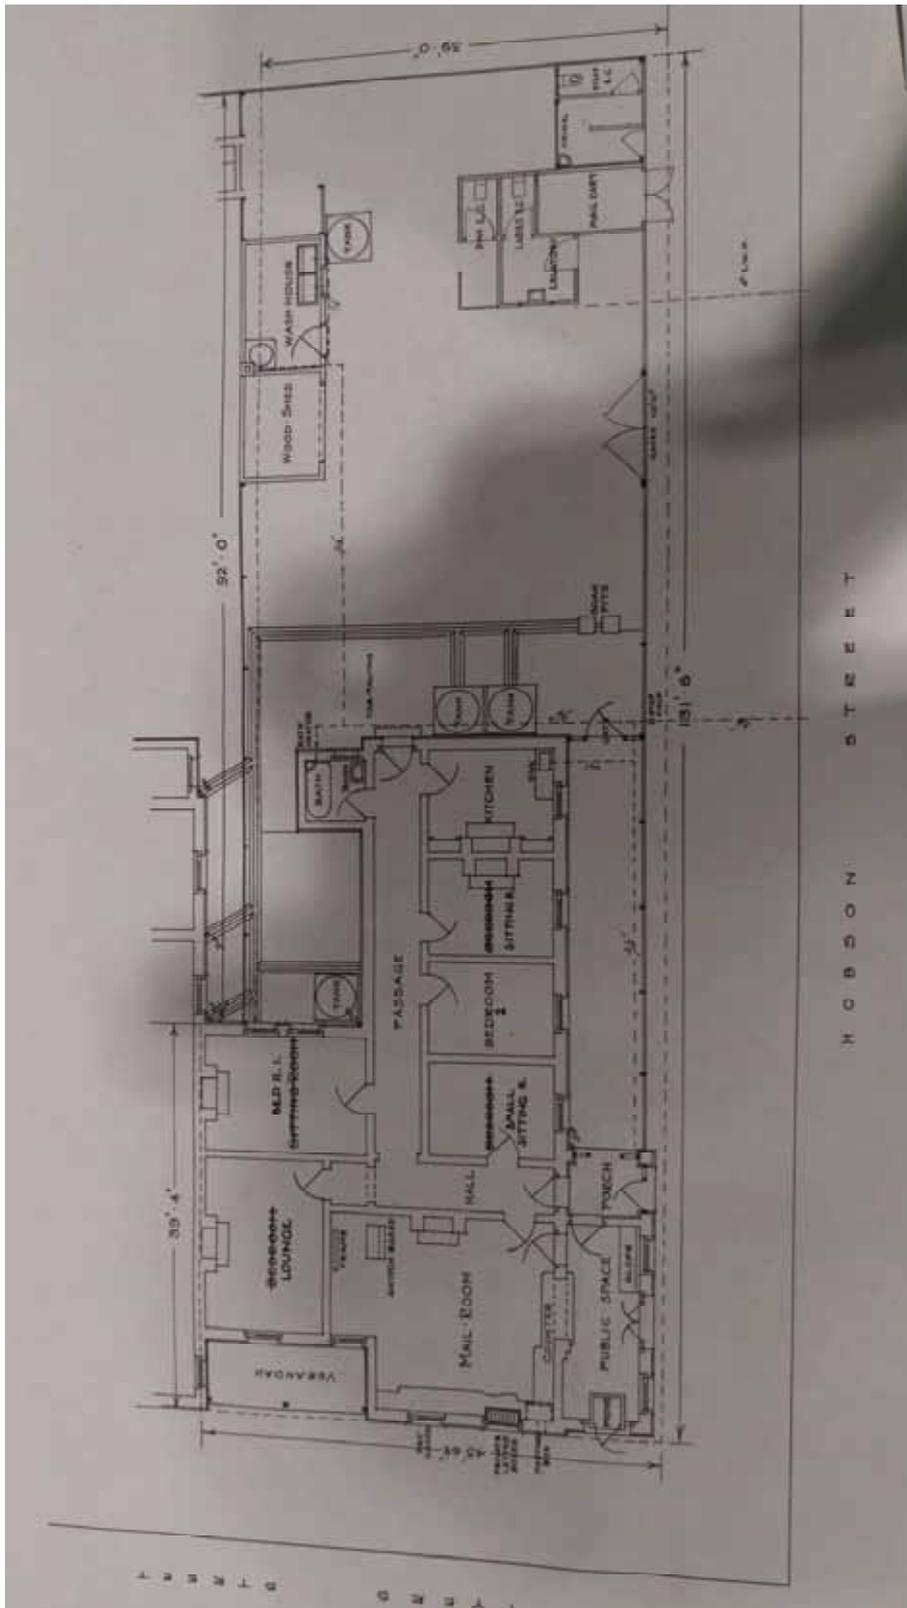
Figure H17. Plan dating to 1952 showing the extent of the post office building and use at this date (Saleta 2016).

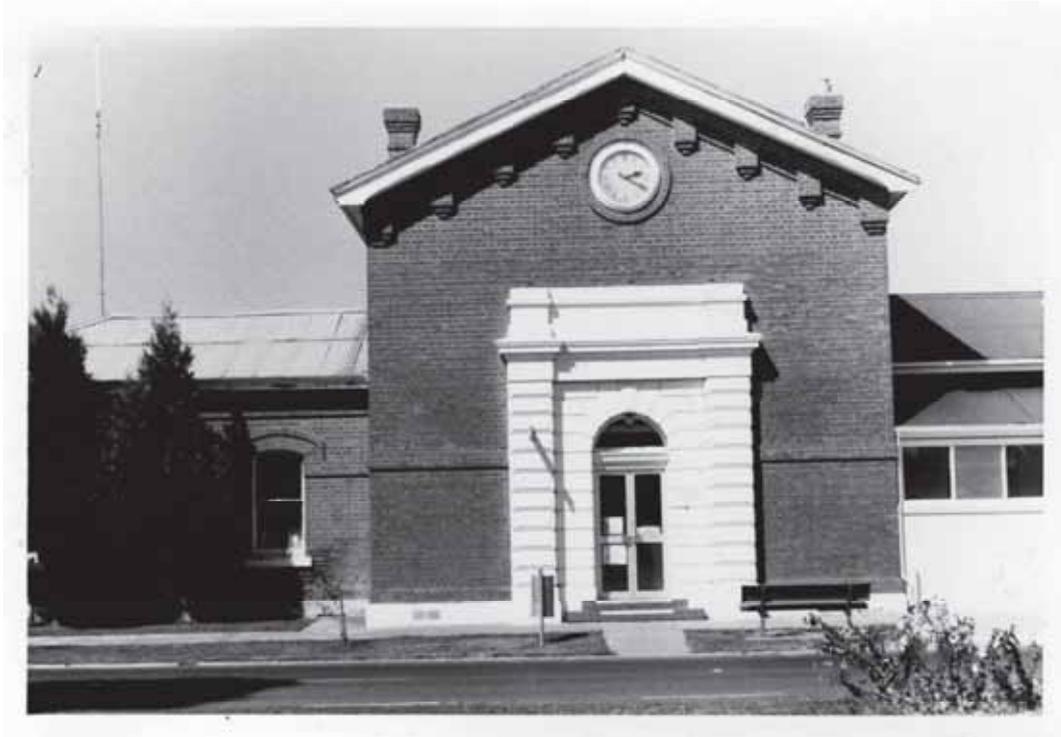
Figure H18. The facade in 1984. The verandah between the court house and post office had been enclosed, with windows to the top portion (SLV).

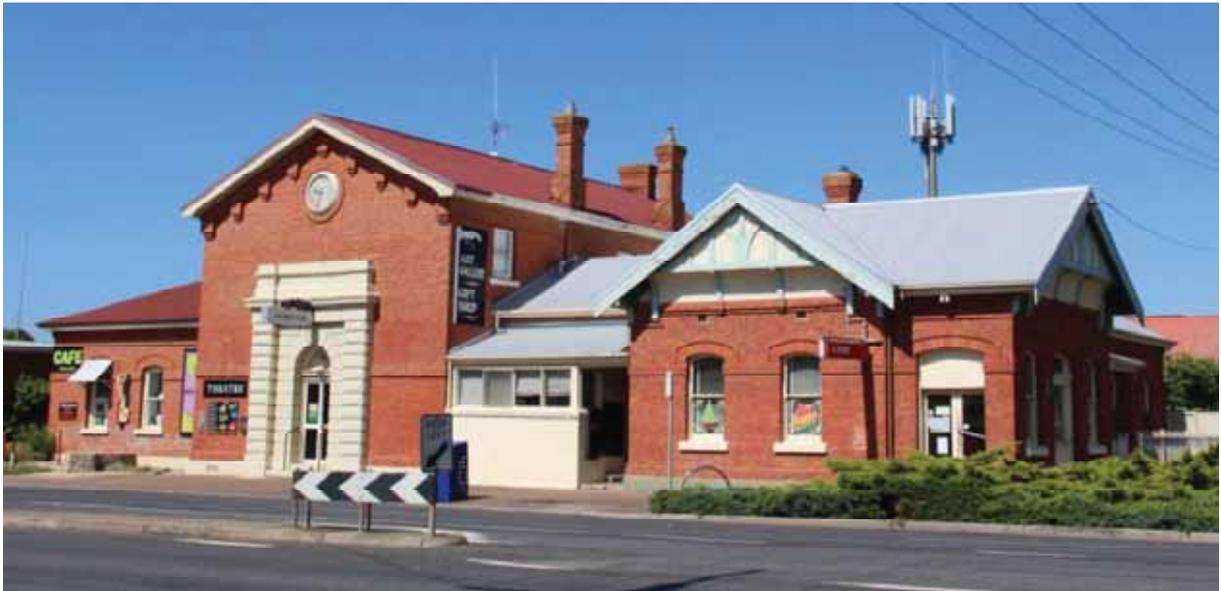
Figure D1. The main elevations of the (left to right) council chambers, two-storey court house and post office with the attached residence to the rear. Stylistically, the buildings are tied together by corbelled courses of brickwork that run horizontally below the eaves and at the tops of the windows, extending over the voussours of each window.

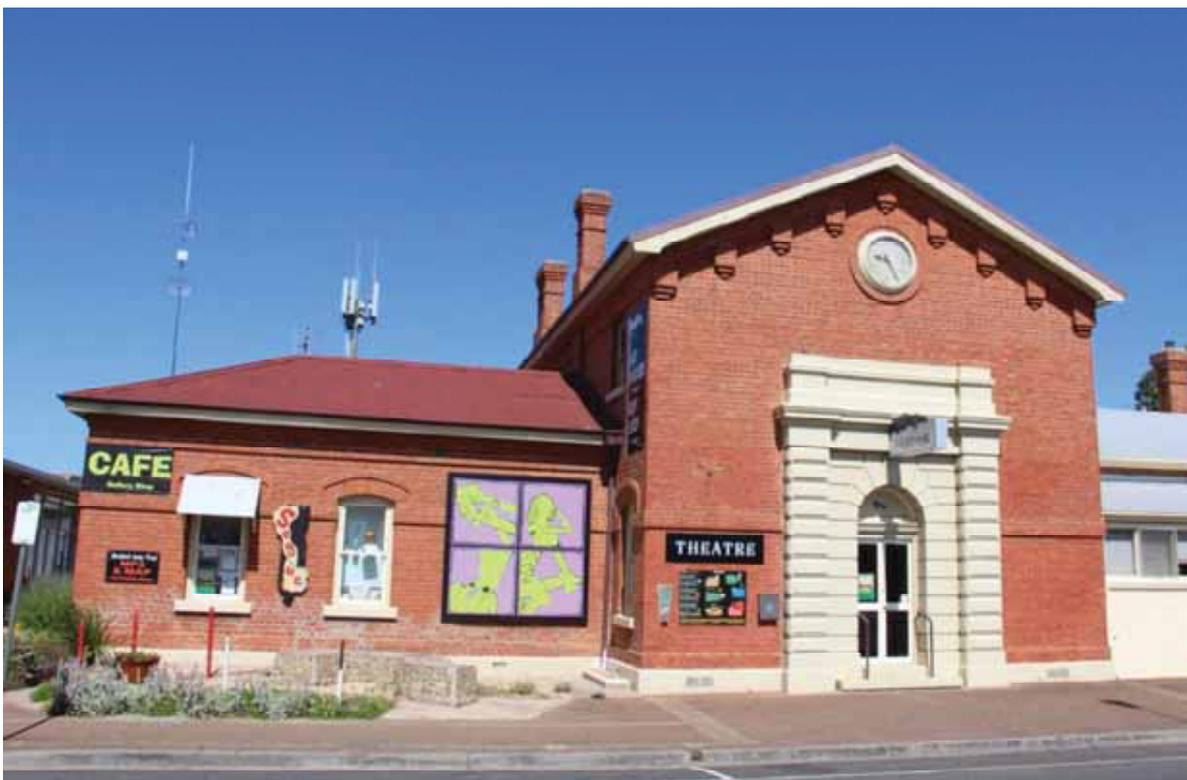
Figure D2. The council chambers (left) and the two-storey court house with the dominant Classical portico, clock and bold corbelled brackets to the eaves.

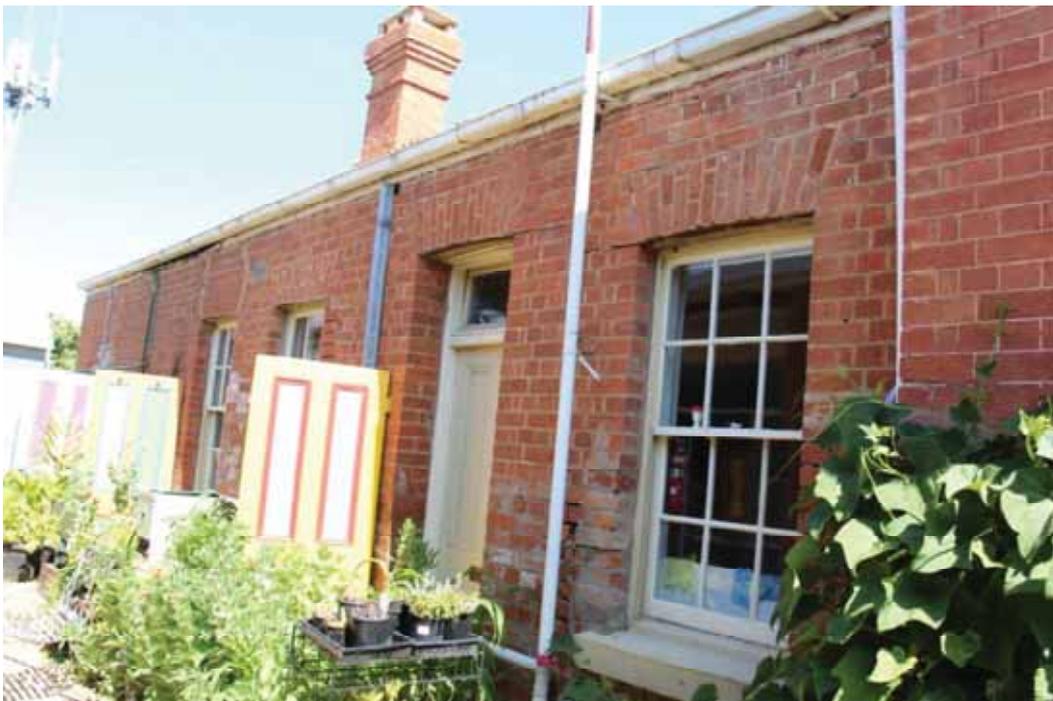
Figure D4. The north elevation of the council chambers, towards the rear, with its six-over-six timber windows.

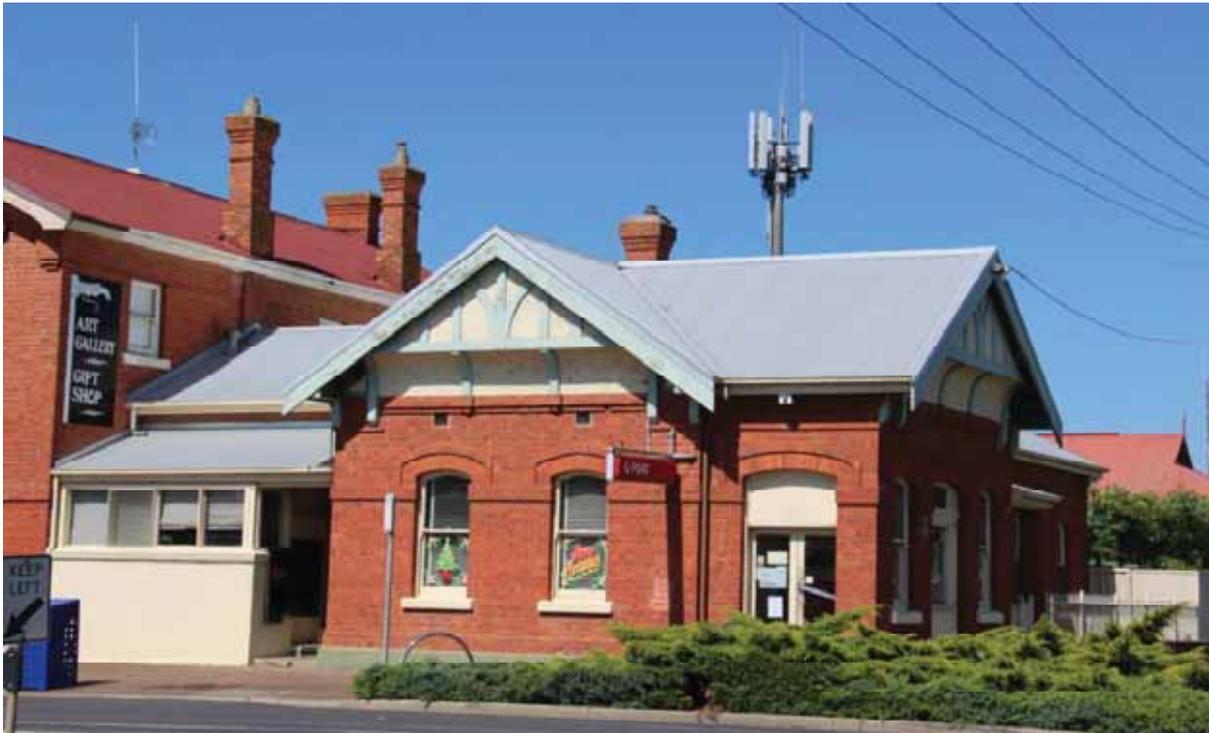
Figure D5. The main elevations of the post office, and the verandah to the left (with later in-fill). The two jettied gabled-ends have roughcast render and timber strapping, creating a half-timbering effect. Note the historic picturesque skyline of roofs and chimneys.

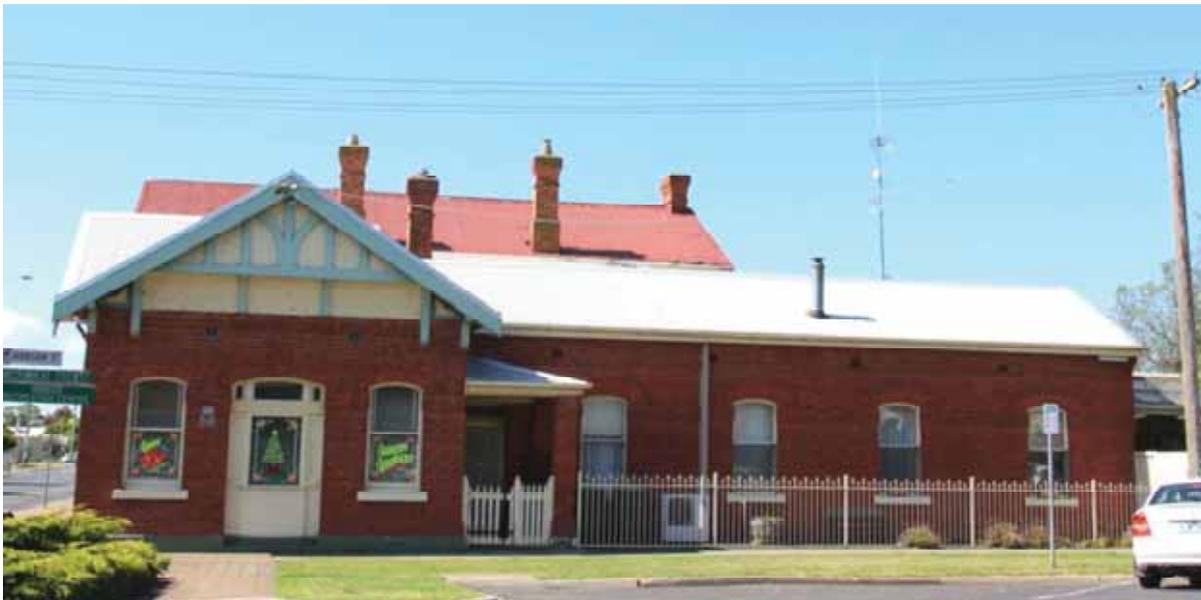
Figure D6. The south elevation of the post office and residence to the rear. The entrance at the centre of the gabled-bay has been altered to become a window. A section of the early (possibly original) fence remains beneath the porch. Note the historic picturesque skyline of roofs and chimneys.

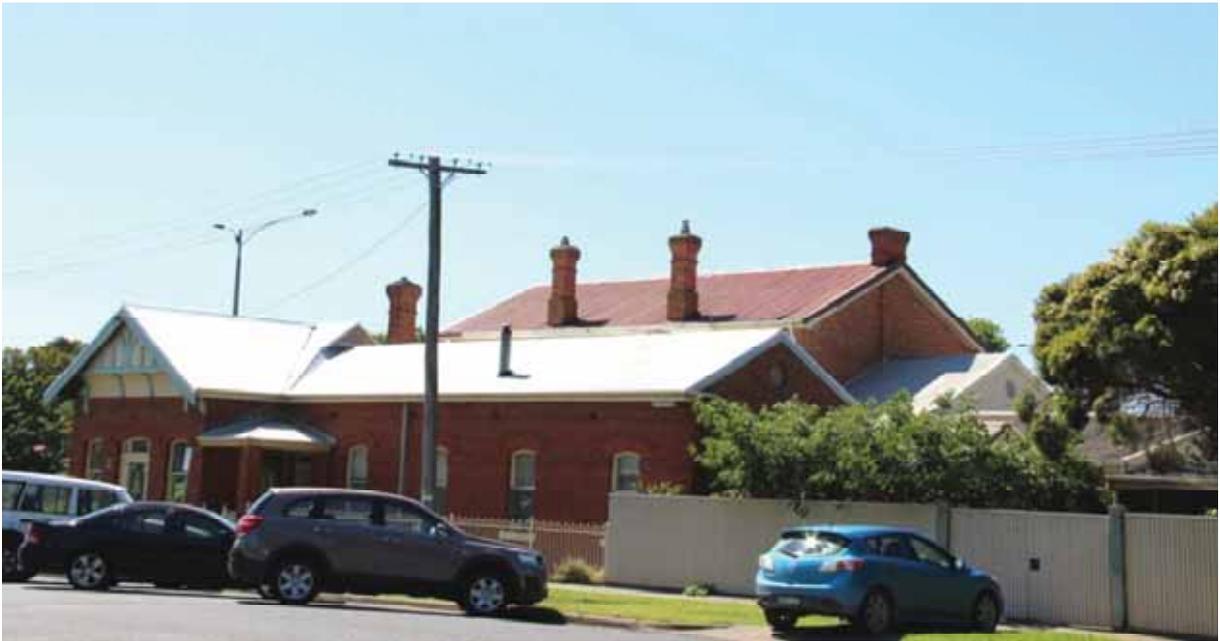
Figure D7. The rear (east) elevations and the complex of historic roofs, which are a significant feature when viewed from Hobson Street.

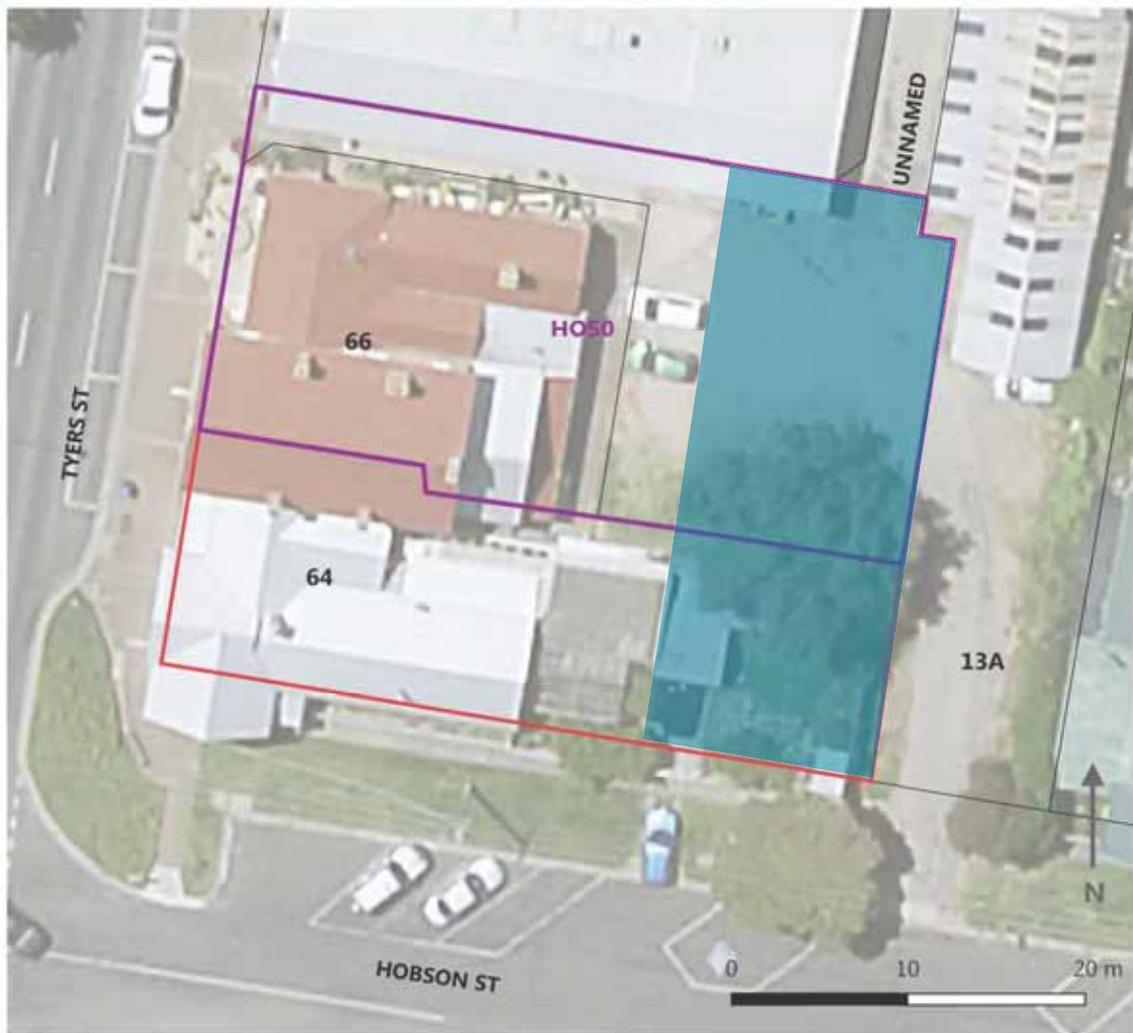
NOTE: The blue shaded area is the preferred location for additions and new development
