— Walter Prototyp

Troubleshooting and Wear Patterns

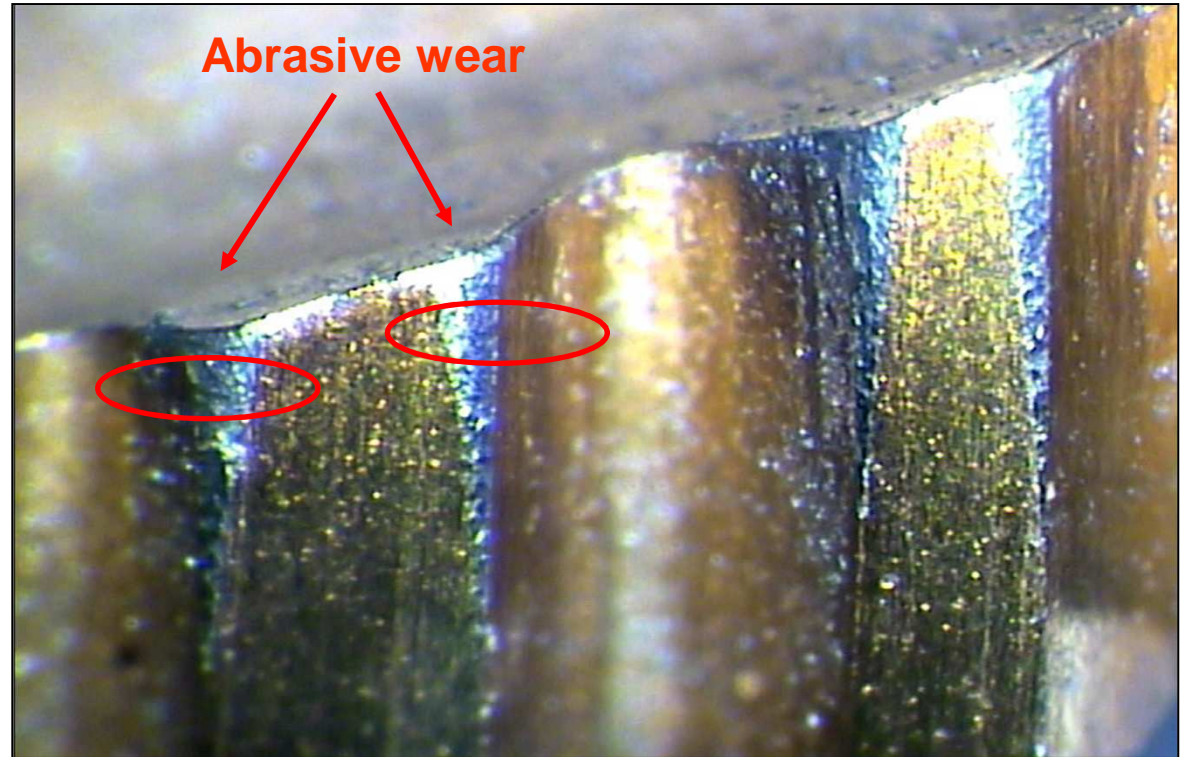
Abrasion

Cause

- Low thread relief
- Inappropriate coating or surface treatment

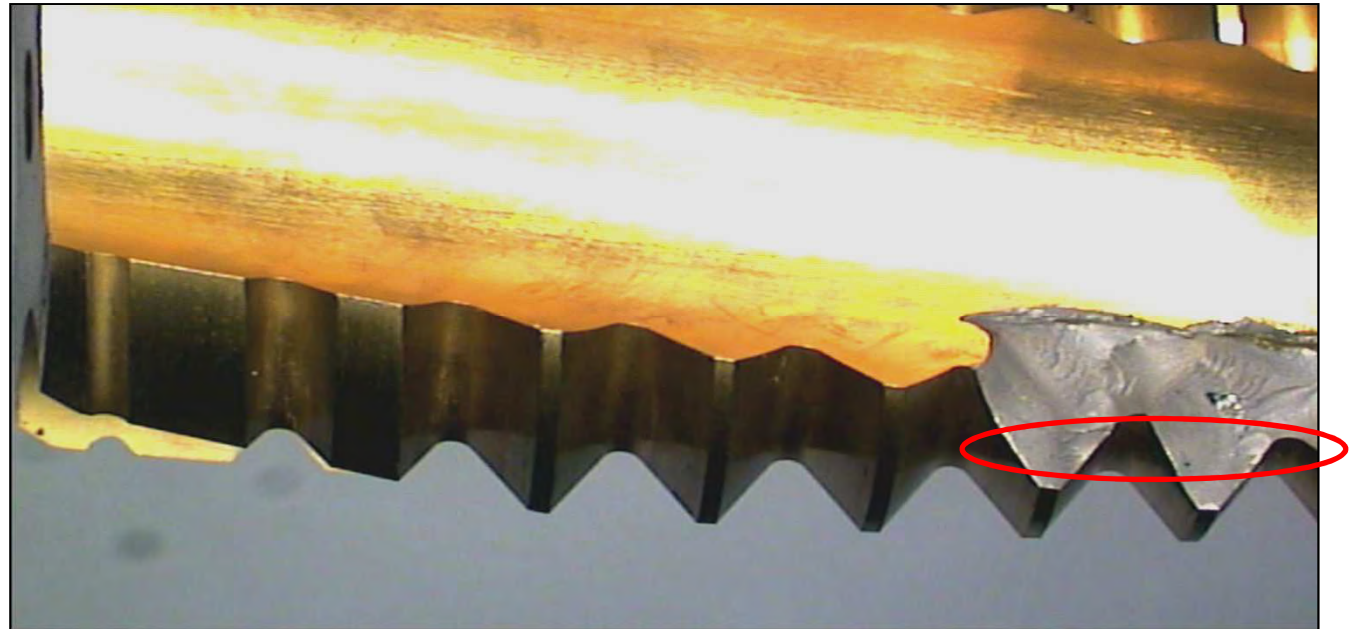
Chipping on the chamfer

Cause

- Rake angle is too positive
- High tool hardness
