This story begins when, during leak testing on a mediumvoltage transformer, the rupture disk fragments violently, causing damage to equipment 19 feet away. The GIS manufacturer investigated the causes for this and found that:

A global manufacturer of high-voltage switchgear was looking for a way to stop the rupture discs on their units bursting prematurely. They wanted the discs to be ready when needed and only burst in a real emergency. They were hampered by not being able to identify the root cause of the problem and therefore specify a disc that would burst as required every time.

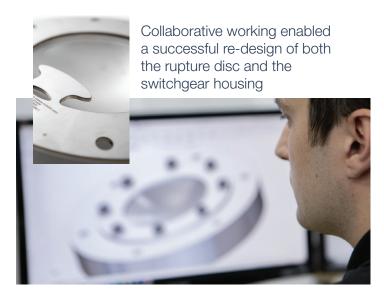
The new designs and test program confirmed the compatibility and robustness of the housing and disc interface. Since using the new designs, the manufacturer has been successfully making safe switchgear units, free from premature burst failures in outdoor conditions, for over a decade,

- The manufacturer revised their housing design process to ensure the mating surface design matched the rupture disc's interface requirements perfectly;
- Our Design Engineers modified the rupture disc's support ring design to offer more robust support;
- Together, we developed a comprehensive test program that included burst tests with the discs installed on the new housings.
