José Paulo dos Santos

Loios Convent – Renovation and Addition as a Hotel

Arraiolos, Portugal 1993–1996

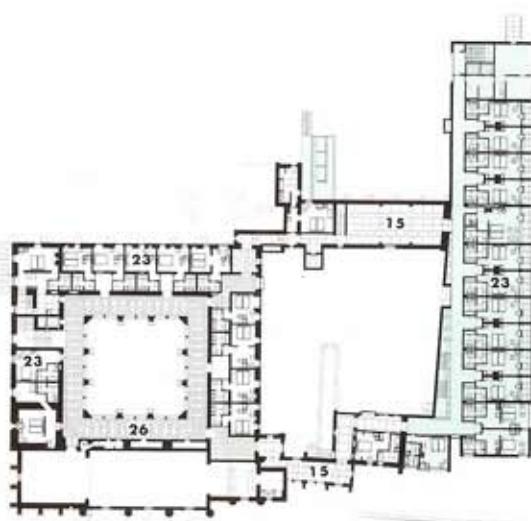
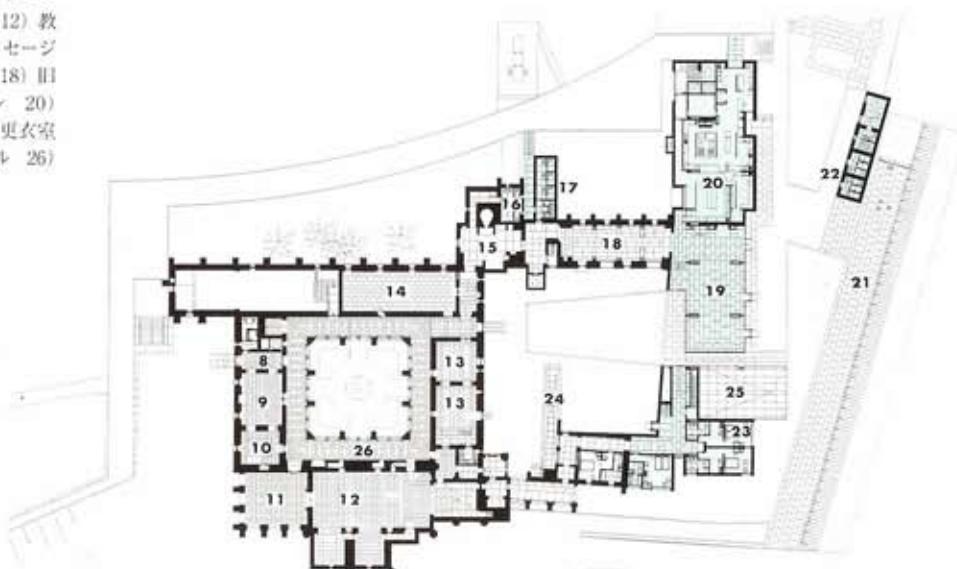
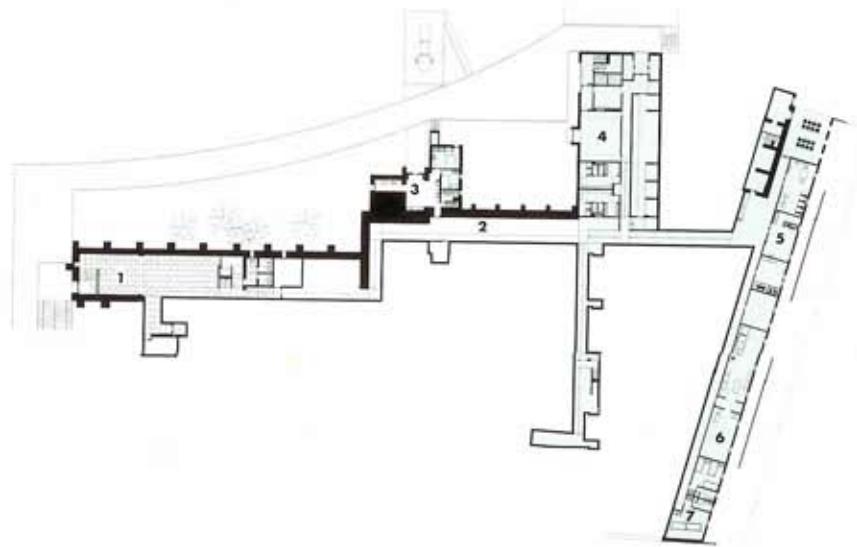
from top: 2nd floor plan, ground floor plan, basement floor plan.

blue colored areas show new additions.

から: 2階平面図、1階平面図、地階平面図
青色は新しく増築された部分を示す。

下階は、大部分が地中に埋まり、協議会やほかの目的で使用される部屋を除いては、職員用施設で占められる。

主階では、回廊、バティオ・エスプラナードの連続する外部空間の周囲に公共の空間が構成されている。

それより上の階は寝室群が収められ、その一部は旧館、残りは新館にある。

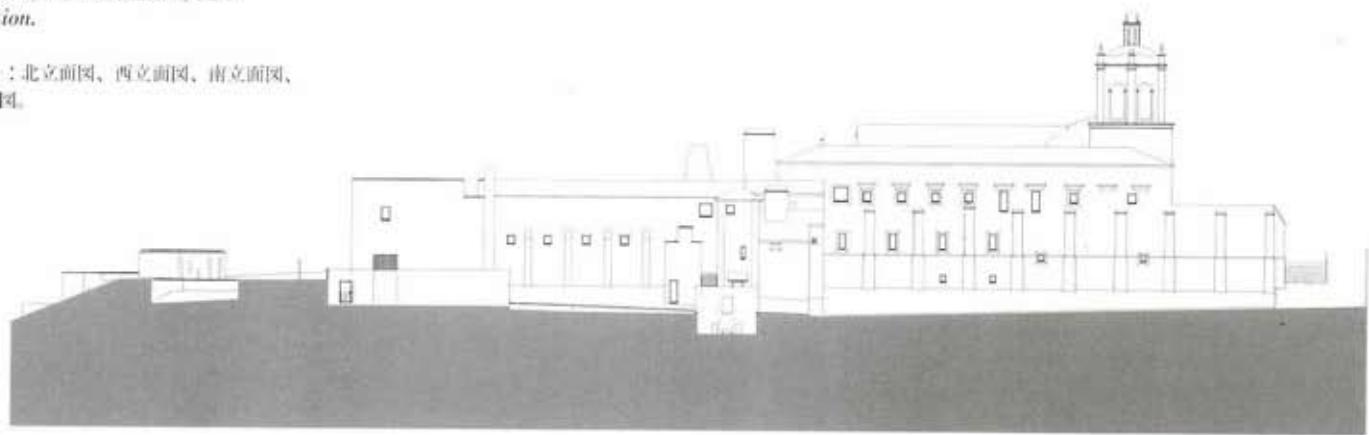
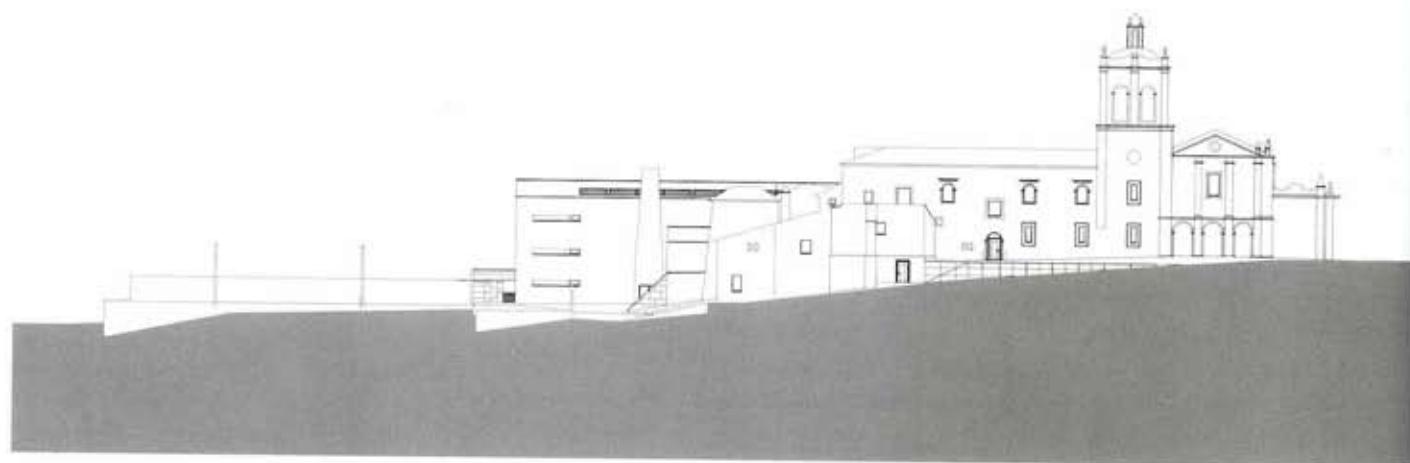
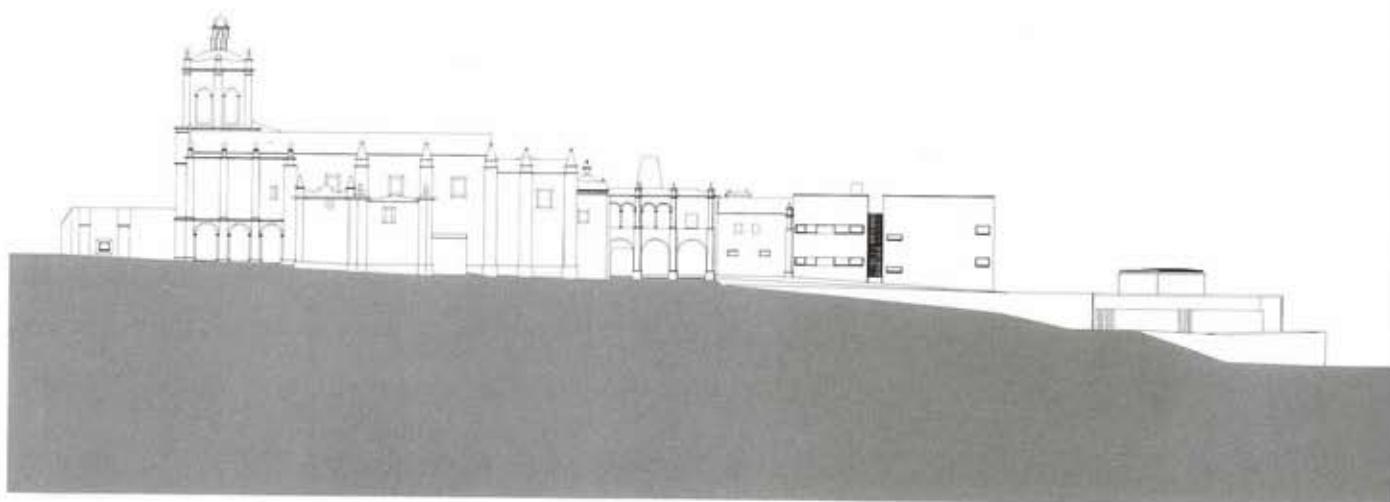
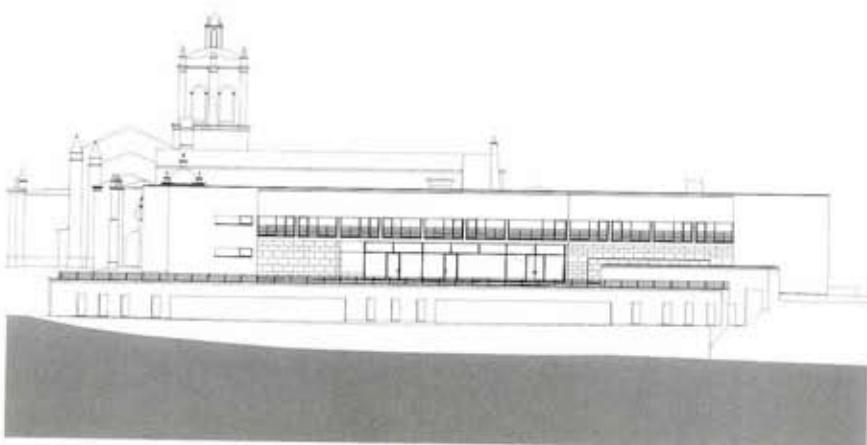
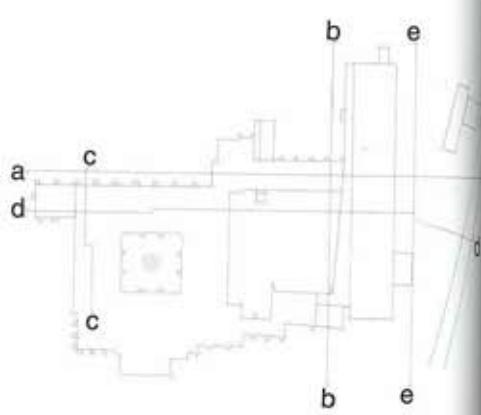
From top: North elevation, west elevation, south elevation, east elevation.

上から：北立面図、西立面図、南立面図、東立面図。

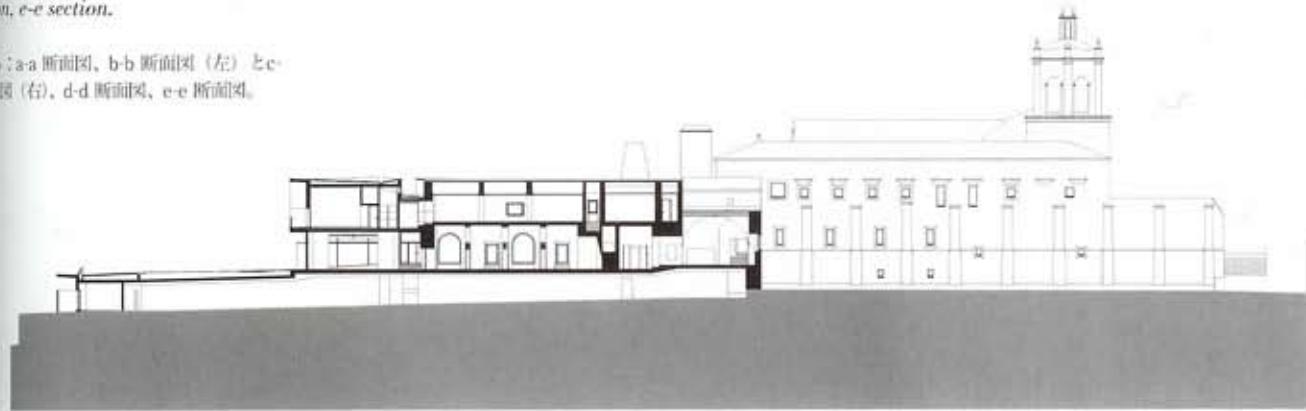
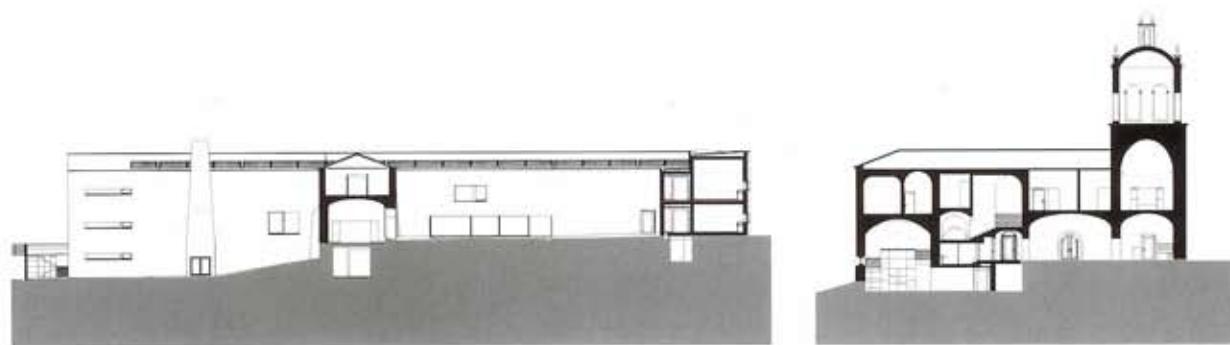
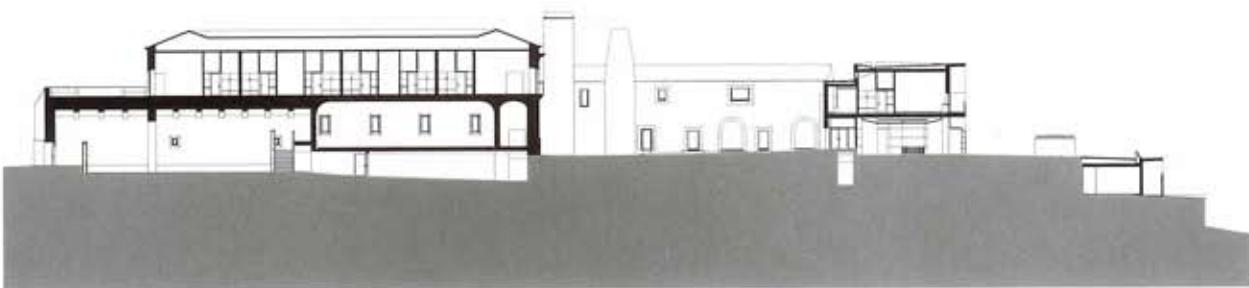
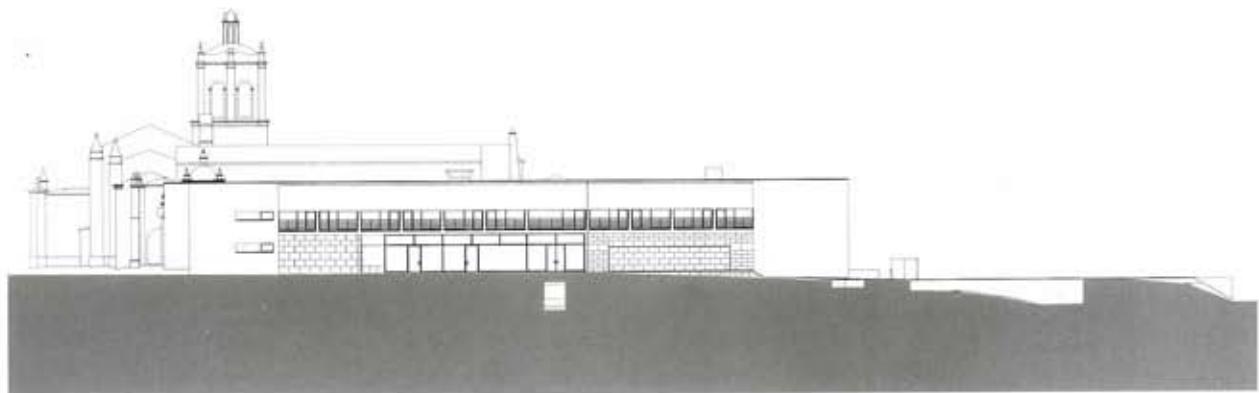
from top: a-a section, b-b section
left) and c-c section (right), d-d
section, e-e section.
