Seventeen-Year-Old High School Student Working as a Warehouse Laborer in Work-Based Learning Program Dies After Forklift Tips Over and Crushes Him - Tennessee

NIOSH In-house FACE Report 2004-03

July 23, 2004

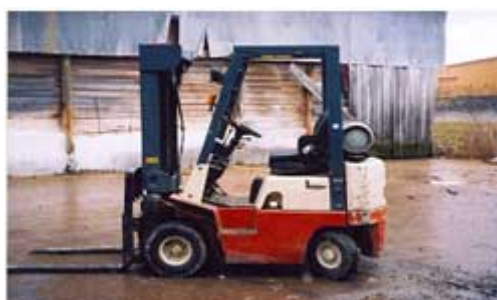
Photo 1. This photo illustrates the forklift used on the day of the incident.

Equipment: The sit-down type 2-ton propane powered forklift ([Photo 1](#)) had been purchased new by the company. It was approximately 2 years old and was equipped with a seat belt and a rollover protective structure (ROPS). The forklift had pneumatic tires and lifting capacity of approximately 3,000 pounds. The manufacturer's operator's manual was located in a pocket behind the operator's seat. The equipment dealer inspected the forklift following the incident and determined that it was in good working order.

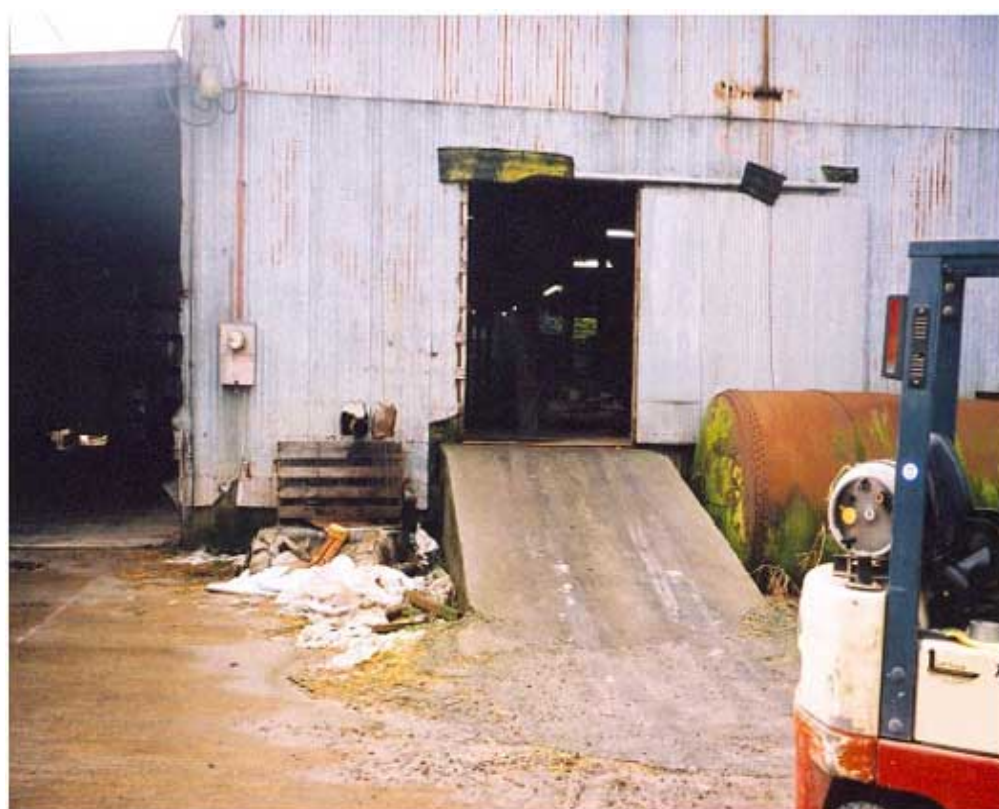
The ramp had an 18.6% grade. It measured 7-foot $\frac{1}{4}$ inches wide, 39 $\frac{1}{2}$ inches high at its point of entry into the warehouse, and 18 feet long ([Photos 2](#) and [3](#)). The entrance/exit of the warehouse was narrow, measuring 70 inches in width. However, a post and an abandoned grain feed dispersal bin located inside left just enough room for the forklift to pass through. Old scrape marks on the forklift and on the post and grain bin inside the warehouse in the only area where the forklift could pass through may be indicative of the tight fit. The local manager said that forklift operators had to speed up to make it up the ramp and then had to slow down at the entrance to fit through the narrow passage after passing through the warehouse door. The ramp's surface was patched and rough where the ramp joined the flat. level parking lot. The local manager

Photo 2. This photo illustrates a close-up of the ramp to the warehouse.

Discussion: Employers should perform an assessment of the travel routes used by forklift operators, including warehouse access/exits, ramp design, the condition of the concrete at the end of the ramp, and the parking lot over which forklifts must travel. According to Swartz² "Operating environments that include railroad tracks, rough pavement, holes in the roadway, uneven surfaces, ramps, grades, or other less than desirable features can be dangerous."

Improving travel surfaces to make them less rough, making access ways wider, and requiring truck drivers to move trucks after off-loading would improve travel pathways for forklift operators. Employers should also consider marking a route with yellow paint that provides forklift operators with guidance regarding specified pathways and appropriate turn radiuses. Employers should also consider posting signs warning forklift operators to drive at slow speed and to use their seat belts. A sign should also be posted warning truck drivers to park their vehicles away from forklift travel routes.

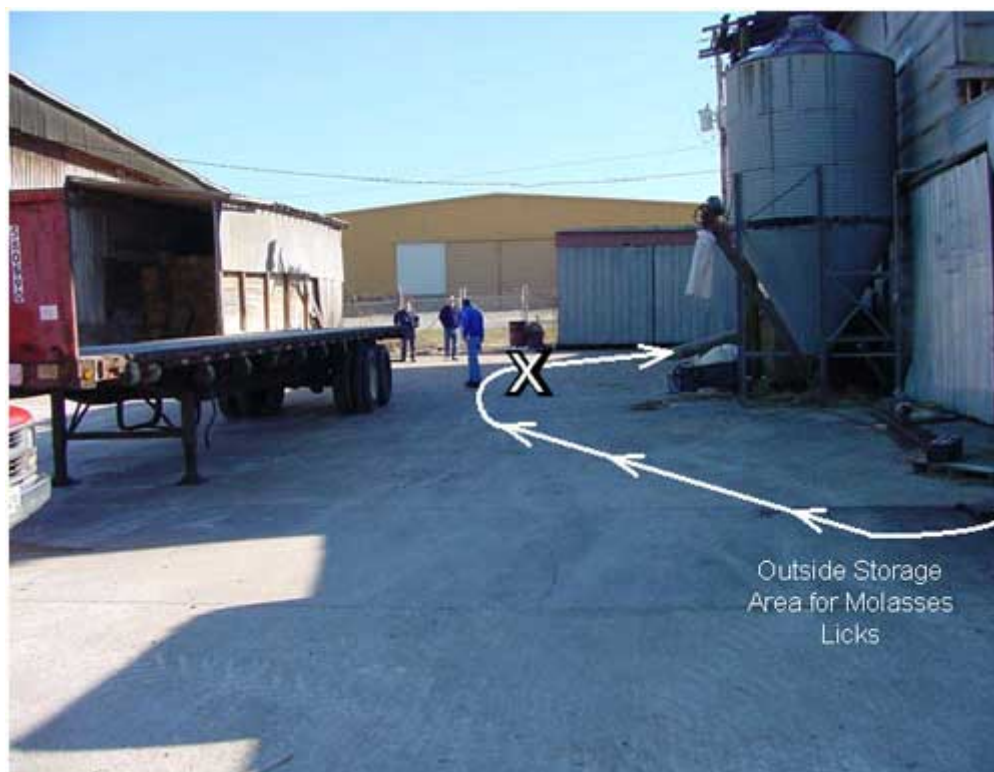
The DSR investigator examined the site on February 3, 2004. Based on information obtained from the local manager, photographs taken the day of the incident, and measurements taken at the site, it appeared that the victim was traveling toward the warehouse ramp on a level surface of the parking lot and made a sharp right turn to enter a narrow ramp leading up to the warehouse. It is surmised that this is when the forklift tipped over onto its left side. The forklift was not loaded but its forks were raised approximately 20 inches so the forks would not dig into the ramp. There was a single 12-foot skid mark located on the parking lot where it is surmised that the victim started into a right turn toward the ramp.

Photo 3. This photograph illustrates the parking lot, warehouse and ramp, and other co-op buildings. Lines on the photo approximate the travel path of the forklift on the day of the incident. An “X” marks the approximate location of the forklift that had tipped over. Photograph courtesy of the Tennessee Department of Labor and Workforce Development, Division of Occupational Safety and Health.

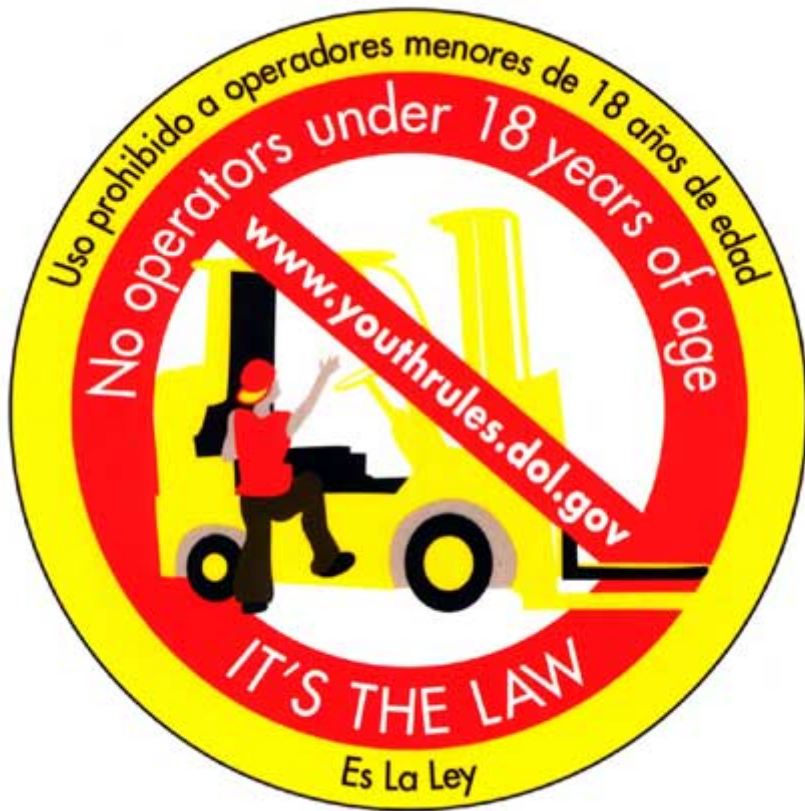
Photo 4. This photo illustrates the sticker “ NO OPERATORS UNDER 18 YEARS OF AGE. IT’S THE LAW,” which is available from the local Wage and Hour office of the U.S. Department of Labor or from the DOL web site <http://www.youthrules.dol.gov/news/posters-stickers-bookmarks/index.htm> (Link Updated 3/14/2013)

Discussion: Employers can obtain a sticker that alerts employees that young workers are not to operate forklifts. Employers can obtain stickers in English and Spanish that indicate "NO OPERATORS UNDER 18 YEARS OF AGE. IT'S THE LAW," from the local Wage and Hour Office of the U.S. Department of Labor ([Photo 4](#)). These stickers can be downloaded from the internet and should be affixed in a conspicuous place on forklifts. As an additional safety precaution, employers should ensure that keys used to operate forklifts are in the possession of only selected workers whom they have authorized and trained to operate forklifts. A supervisor should be assigned to ensure, through periodic inspections, that only authorized and trained operators are operating forklifts.
