Playa Verde Bridge | Coro Coro, Bolivia | March 2014

Products:
ShoreGuard® SG-425

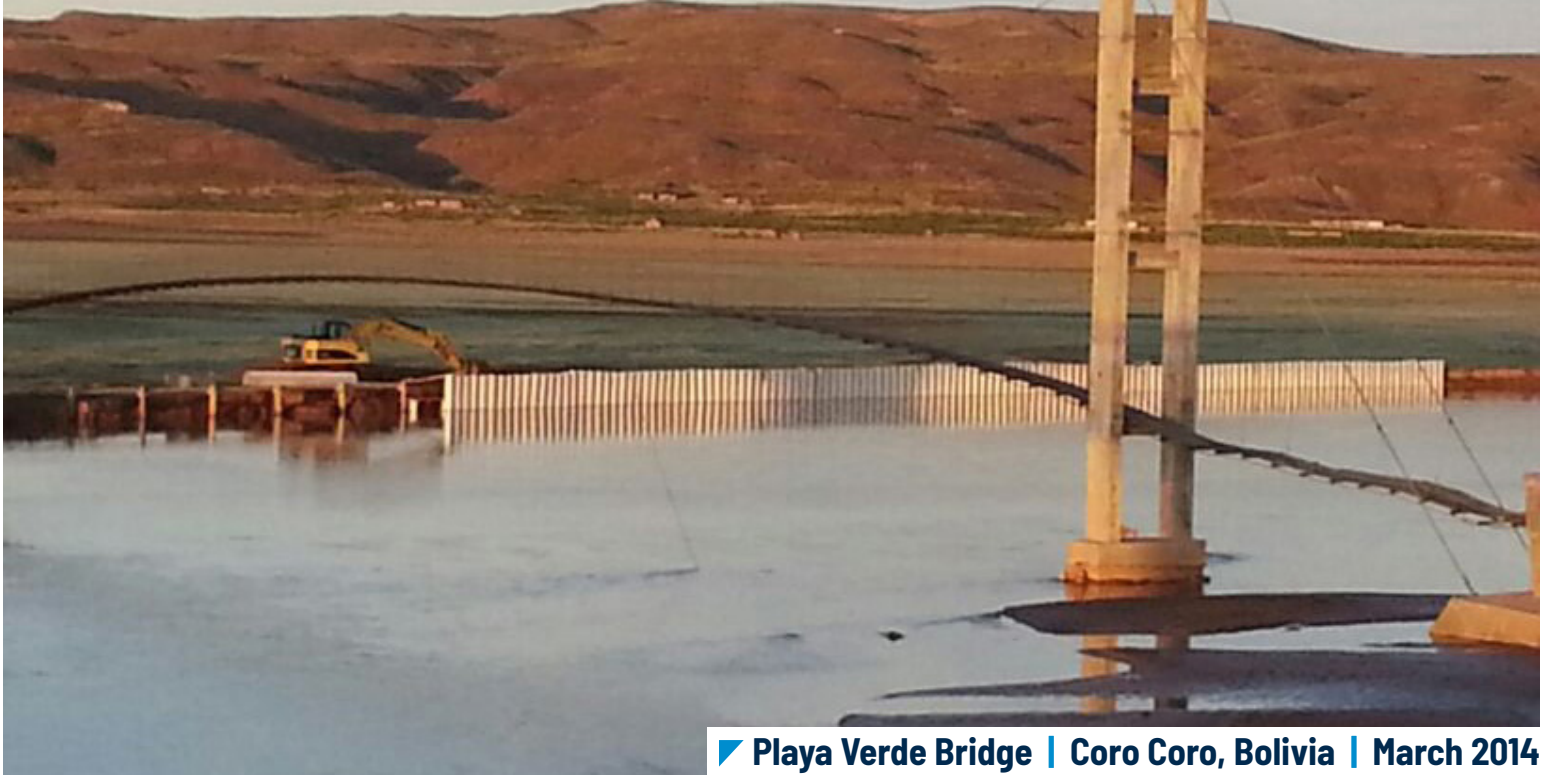
ShoreGuard®, being 83% lighter than similar steel profiles, was set and pressed in using an excavator.
