► Hunting Island State Park Groin | Hunting Island State Park, SC | Jan 2020

UltraComposite™ UC-95

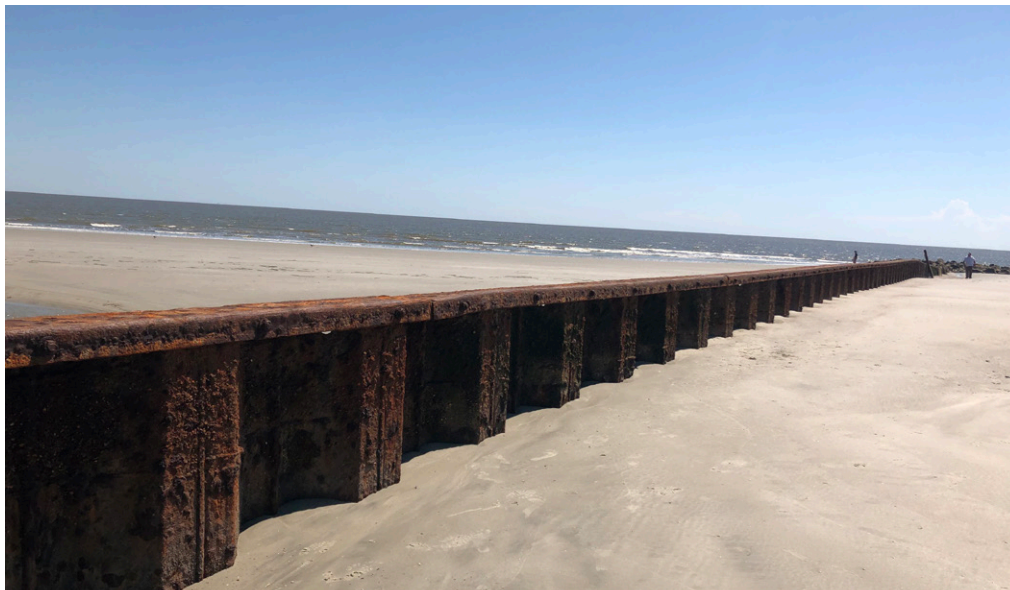
Hunting Island, a barrier island off South Carolina, has one of the highest erosion rates along the U.S. coastlines. The 5,000-acre park stretches across five miles of beach and encompasses marsh and maritime forests. It is one of the state's most popular parks with more than 1 million visitors a year. Four existing steel sheet pile groins, installed in 2007, required maintenance and a new solution due to severe corrosion and decay.

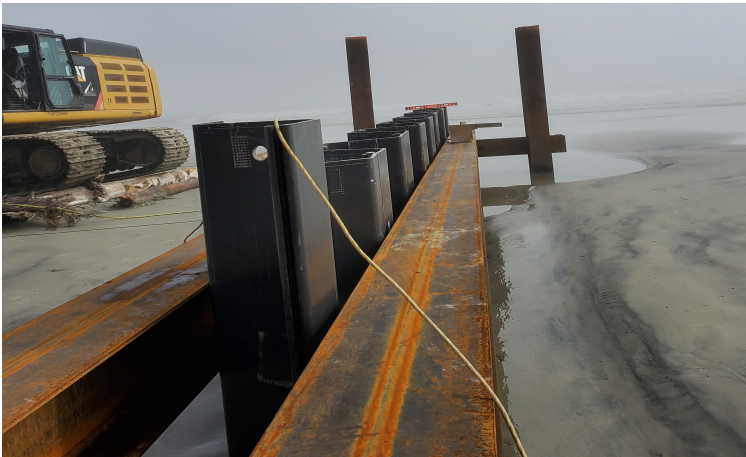
UltraComposite UC-95 sheet pile was installed in two months due to a strict schedule set to finish before the start of turtle nesting season. Simultaneously, the Beach Nourishment Project was underway. Using an excavator-mounted vibratory hammer, UC-95 sheets were driven in pairs covering 5 ft of wall. A pre-formed concrete cap was then installed. Post project completion, rock mattresses and SCDOT Class F Armor Stone were set on both sides of installed sheet pile.
