## Regency Road to Pym Street (R2P) Project

Swart & Sons were contracted to carry out painting and concrete repair works on a number of the components of this major government funded project, including the Regency Road overbridge, walkways and ramps, concrete panels and steel gantries.

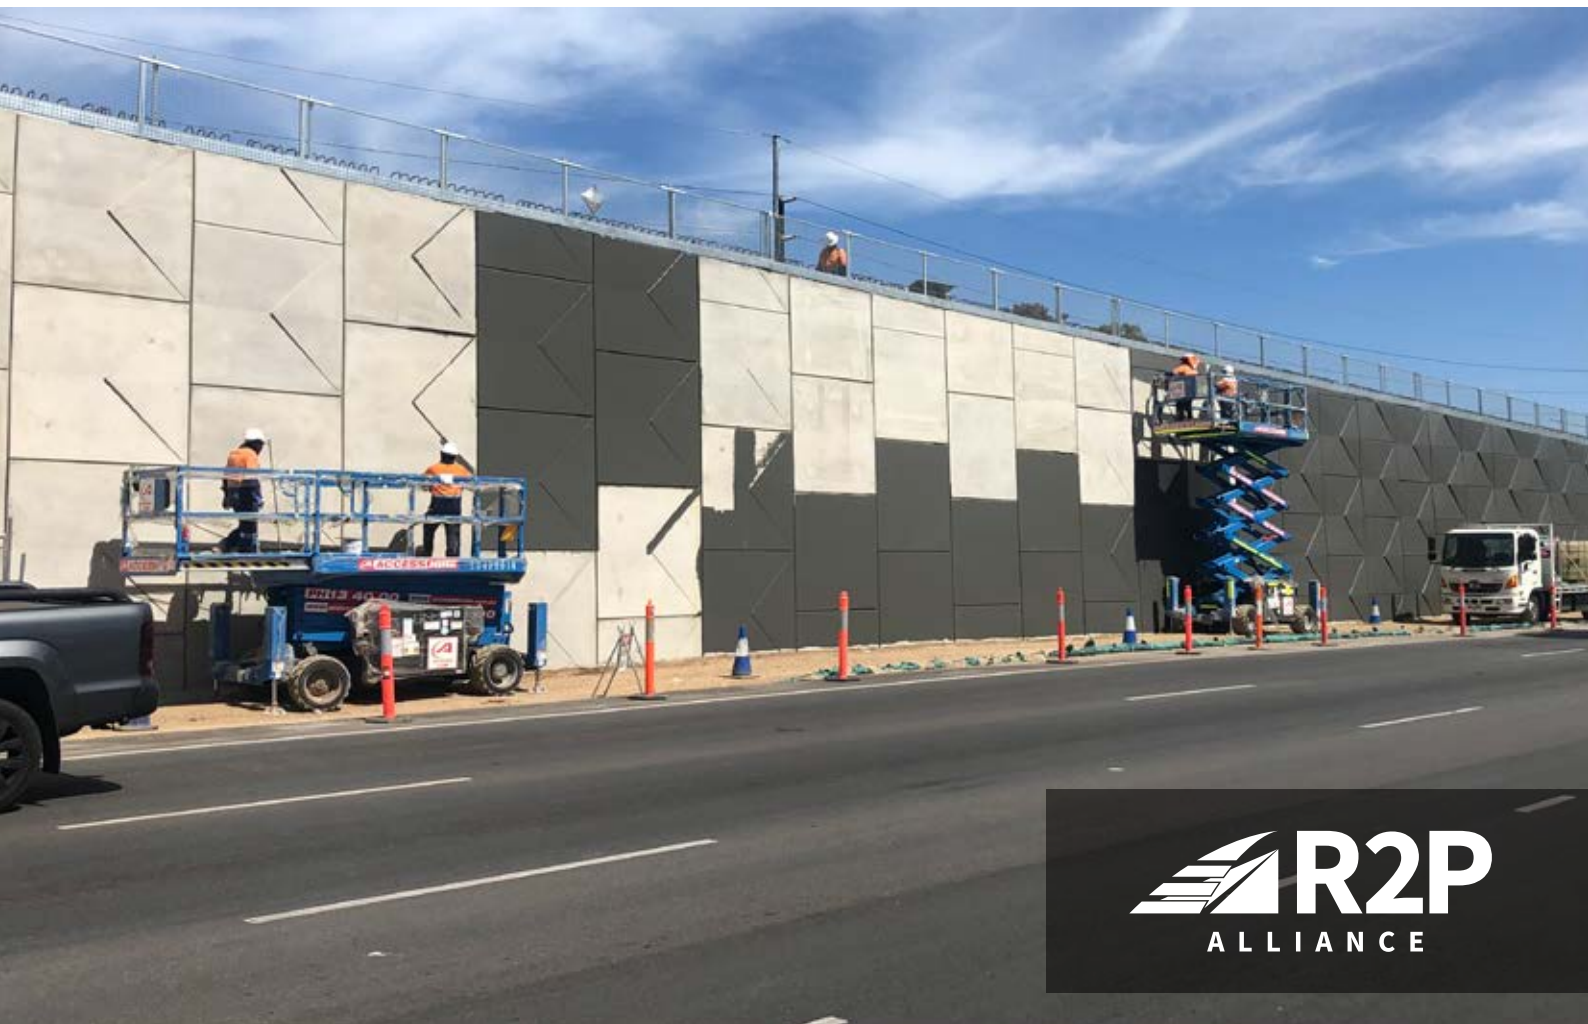
**Concrete panels on the left cleaned, moisture tested and ready for coating; panel on the right coated with WFT testing being carried out**

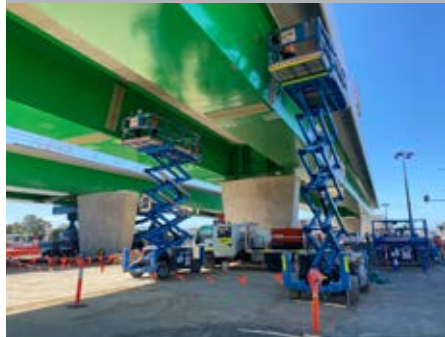
**Application of three-component protective coating system to steelwork under Regency Road overbridge (deck diaphragm, weld and splice plates)**

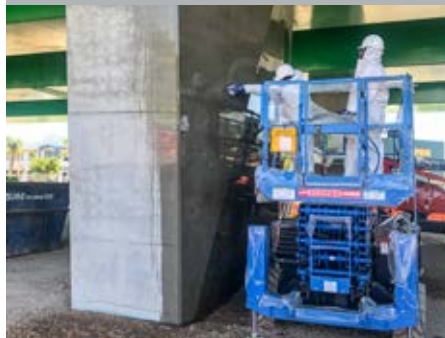
**Preparing concrete piers for application of anti-carbonation/anti-graffiti coating under the work previously carried out on the Regency Road overbridge**
