Cincinnati Healthcare Center

A Thermoplastic Rubber Roof Coating to Extend the Roof's Life

Healthcare Center
Cincinnati, OH

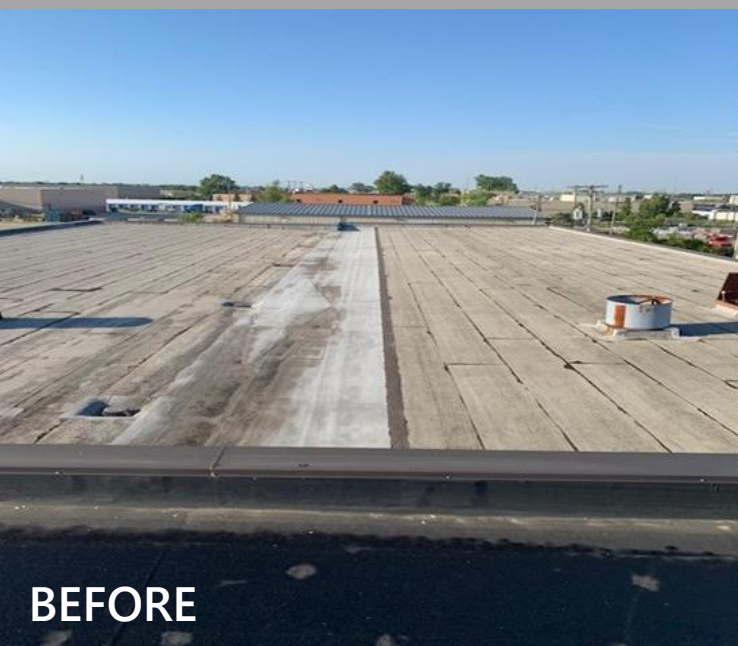
BEFORE

This aged modified bitumen roof membrane

was leaking and showing signs of wear and tear. Instead of replacing the roof with completely new material (and disposing of the old material in a land fill), this healthcare center in Cincinnati decided to restore the roof with Karnak 502 Thermoplastic Rubber two-part roof coating.

Karnak 502 Thermoplastic
Rubber Roof Coating over
Modified Bitumen membrane

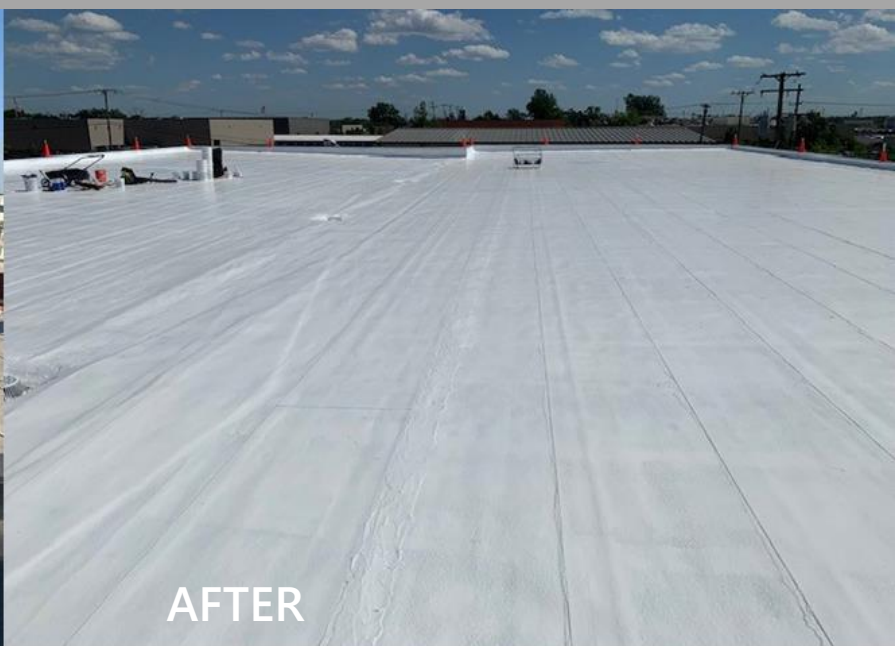
AFTER

This choice saved the customer tens of thousands of dollars and extended the roof's life by 10 to 15 years.

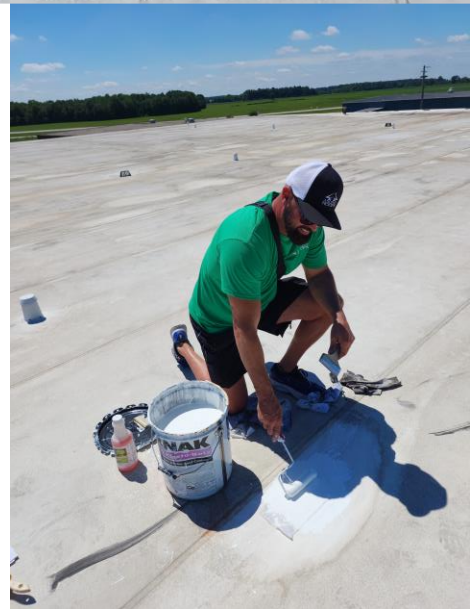
*Performing an adhesion
test with Karnak 502*
