MANDATORY BULLETIN No.

EV97-030a SR

- 1. CONCERNING:** All the aircraft of **Eurostar, SportStar and Harmony** types with ROTAX engine 912 UL, 912 ULS or 914 UL, affected by the bulletins of engine manufacturer No. SB-912-066, SB-914-047, SB-912-066UL and SB-914-047UL.

- 2. REASON:** The engine manufacturer orders by the above mentioned bulletins to measure temperature of coolant instead of cylinder head temperature with the engines with the design change of cylinder heads.

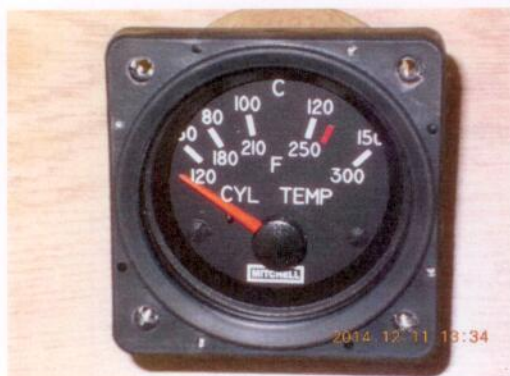
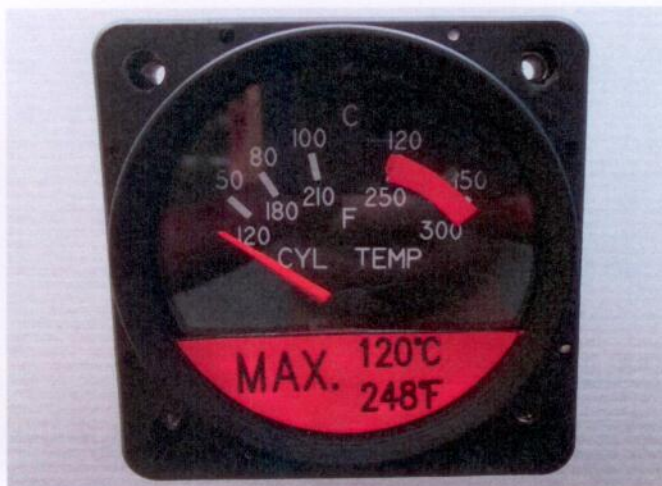
Fig.1 – View of the instrument with the analogue indicator of temperature:

Modify the instrument, originally indicating just cylinder head temperature according to Fig. 1:

- By sticking the red self-adhesive label, covering part of scale with the value of 120°C (248°F) up to the scale end, on the instrument glass.
- By sticking the red self-adhesive label with the text of **MAX. 120°C** on the lower half of instrument glass.

The numbers and original letters on the instrument mustn't be hidden by the modification!

- a) before modification
- b) after modification (magnified)

- **Coolant temperature:**
Maximum 120 °C/248 °F
- **Measurement of coolant temperature by analogue instrument**, if applied.
Coolant temperature is measured by **coolant thermometer**, which is the original instrument modified by sticking the red arch and plate with limitation **Max. 120 °C/248 °F** on the instrument glass. The red arch hides the unused part of scale from the temperature of 120 °C/248 °F up to the end of scale.
- **Measurement of coolant temperature by integrated digital instrument**, if applied.
Parameter **Cylinder head temperature** is replaced by parameter **Coolant temperature** with the limitation **Maximum temperature 120 °C/248 °F**.
