# Significant Environmental Impact (SEI) Natural Gas Leaks

## Shared Action Plan Year 1 (2019/2020)

### Utilities Enacting the Leak Extent Method

April 27th 2021

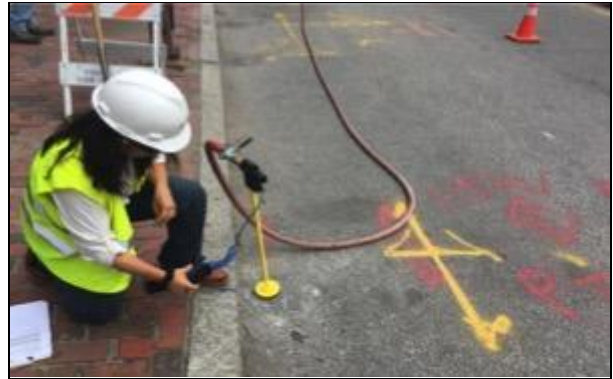
HEET testing the FluxBar

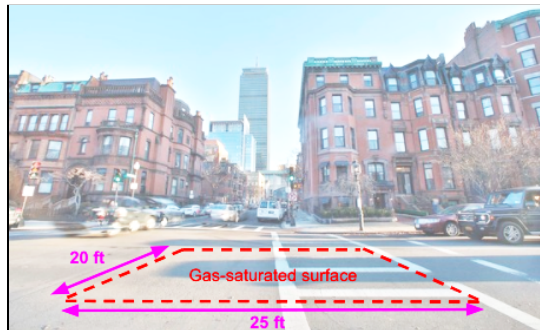
The study measured leak emissions using the chamber method, a peer reviewed method for measuring emissions over time, and then tested five proposed proxy methods for identifying the largest volume leaks quickly in the field. Gas workers worked together with grassroots volunteers and scientists to collect the data on leaks across the state.

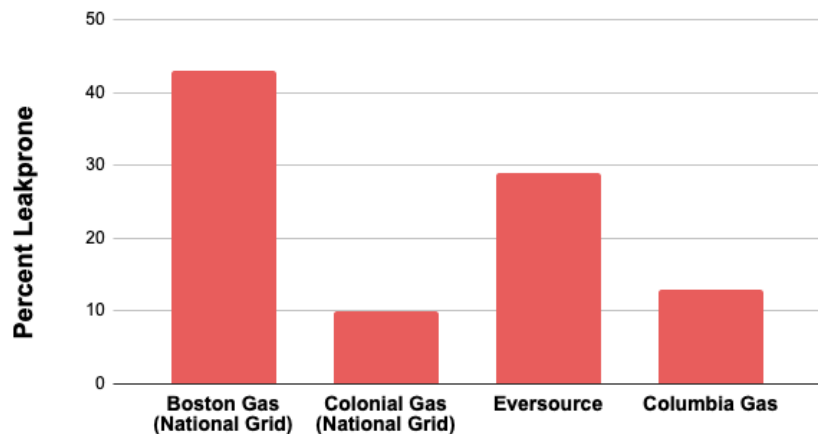
The chart on the right shows the percent of leakprone infrastructure for the largest Massachusetts gas utilities. Leakprone infrastructure has historically referred to non-cathodically protected steel, cast iron and wrought iron pipes. According to D.P.U. 20-GLR-01, 'Report to the legislature on the prevalence of natural gas leaks in the natural gas system', National Grid is now including pre-1985 plastic/Aldyl-A as leakprone, which was 3% of their system in 2020.

Source : Report to the Legislature (D.P.U 20-GLR-01), 2020

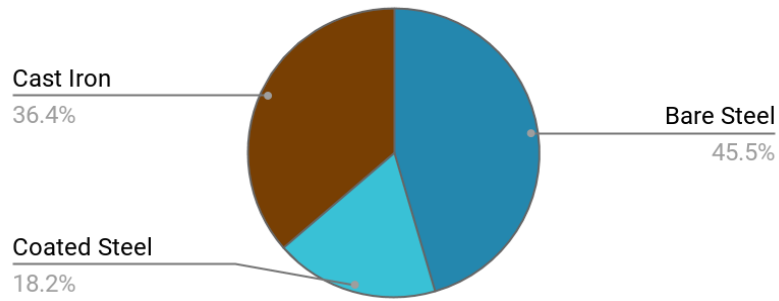
### Distribution of HEET Verified SEIs by Pipe Material

Bare steel and cast iron pipes appeared to be more likely to develop SEIs, especially when compared to the material distribution of the Columbia Gas territory below. This is consistent with our understanding of where most leaks in general are occurring. More data is needed to confirm this tendency since this was a very small dataset.

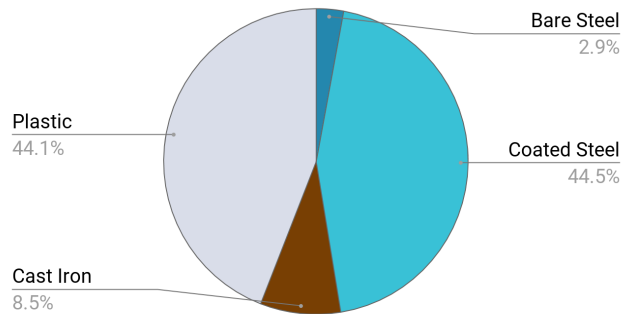
There were no SEIs reported or verified on plastic pipes. Columbia Gas territory as a whole has over 44% plastic pipes. This suggests that plastic pipes are less likely to develop SEIs.

2019 Columbia Gas System Enhancement Plan/Pipe Materials for All of Eversource Territory (Source: D.P.U. 19-GSEP-05 table II-1)

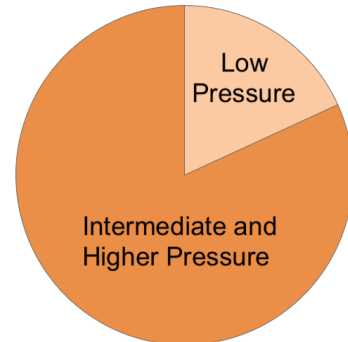
### Distribution of HEET Verified SEIs By Pressure

We examined the distribution of the 11 SEIs by pipe pressure. Less than 20% occurred on low pressure pipes. We did not have information on pipe pressure across the entire Columbia Gas territory to use as a reference and give this result more meaning.

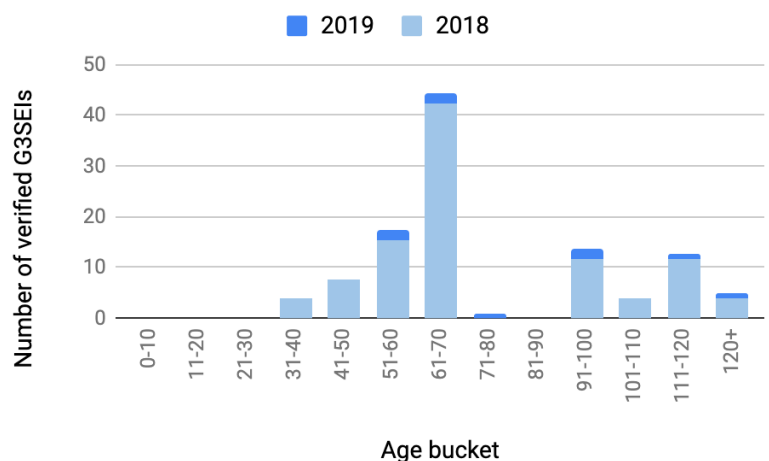
### Distribution of HEET Verified SEIs By Age of Pipe

We examined the distribution of the 9 of the 11 SEIs by the age of the pipe installation and found it to build on last year's pattern. We did not have information on ages of pipes across the entire Columbia Gas territory to compare this with. The median age was 75 and the average age was 83. We suggest that the gap in the 71-91 years old range is possibly due to no new pipes being installed because of World War II, and the spike around 60 years old is possibly due to a building boom leading to an increase in the number of pipes being installed at that time.

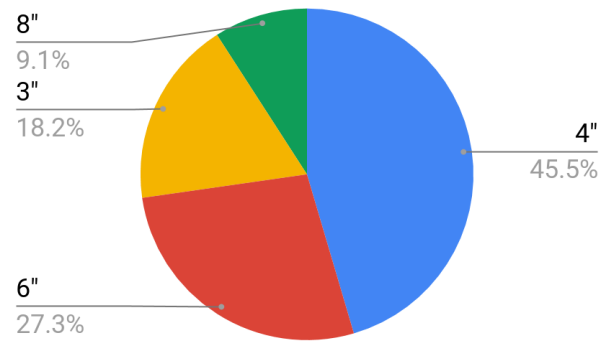
### Distribution of HEET Verified SEIs By Pipe Diameter

We examined the distribution of these 11 verified SEIs by pipe diameter and found they most commonly occurred on 4" pipe.

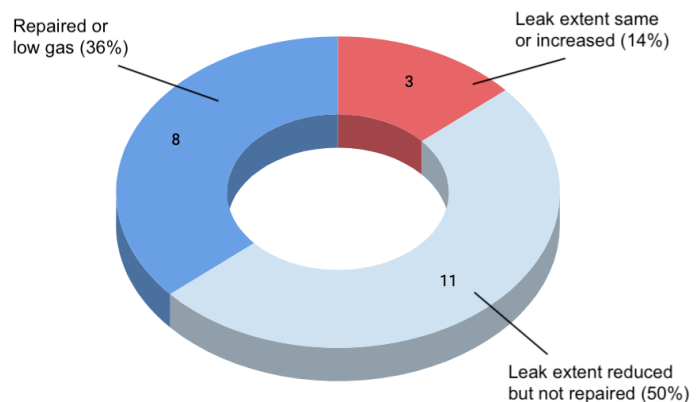
### Success Rate of Verified SEIs Repairs

Of the 159 leaks we surveyed, 29 leaks were reported repaired by the utilities. To allow all residual gas to leave the soil in the area, HEET returned to 27 of these leaks, 22 of which were verified SEIs, at least a month after repair to check for the presence of gas. If there was any, we recorded if the leak extent was smaller, the same, or larger. Whilst this data set is too small to be conclusive, the results follow a concerning trend from the trial year and the large volume leak study where only 1/3<sup>rd</sup> of the leaks are fixed by repair

work. The PHMSA funded study also included a repair rate analysis of 25 different verified SEIs and also found that only 1/3<sup>rd</sup> of these were actually fixed after repair work.

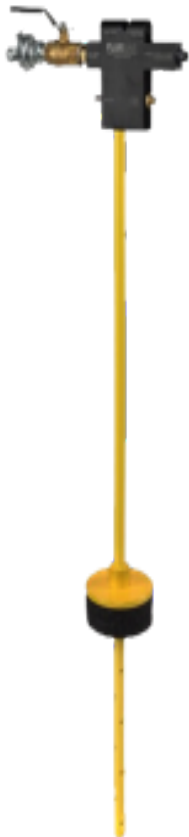
The FluxBar was invented during the pilot study through a collaboration of HEET, Eversource, Columbia Gas, Gas Safety Inc, Boston University Nathan Phillips and Millibar. The FluxBar is a utility-familiar tool that was redesigned to allow gas companies to compare the emissions of leaks in order to identify which were the largest just prior to repair. The FluxBar is not intended as a tool to identify SEIs as it requires a truck compressor and therefore can only be used by the leak repair crew just prior to repair. This repair crew use of the FluxBar on a significant number of SEIs could help result in data about SEIs, such as the pipe material, age or pressure that are correlated with SEIs, making identifying SEIs more efficient. It could also provide much needed directly measured flux data, potentially quantifying emissions reduced for carbon credits.

The FluxBar is inserted through a hole drilled through the road over the leak. It is connected to a truck compressor that blows air through the horizontal top of the tool. The flow of air, thanks to the Venturi effect<sup>27</sup>, vacuums air up the standpipe at a steady three cubic feet per minute. A combustible gas indicator connected to the FluxBar head can then measure the percent of gas in that steady air flow from under the road surface, right over the leak. The gas readings over time are noted to calculate the steady state plateau. The result allows a consistent comparison of directly measured flow rate from one leak to the next.

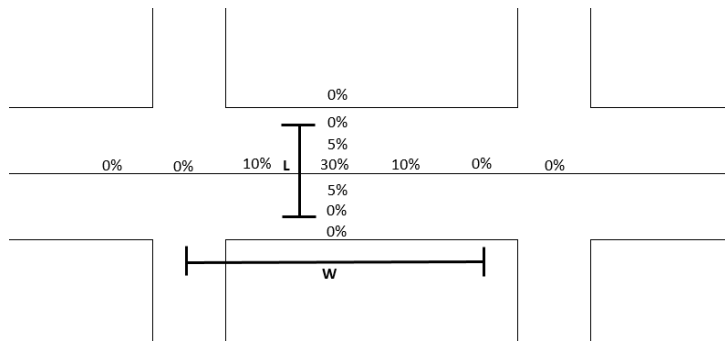
Figure 1 Capturing Leak Extent

1. Establish the initial leakage perimeter of the suspected leakage area using a surface gas detection survey in accordance with appropriate Company standards or procedures.
2. If a gas indication is found, continue to establish the leakage perimeter by using the subsurface gas detection survey in accordance with appropriate Company standards or procedures.
3. Leak Extent is measured by multiplying the greatest width (perpendicular to the pipe) by the longest length (parallel to the pipe) to get total surface area. The width and length is established based on zero to zero readings.
