Locality: HEYFIELD
Place address: GEORGE STREET
Citation date 2016
Place type (when built): Soldiers' Memorial
Recommended heritage protection: Local government level
Local Planning Scheme: Yes
Vic Heritage Register: No
Heritage Inventory (Archaeological): Yes

Place name: Heyfield Soldiers' Memorial and Pencil Pines

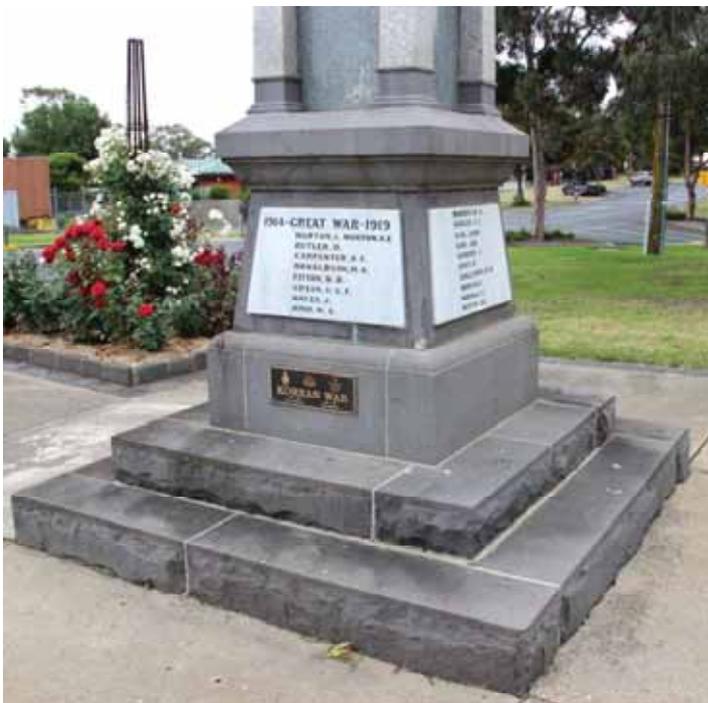
Figure D1. The bluestone quarry-faced stepped plinth, finely tooled pedestal, and the base and capitals of the cenotaph piers. Hand crafted marble plaques for WW1 and a new machine made bronze and paint plaque for the Korean War.

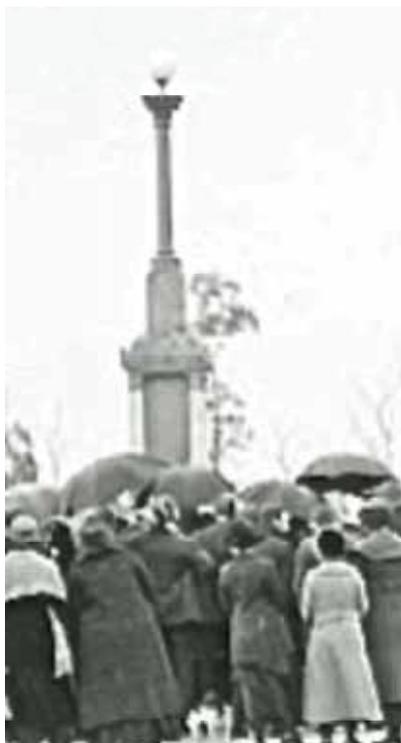
Figure D5a. The original form of the monument in 1923.

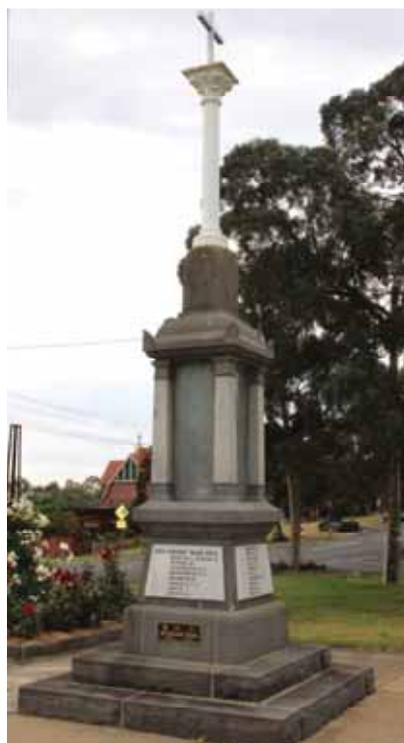
Figure D5b. The monument in 2015.
