FACILITY CONDITION ASSESSMENT

SACRAMENTO CITY UNIFIED SCHOOL DISTRICT
5735 47th Avenue
Sacramento, California 95824

CAPITOL COLLEGIATE ACADEMY
2118 Meadowview Road
Sacramento, California 95832

June 12, 2020

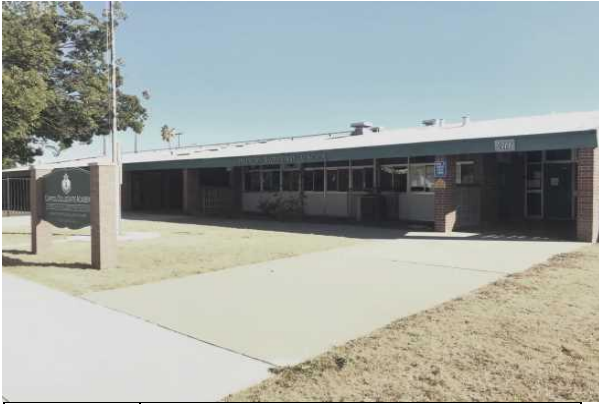
#1

FRONT ENTRY

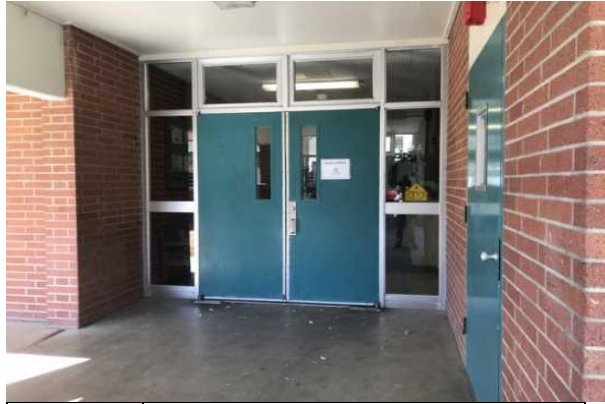
#2

FRONT ENTRY

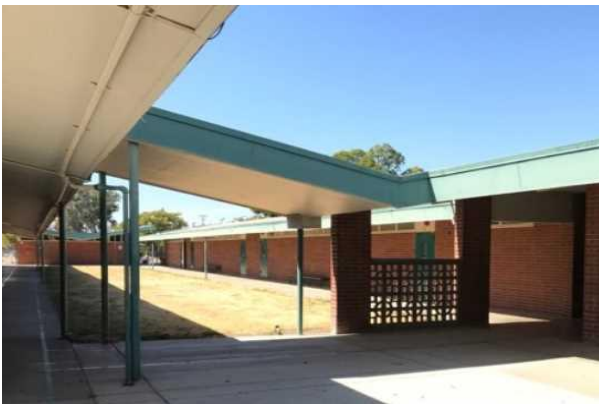
#3

BUILDING 001

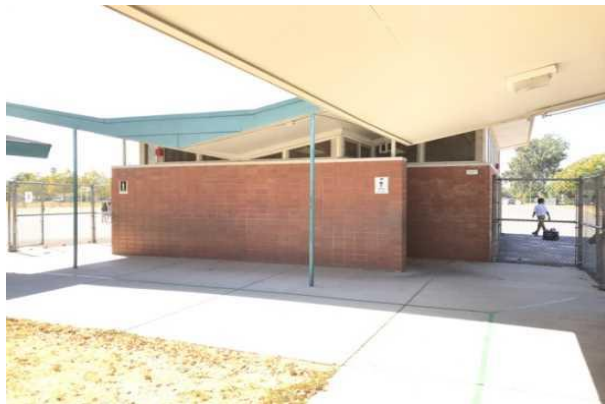
#4

BUILDING 002

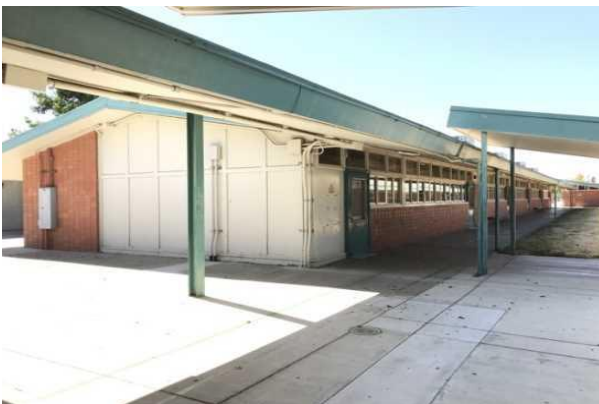
#5

BUILDING 003

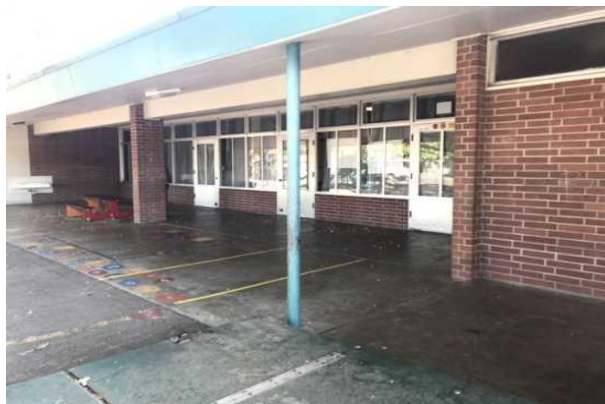
#6

BUILDING 004

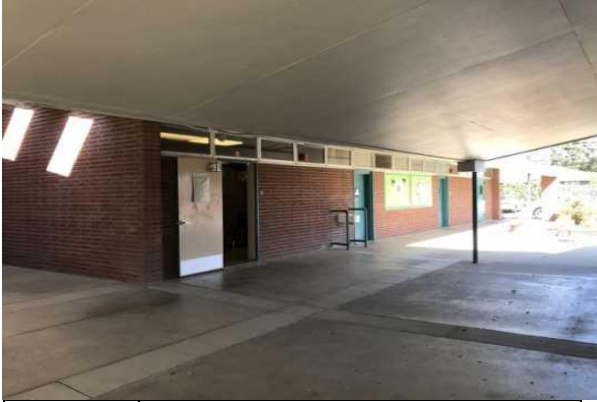
#7

BUILDING 005

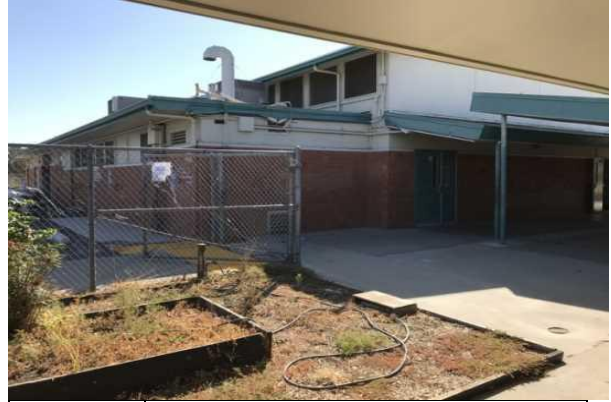
#8

BUILDING 006

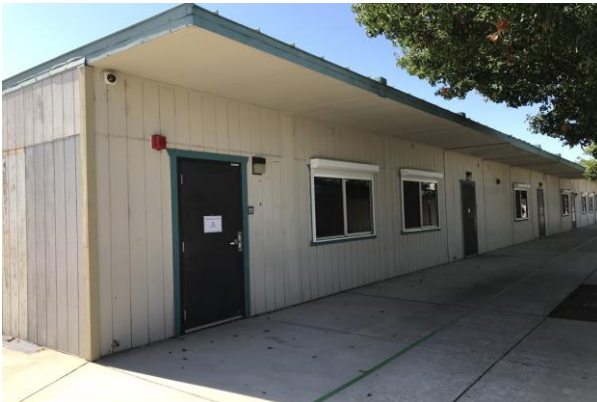
#9

BUILDING P01

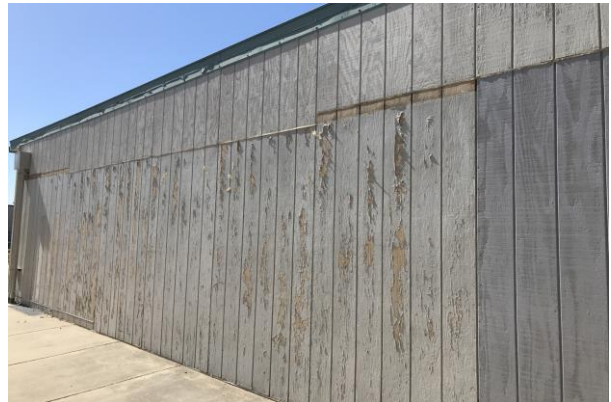
#10

BUILDING P01 SIDE WALL

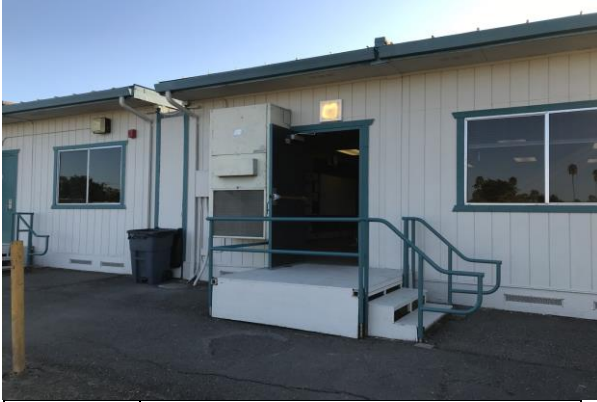
#13

BUILDING P09

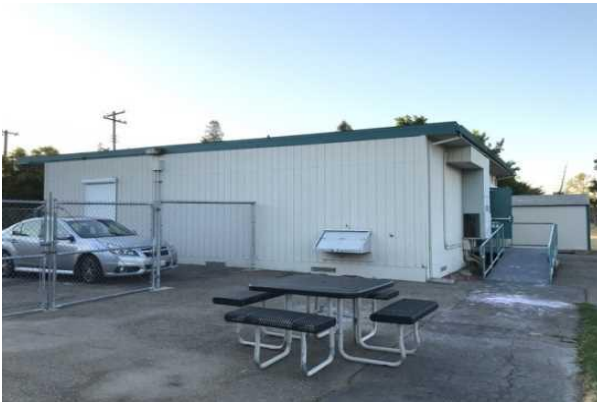
#15

BUILDING P11

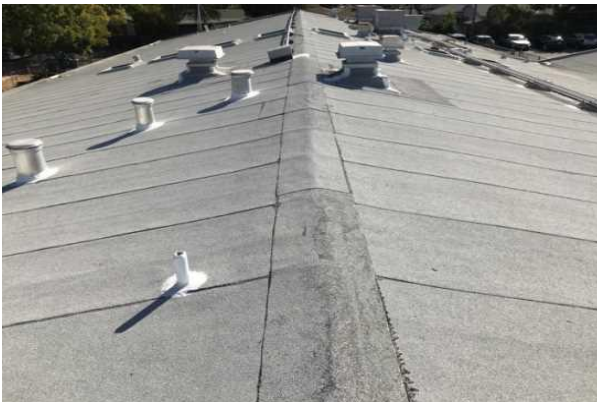
#16

NEW RESTROOM BUILDING

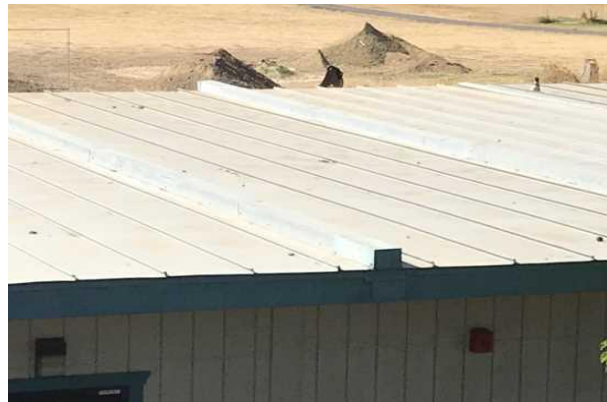
#17

ROOF, MODIFIED BITUMINOUS

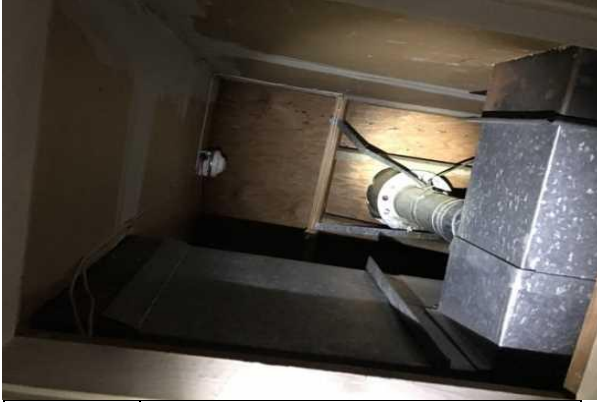
#18

ROOF, METAL

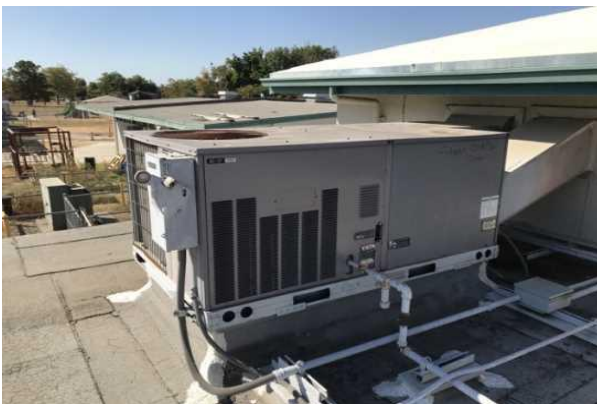
#28 PACKAGED UNIT, 003

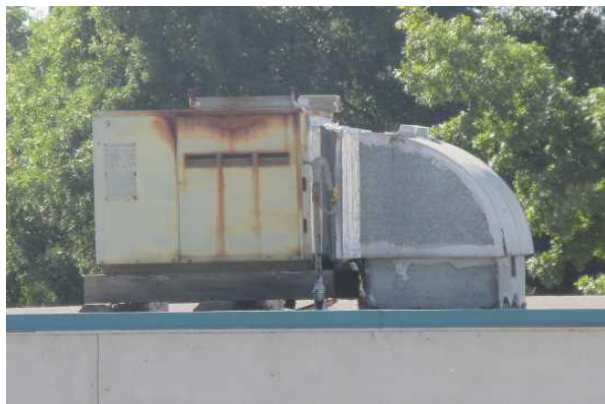
#29 PACKAGED UNIT (RTU), 006

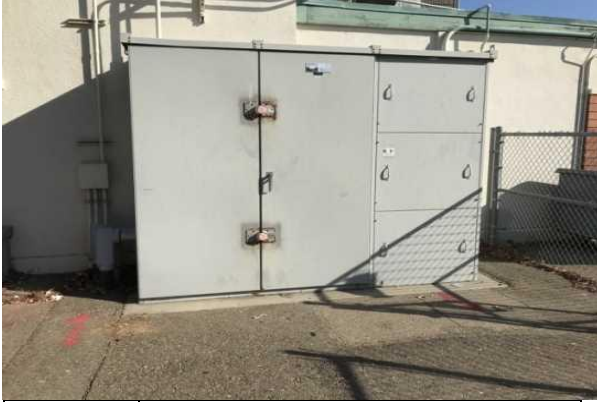
#30 PACKAGED UNIT (RTU), P08

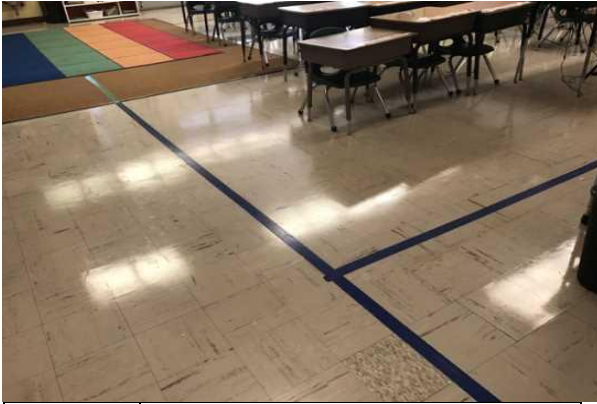
#42

CARPET AND VINYL ASBESTOS
TILE IN CLASSROOM
