FACILITY CONDITION ASSESSMENT

SACRAMENTO CITY UNIFIED SCHOOL DISTRICT
5735 47th Avenue
Sacramento, California 95824

AMERICAN LEGION
3801 Broadway
Sacramento, California 95817

June 17, 2020

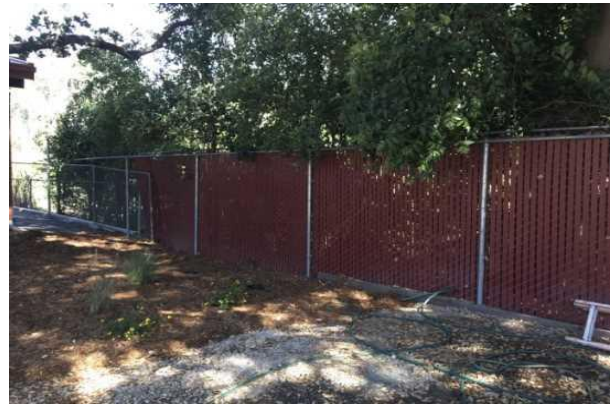
#69

LANDSCAPING
