# FACILITY CONDITION ASSESSMENT

SACRAMENTO CITY UNIFIED SCHOOL DISTRICT  
5735 47<sup>th</sup> Avenue  
Sacramento, California 95824

HIRAM JOHNSON HIGH SCHOOL  
6879 14th Avenue  
Sacramento, California 95820

June 17, 2020

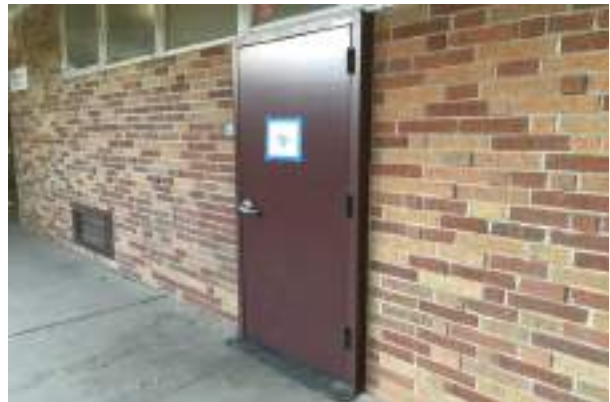
#6	EXTERIOR DOOR, WOOD SOLID-CORE
----	--------------------------------

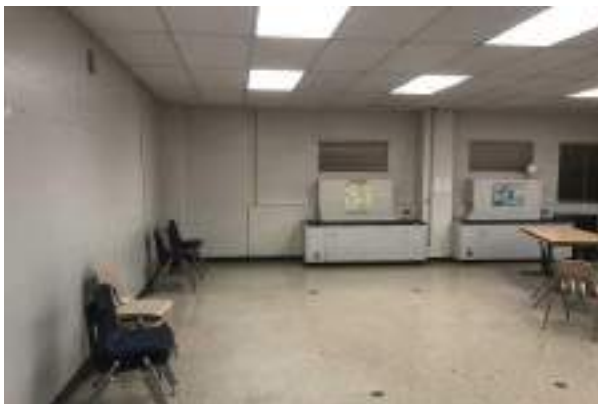
#17	001 A WING, B WING, CLASSROOM INTERIORS
-----	---

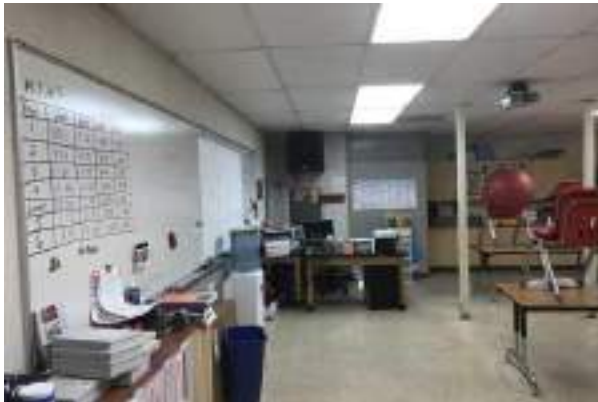
#27	PORTABLE CLASSROOM
-----	--------------------

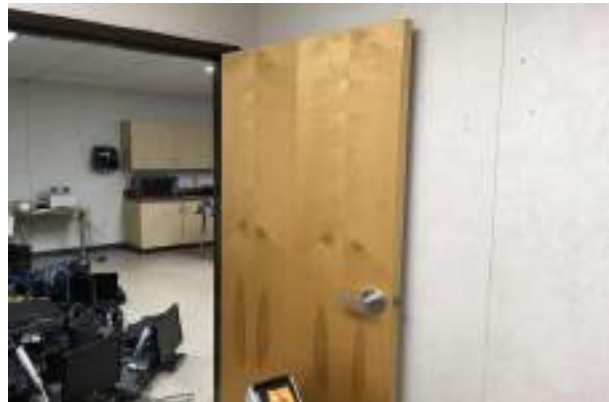
#28	INTERIOR DOOR, WOOD SOLID-CORE
-----	--------------------------------

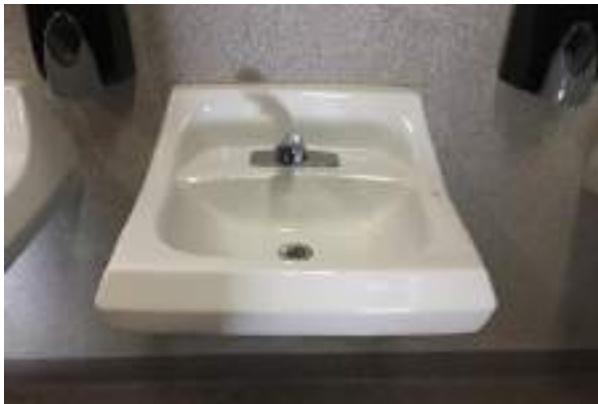
#29	SINK/LAVATORY, WALL-HUNG, ENAMELED STEEL
-----	--

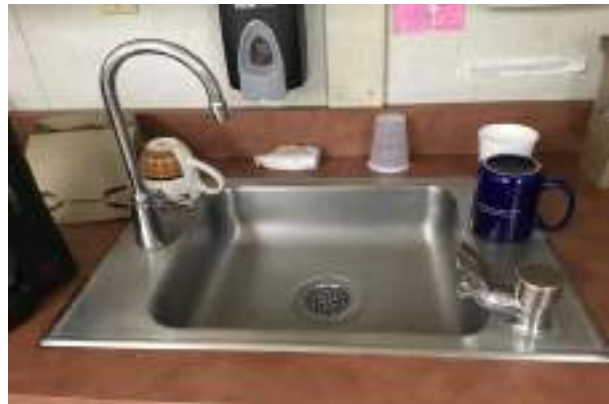
#30	SINK/LAVATORY, VANITY TOP, STAINLESS STEEL
-----	--

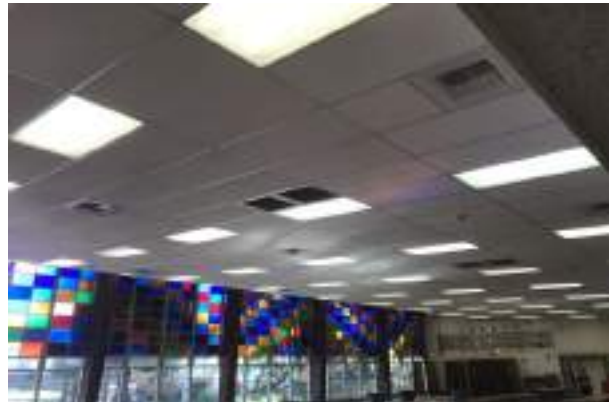
#34	LIGHTING SYSTEM, INTERIOR, MEDIUM DENSITY AND STANDARD FIXTURES
-----	---

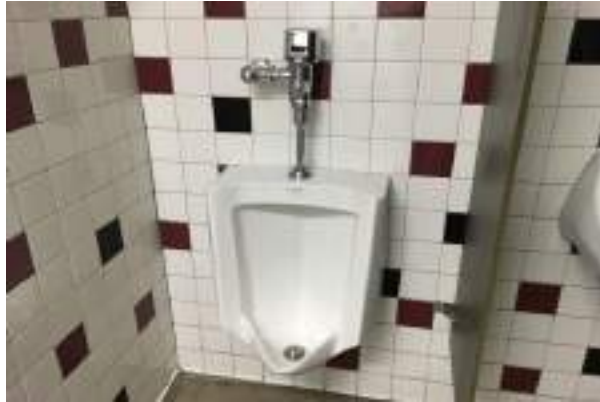
#37	URINAL, STANDARD
-----	------------------

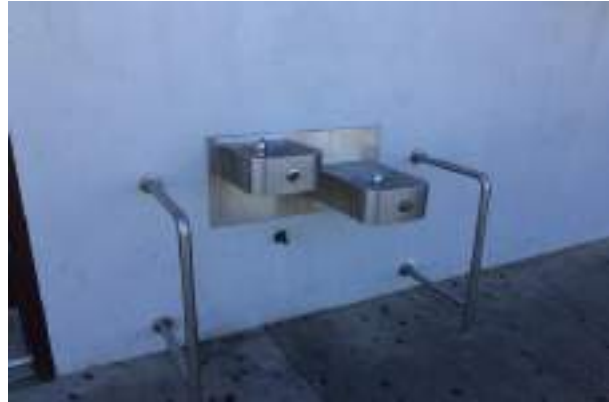
#38	DRINKING FOUNTAIN, OUTSIDE/SITE STYLE
-----	---------------------------------------

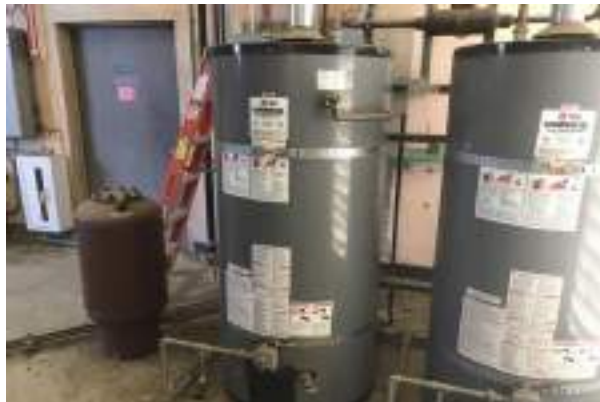
#41	013 ROTC, DOMESTIC WATER HEATERS, GAS, COMMERCIAL
-----	---

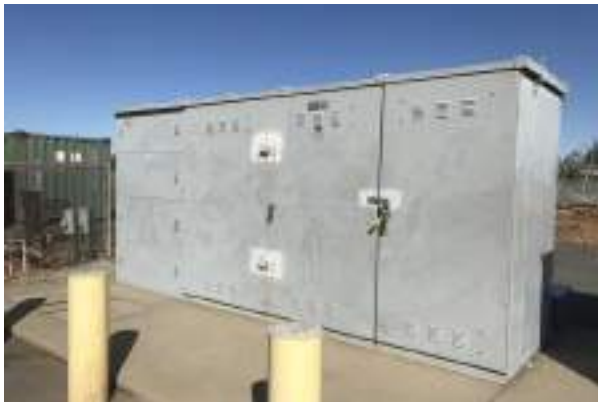
#53	BUILDING/MAIN SWITCHBOARD
-----	---------------------------

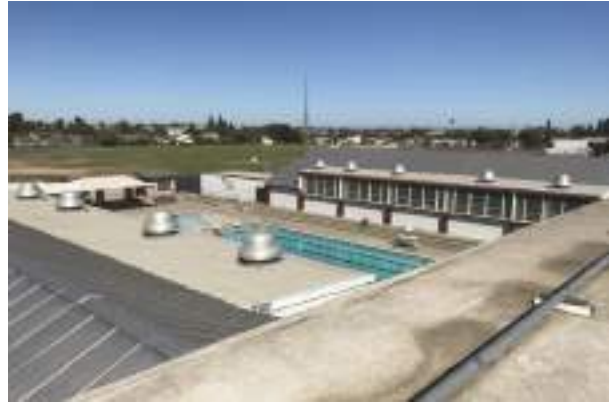
#56	014 GYMNASIUM, SWIMMING POOL
-----	------------------------------

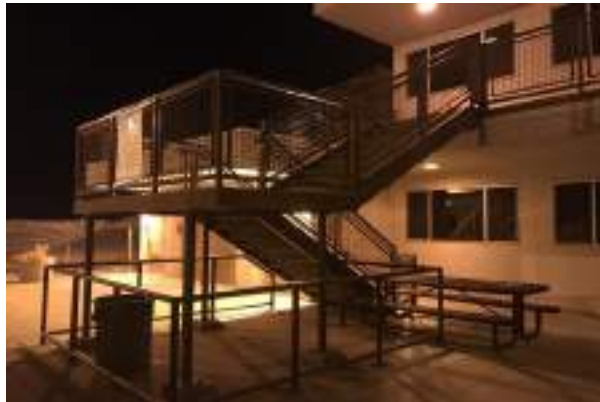
#57	P03 X09-X12, EXTERIOR STAIRS, METAL OR PAN-FILLED
-----	---

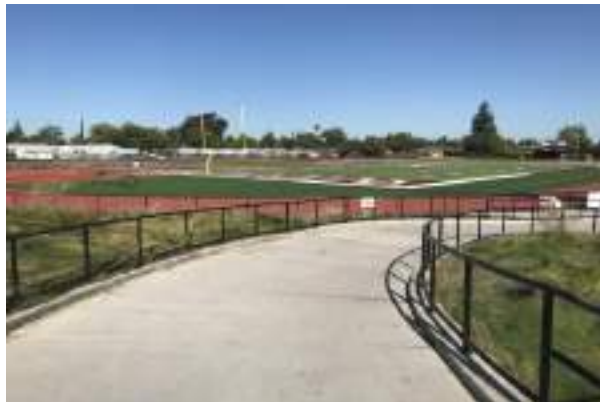
#59	PLAY SURFACES, ARTIFICIAL TURF
-----	--------------------------------

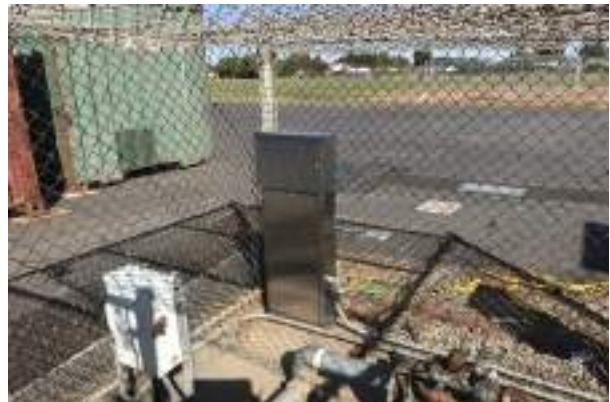
#60	SITE IRRIGATION SYSTEM
-----	------------------------
