# SAMPLE HANDOVER REPORT

## BUILDING INSPECTION REPORT

SAMPLE ADDRESS  
Wellington  
New Zealand

Inspected by: Kieran Long | Inspection Date: 31 May 2023 | Ph: 0212621120

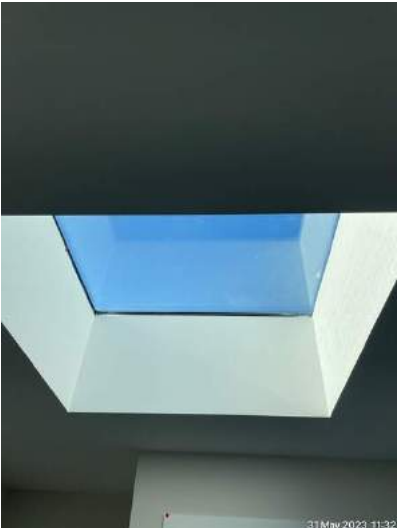
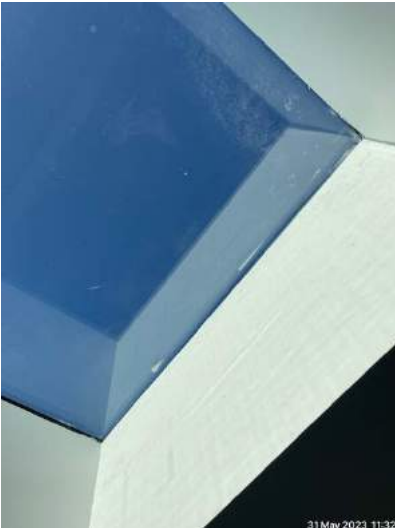
Photo Ref #1: Skylight - Excess paint to interior and exterior of skylight	Photo Ref #2: Skylight - Excess paint to interior and exterior of skylight

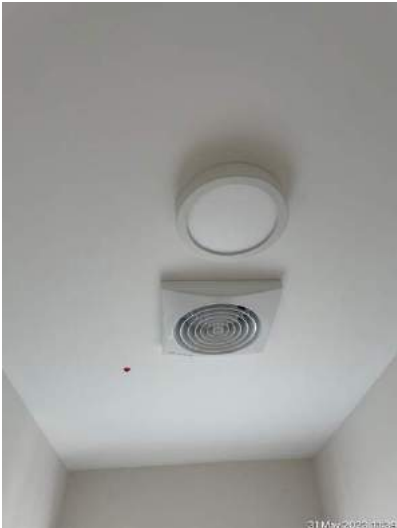
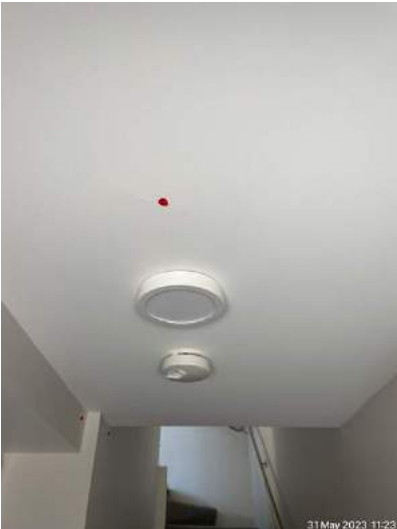
Photo Ref #3: Separate toilet - plaster/paint imperfection	Photo Ref #4: Separate toilet - plaster/paint imperfection

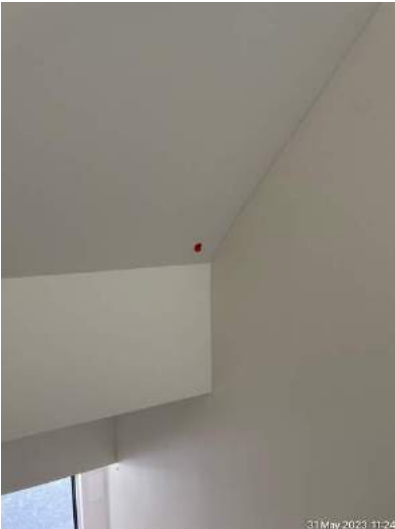
Photo Ref #5: Hallway ceiling - plaster/paint imperfection	Photo Ref #6: Hallway ceiling - plaster/paint imperfection

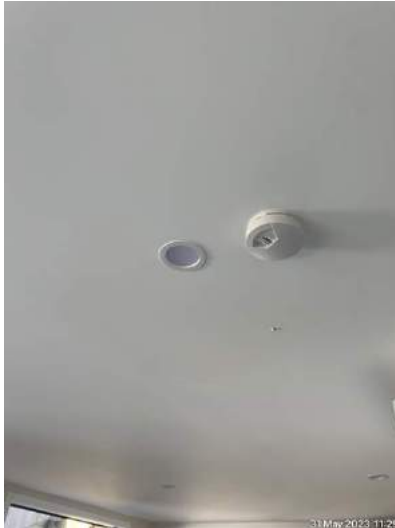
Photo Ref #7: Lounge ceiling  
infront of steps - plaster/paint  
imperfection

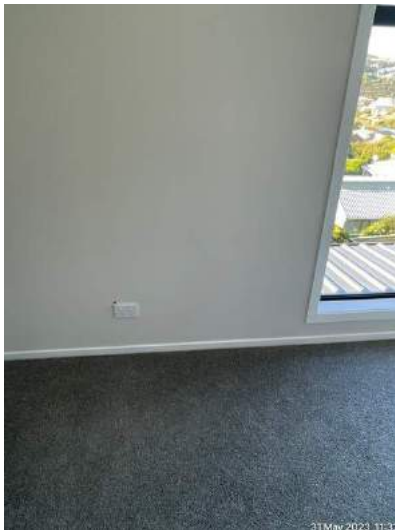
Photo Ref #8: Upstairs spare  
bedroom - plaster/paint  
imperfection

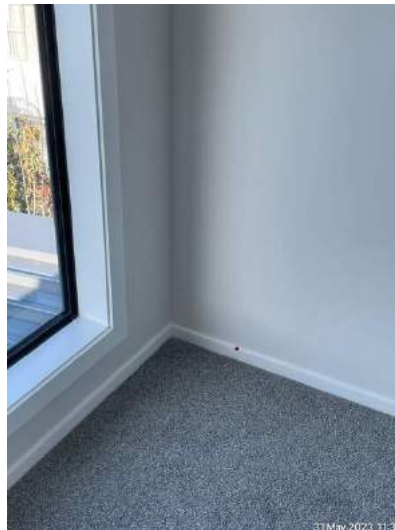
Photo Ref #9: Upstairs spare  
bedroom - plaster/paint  
imperfection

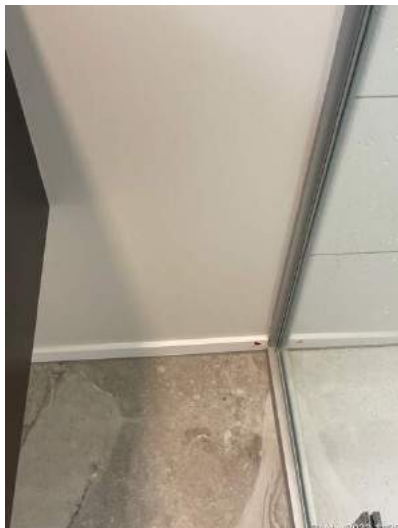
Photo Ref #12: Bathroom  
Upstairs spare bedroom -  
plaster/paint imperfection

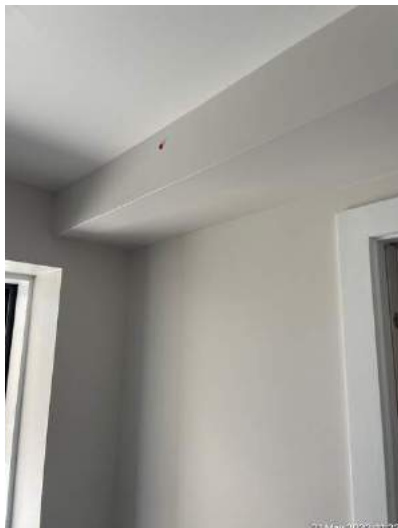
Photo Ref #18: Entrance way - plaster/paint imperfection

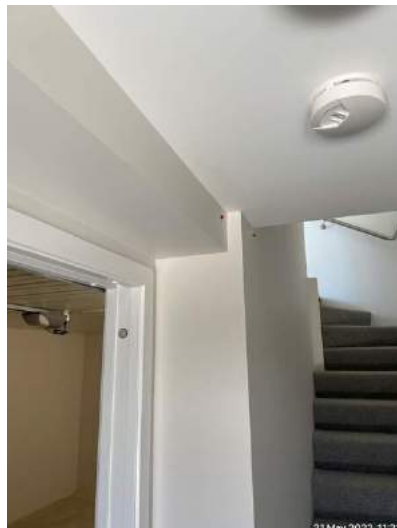
Photo Ref #19: Entrance way - plaster/paint imperfection

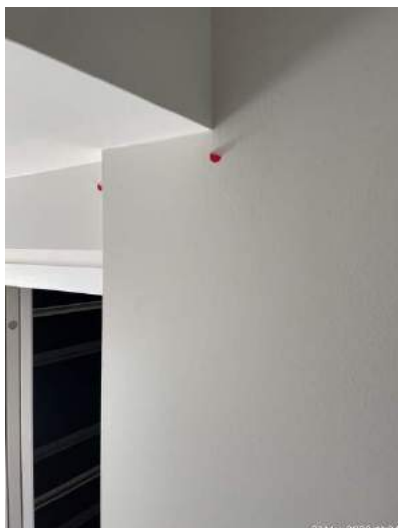
Photo Ref #21: Entrance/Hallway - plaster/paint imperfection

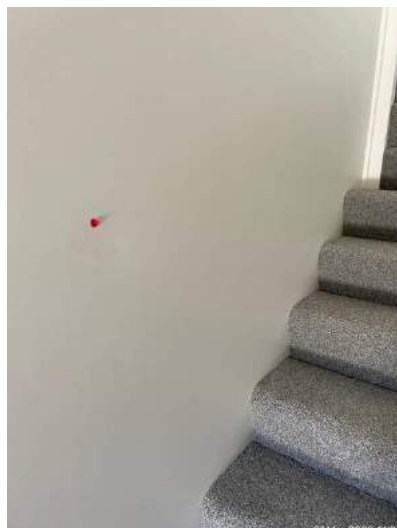
Photo Ref #22: Entrance/Hallway - plaster/paint imperfection

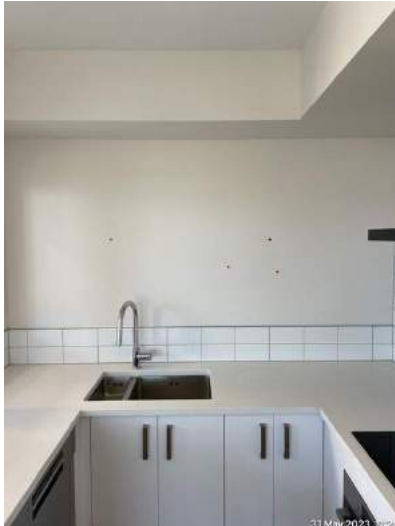
Photo Ref #26: Kitchen back wall - plaster/paint imperfection(Back wall not sanded)

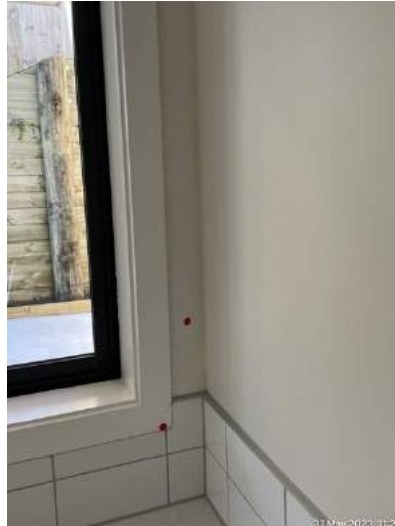
Photo Ref #27: Kitchen wall - plaster/paint imperfection

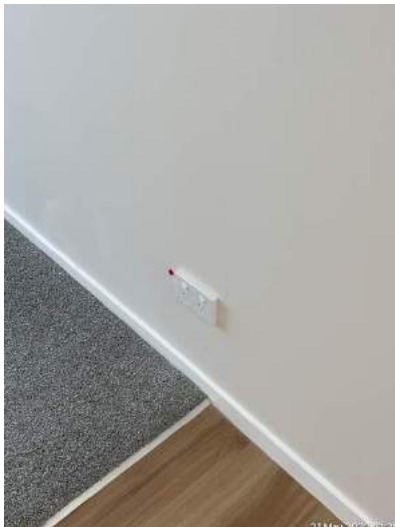
Photo Ref #29: Lounge - plaster/ paint imperfection

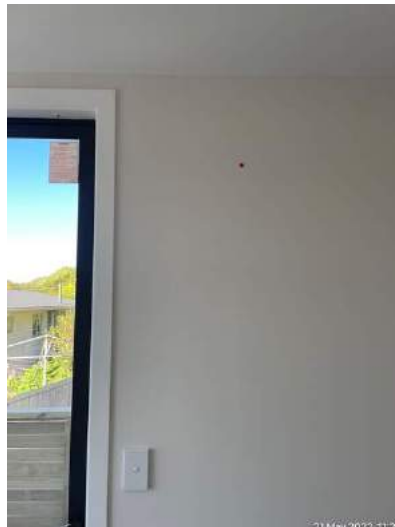
Photo Ref #30: Lounge - plaster/ paint imperfection

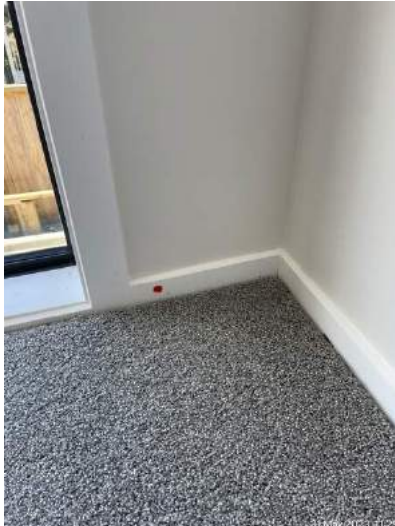
Photo Ref #32: Lounge - plaster/paint imperfection

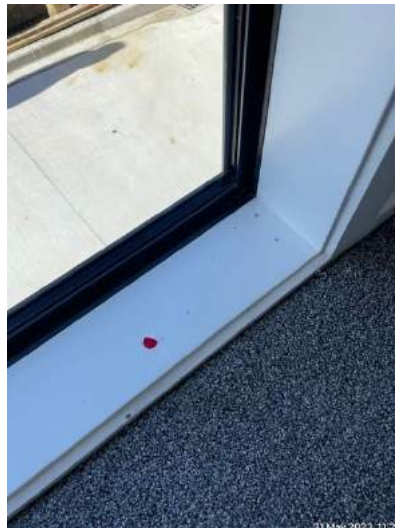
Photo Ref #35: Minor putty defects

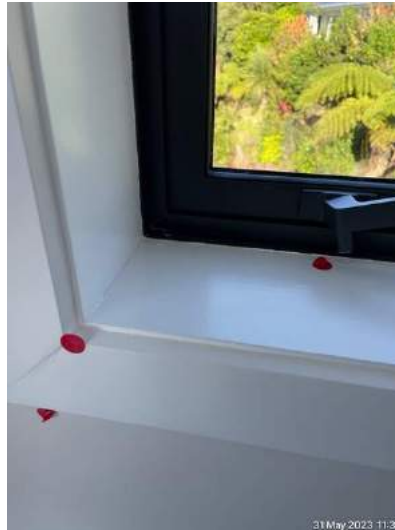
Photo Ref #43: Plaster/paint imperfection

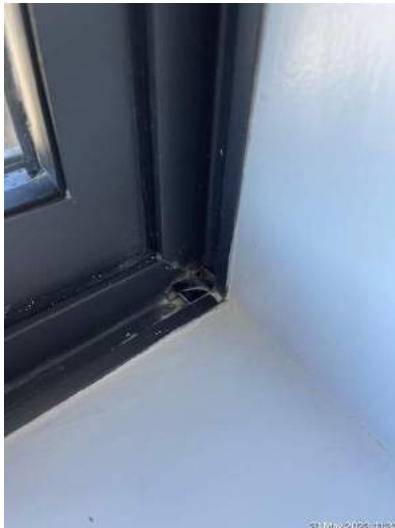
- The window has excess construction dust/dirt around the sill drains. Sill drains are used to allow excess moisture/condensation that can occur to the interior of the window to drain to the exterior. These should be cleared to ensure they can drain freely.

Photo Ref #45: Excess construction dust/dirt around the sill drains

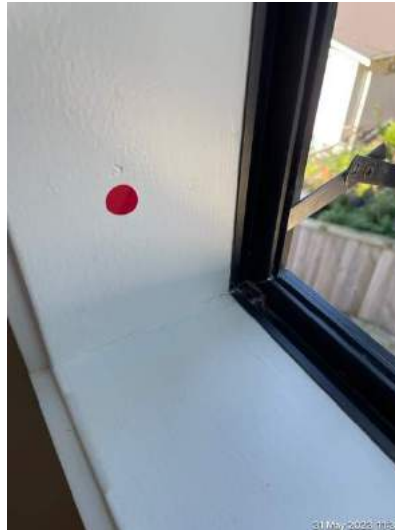
Photo Ref #47: Plaster/paint imperfection

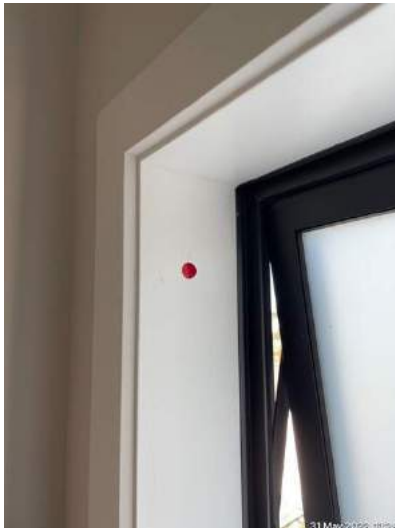
Photo Ref #49: Plaster/paint imperfection

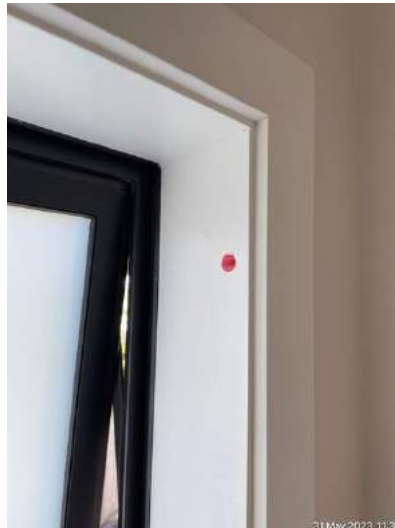
Photo Ref #50: Plaster/paint imperfection

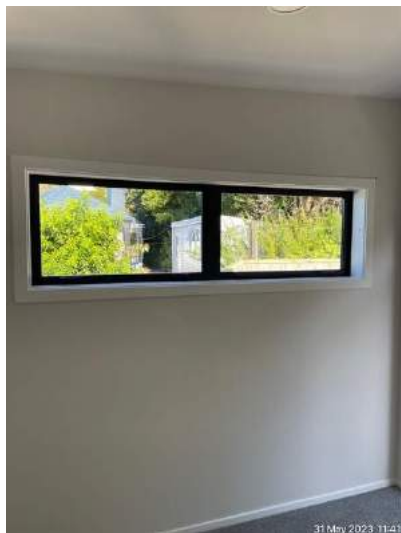
Photo Ref #51

Master bedroom window: The window was operating as to be expected. Some general plaster/paint imperfections were sighted. Refer to photographs and details below.

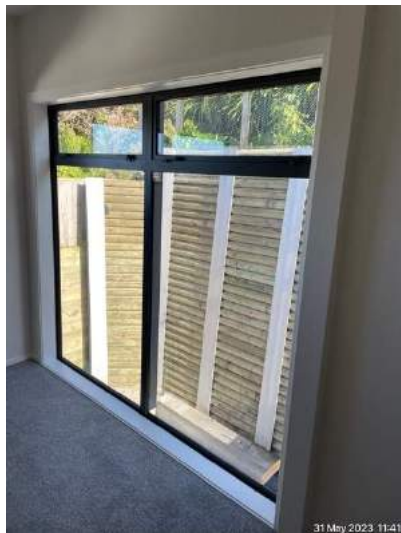
Photo Ref #53

Master bedroom window: The window was operating as to be expected. Some general plaster/paint imperfections were sighted. Refer to photographs and details below.

Sill Drain Details:	- The window has excess construction dust/dirt around the sill drains. Sill drains are used to allow excess moisture/condensation that can occur to the interior of the window to drain to the exterior. These should be cleared to ensure they can drain freely.
Rating:	Minor Maintenance

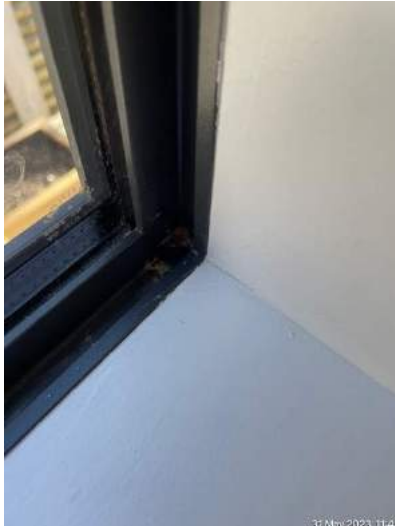
Photo Ref #56: Excess construction dust/dirt around the sill drains

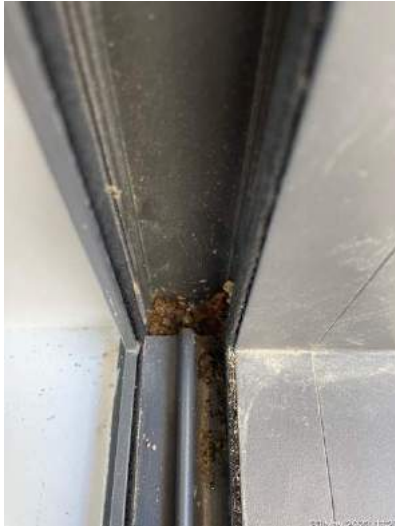
- The door has excess construction dust/dirt around the sill drains. Sill drains are used to allow excess moisture/condensation that can occur to the interior of the door to drain to the exterior. These should be cleared to ensure they can drain freely.

Photo Ref #61: Excess construction dust/dirt around the sill drains

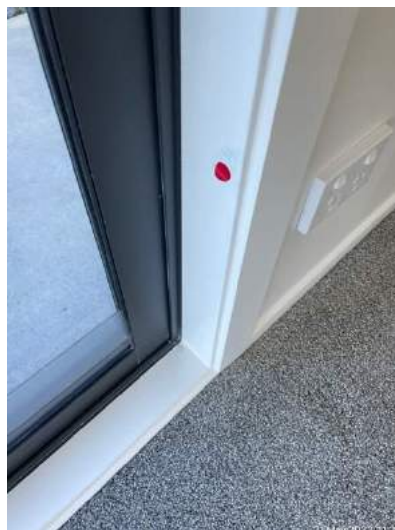
Photo Ref #64: Plaster/paint imperfection

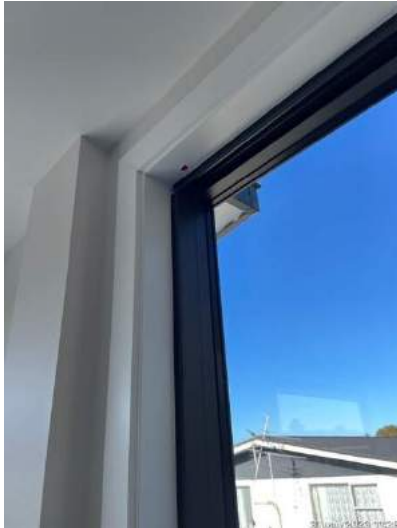
Photo Ref #66: Plaster/paint imperfection

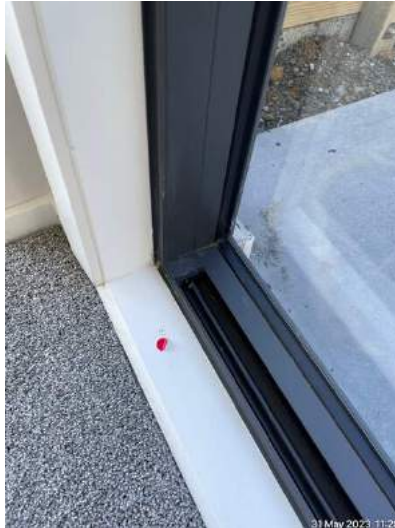
Photo Ref #67: Plaster/paint imperfection

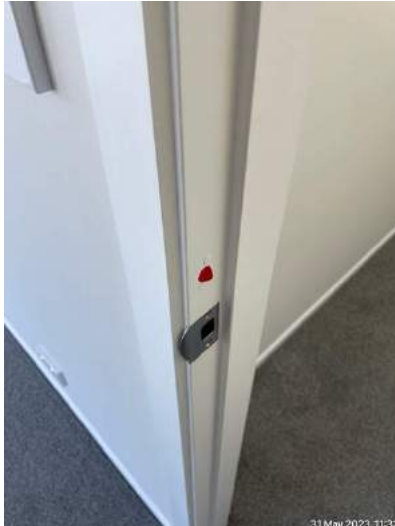
Photo Ref #72: Plaster/paint imperfection

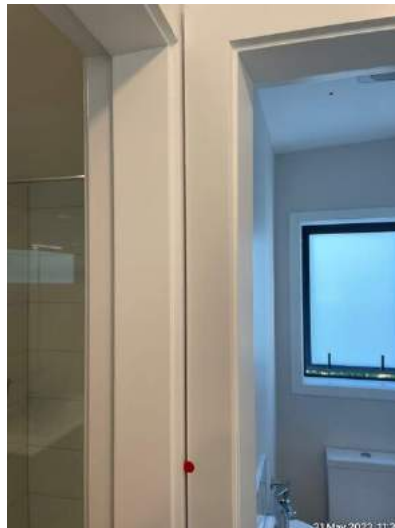
Photo Ref #74: Screw heads were visible between bathroom and separate toilet door

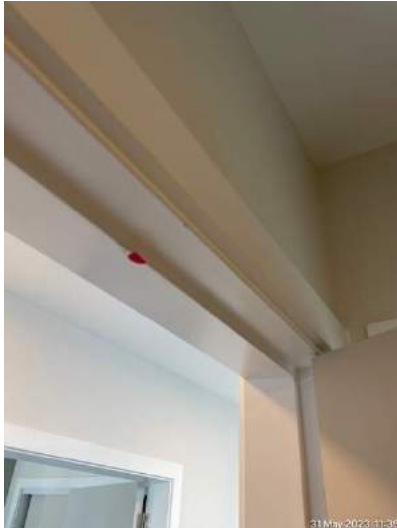
Photo Ref #76: Paint  
imperfection to upper jam

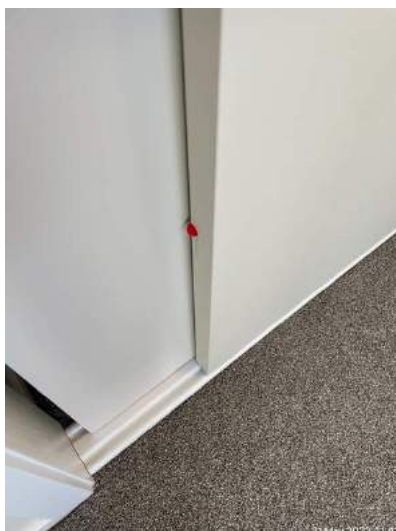
Photo Ref #87: Paint imperfection

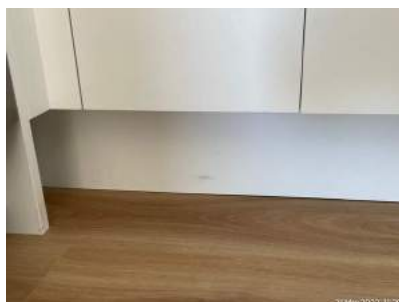
Photo Ref #93: Suff marks to toe kicks

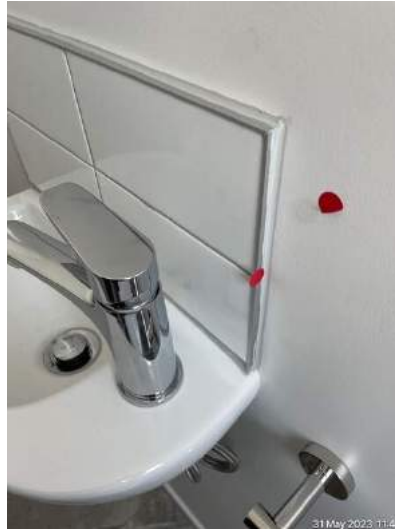
Photo Ref #108: Excess paint to tile trim

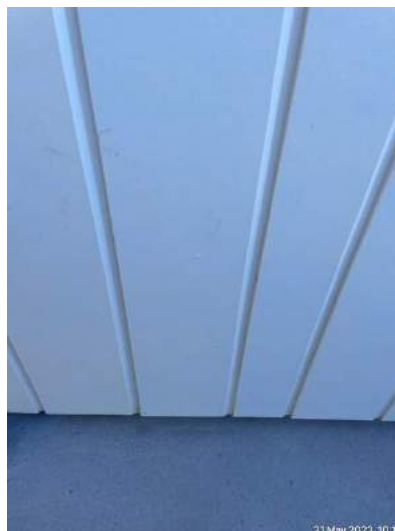
Photo Ref #117: Southern wall - imperfections to paint coating

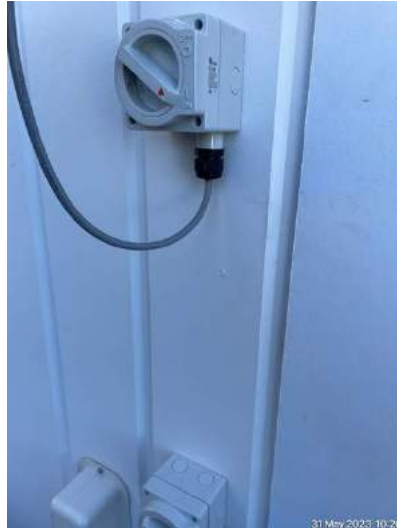
Photo Ref #120: Southern wall - imperfections to paint coating

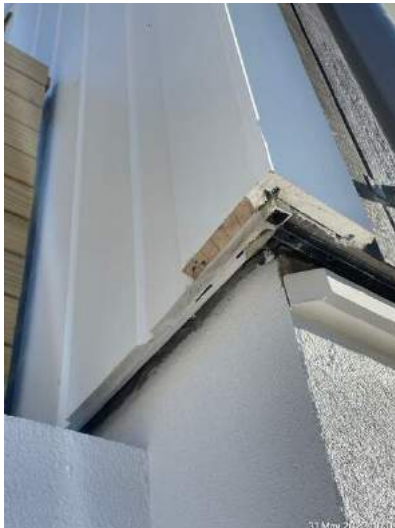
Photo Ref #122: Bottom of southeastern box corner not painted

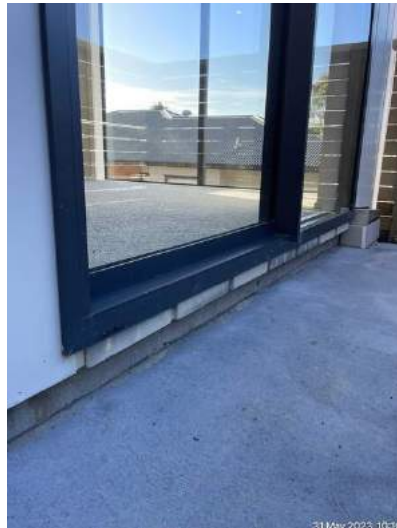
Photo Ref #123: Southern wall - bottom of cladding not painted

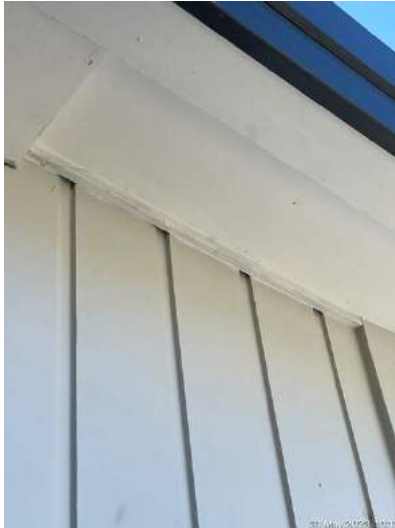
Photo Ref #125: Southern wall - Untidy finishing at eave junction - maintenance required

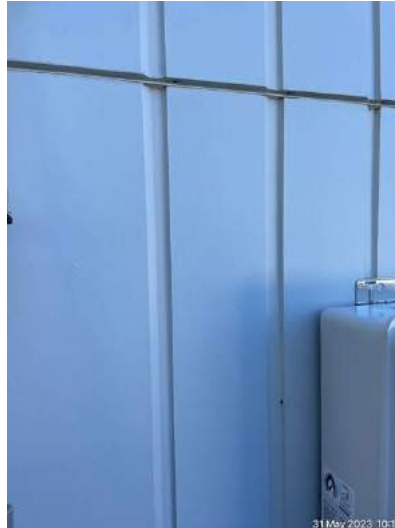
Photo Ref #126: Southern wall - imperfections to paint coating

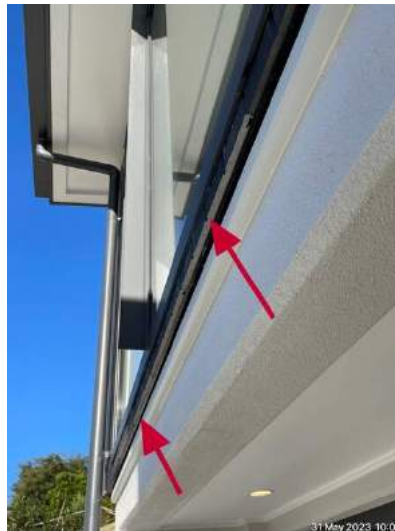
Photo Ref #132: Eastern wall - bottom edge of cladding not painted

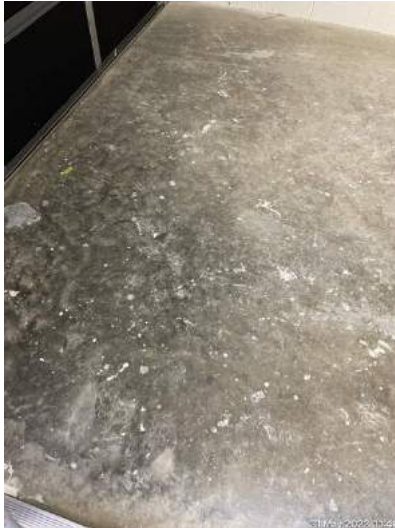
Photo Ref #155: Excess paint was in place to the garage concrete floor

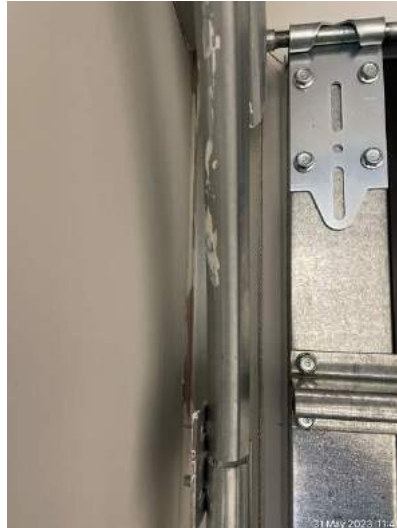
Photo Ref #156: Unpainted areas either side of garage door

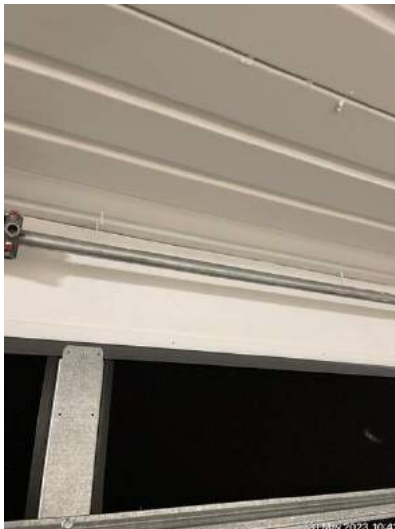
Photo Ref #158: Unpainted areas either side of garage door

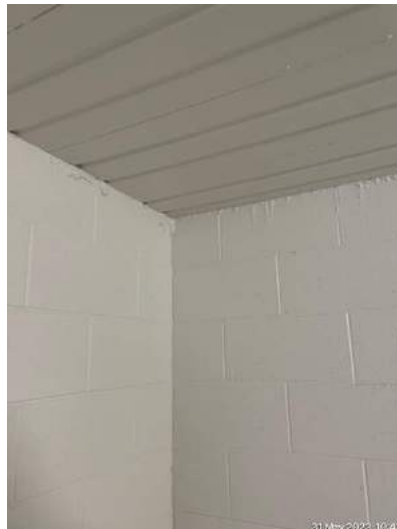
- Exposed nails were sighted coming through the ceiling above the garage door. This could be a hazard. These require removal with a smooth finish.
- Excess paint was in place to the garage concrete floor. This requires cleaning.
- Excess concrete seepage was sighted around the garage masonry block walls.

Photo Ref #159: Untidy concrete seepage around garage walls
